# ANNUAL REPORT FOR 2005

**Cedar Point Mitigation Site  
Carteret County  
Project No. 6.16901T  
TIP No. R-2105 AB**

Prepared By:  
Natural Environment Unit & Roadside Environmental Unit  
North Carolina Department of Transportation  
December 2005

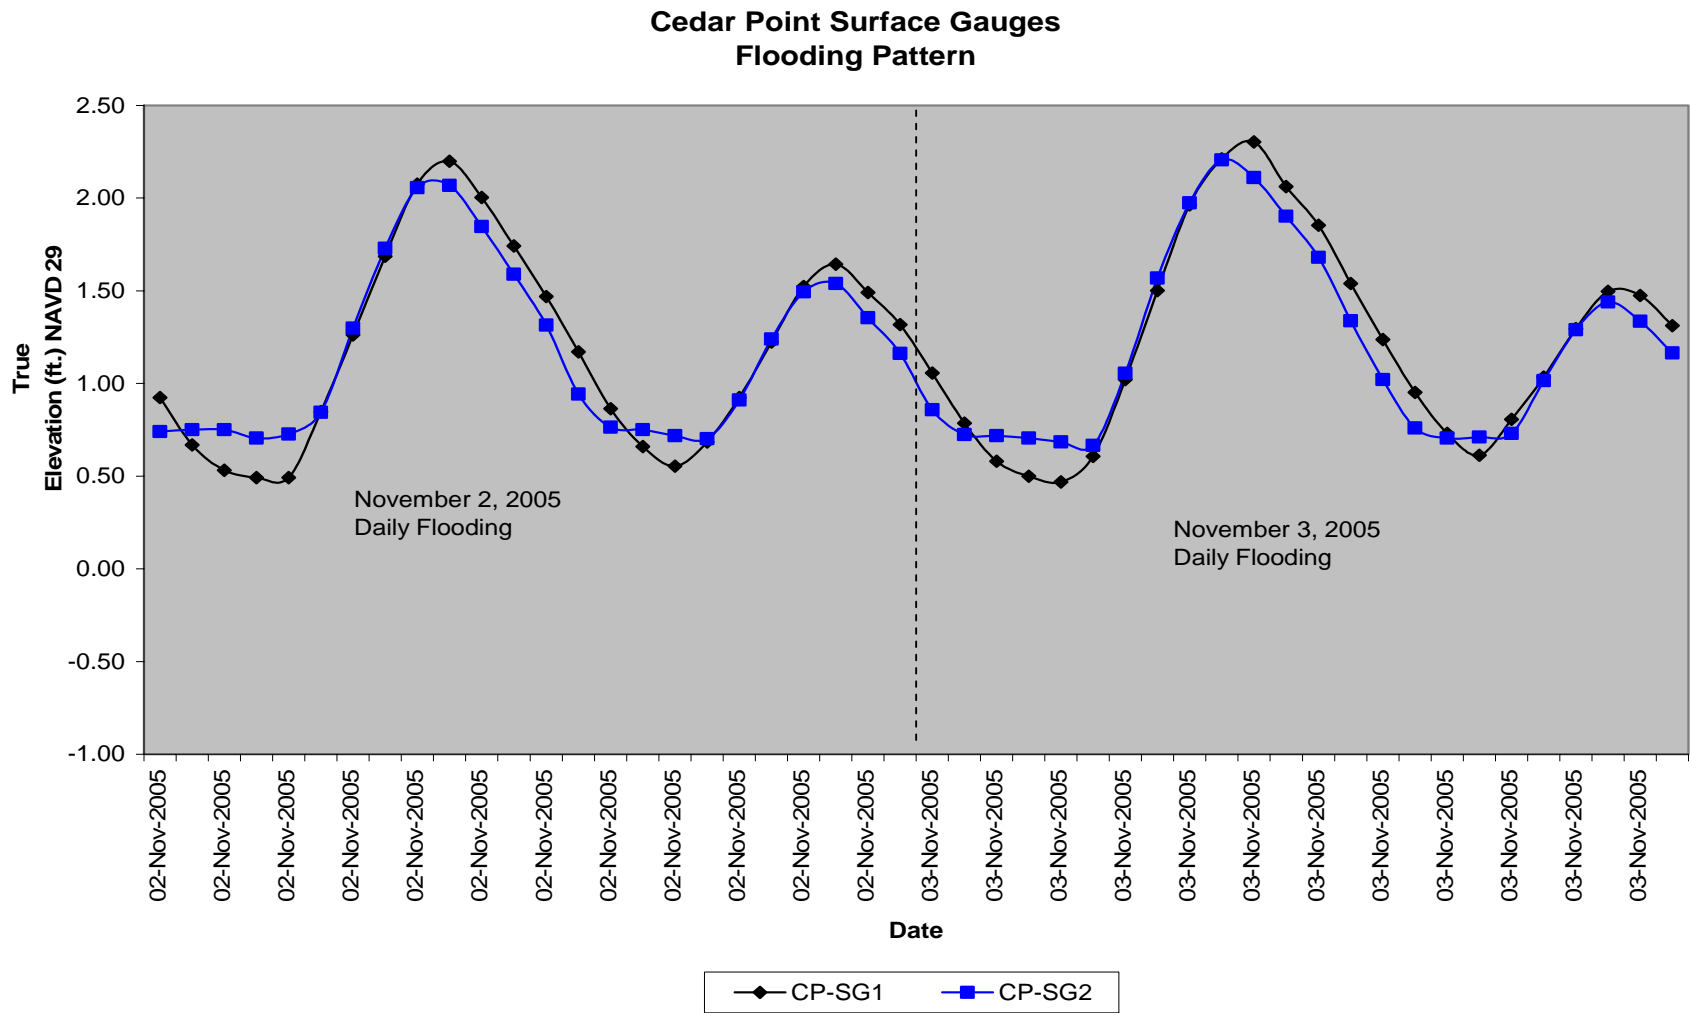
Figure 3. Plot of Daily Flooding Pattern (2-day period shown)

Figure 3 is a surface water plot of the data recorded at both gauges over a two-day period. This figure illustrates that flooding occurs twice daily as required in the permit conditions. The two days in the plot were chosen at random and are representative of conditions throughout the growing season.

The surface gauges indicate that the site is being flooded twice daily during the growing season. An examination of the water levels over a two-day period (Figure 3) illustrates that the site floods twice daily under average climatic conditions. The two days in the plot were chosen at random and are representative of typical conditions during the growing season.
