Monitoring Data Record

Project Title: U-2524AC Site 1 COE Action ID: 200321137

Stream Name: UT No. 9 to Bull Run DWQ Number: 030909

City, County and other Location Information: Greensboro Western Loop, Guilford Co.

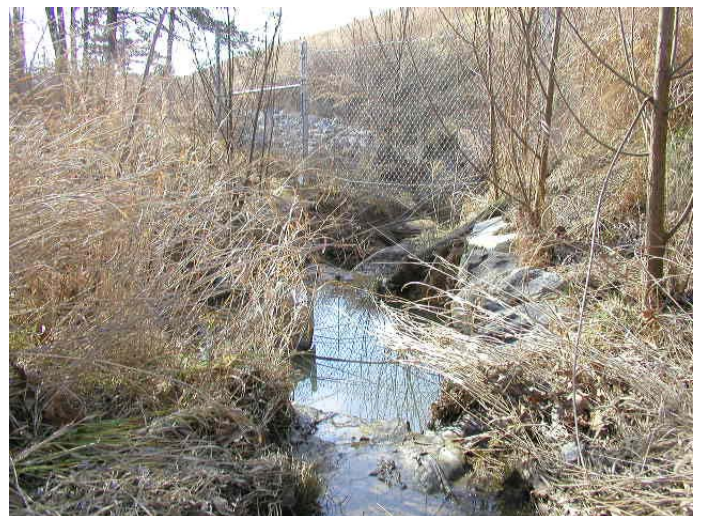
Photo Point #3 (Downstream)

This is the Year 4 Winter evaluation of this stream relocation. The stream is stabilized at this time, except for some minor bank erosion that still exist below a crossvane (Photo Point #3 Downstream). It was also noted during this monitoring evaluation that the last rock on the left arm of this crossvane has dropped off into the channel. A bankfull event occurred at this stream relocation in August 2008. NCDOT will continue to monitor this stream relocation.

2/9/09	Station Number 58+20-L-	Station Number	Station Number	Station Number	Station Number
Structure Type	Crossvane				
Is water piping through or around structure?	Last rock on left arm of crossvane has fell into channel				
Head cut or down cut present?					
Bank or scour erosion present?	Minor erosion present
