Monitoring Data Record

Project Title: R-967CA (NC 24/27) COE Action ID: 200331135
Stream Name: UT Big Meadow Creek (Site 1) DWQ Number: 030891
City, County and other Location Information: Locust, Stanley County, NC 24/27 (Sta. 17+00 - L-)
Date Construction Completed: 7-30-04 Monitoring Year: (2) of 5
Ecoregion: _____ 8 digit HUC unit 03040105
USGS Quad Name and Coordinates: _____

UT Big Meadow Creek

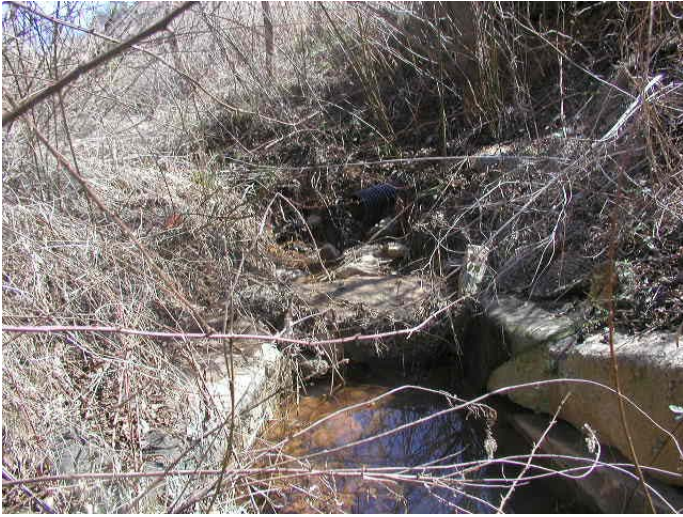
Photo Point #4 (Upstream)

UT to Big Meadow Creek is stabilized for the Year 2 Winter evaluation, except for, a crossvane at Sta. 16+40 (PP#4 Upstream) which has water piping under the crossvane and a slight headcut has formed. NCDOT will continue to monitor this stream relocation for stability. Remedial action is not warranted at this time.

Date Inspected	Station Number	Station Number	Station Number	Station Number	Station Number
2/23/09	16+40 (PP#4 Upstream)				
Structure Type	Crossvane				
Is water piping through or around structure?	Water is piping under crossvane				
Head cut or down cut present?	slight headcut				
Bank or scour erosion present?					
Other problems noted?
