ANNUAL REPORT FOR 2003

Bridge Maintenance Mitigation Site

New Hanover County

Project No. 8.2250109

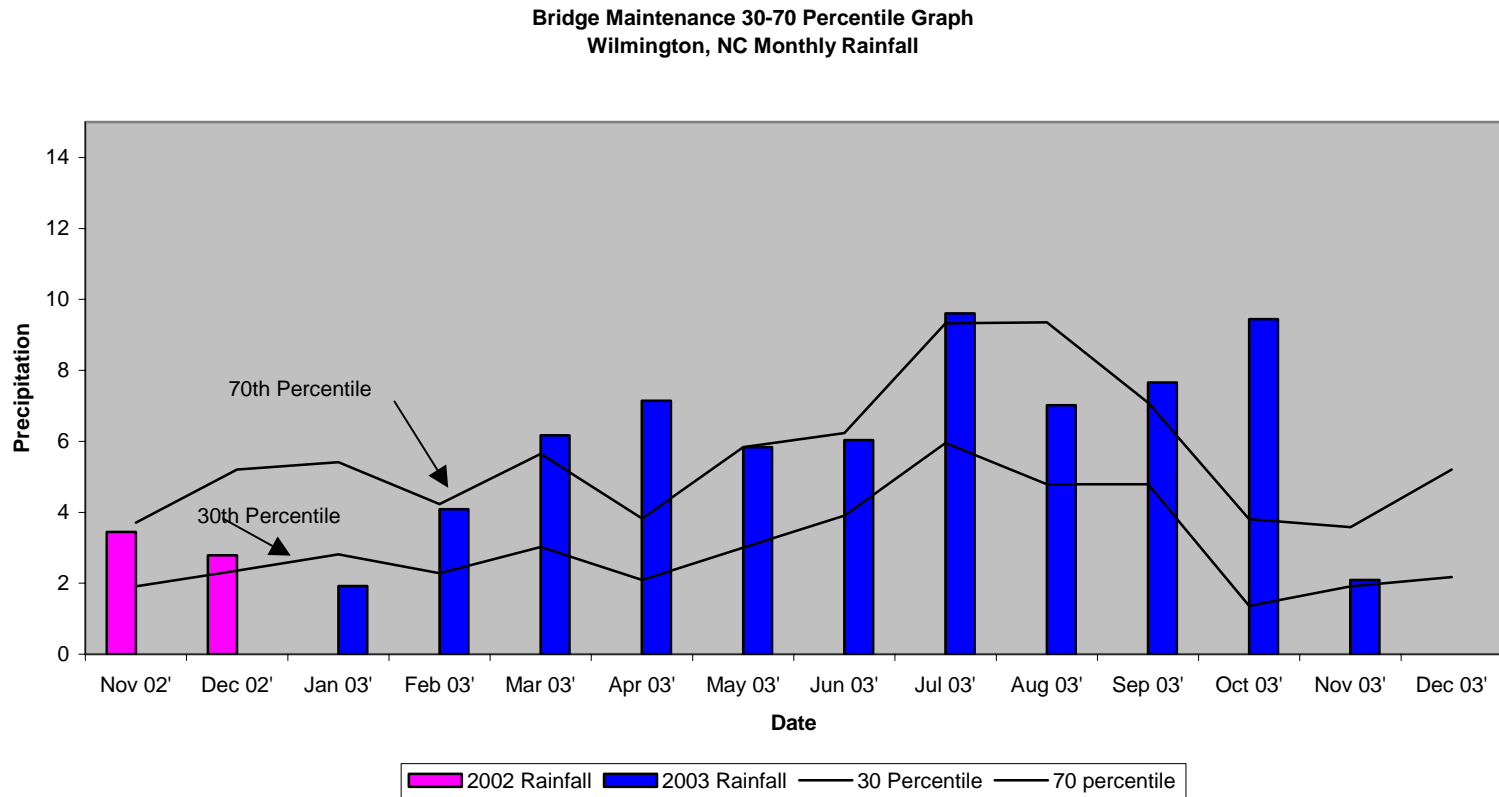
FIGURE 3: 2003 30-70 Percentile Graph

For the 2003-year, March, April, July, September, and October experienced above average rainfall. The month of January recorded below average rainfall for the site. November (02'), December (02'), February, May, June, August, and November experienced average rainfall. Overall, 2003 experienced an average rainfall year.

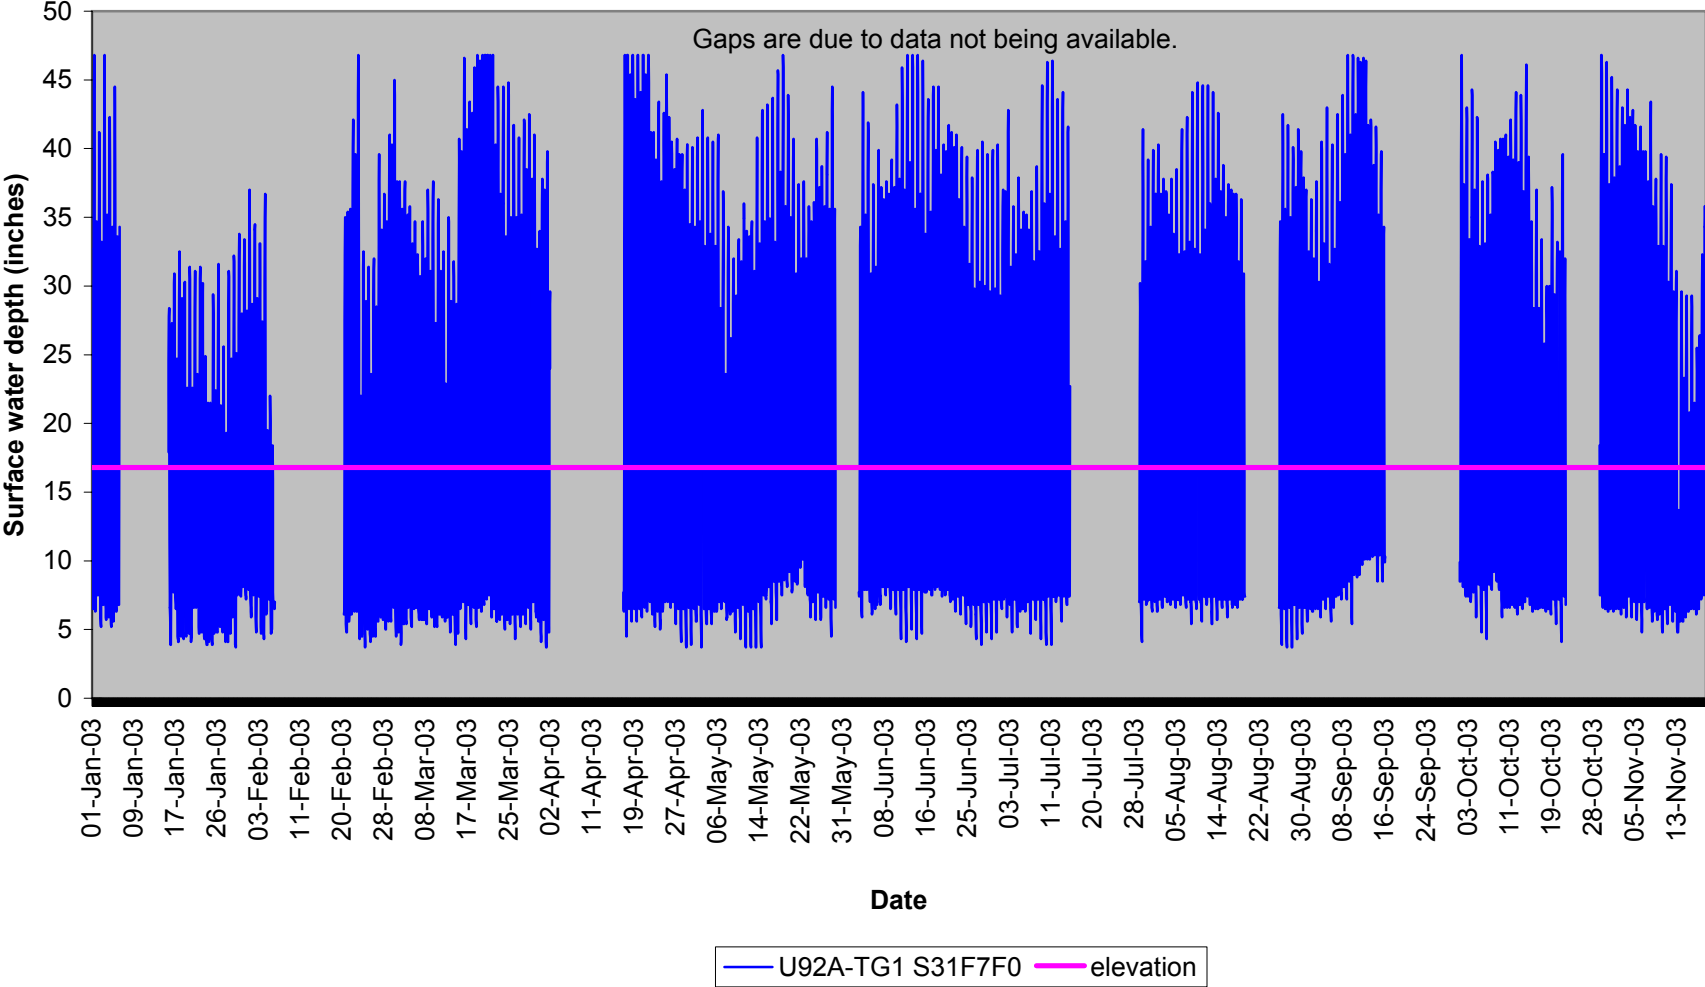
Bridge Maintenance Tide Gauge U92A-TG1

The surface gauge indicated that the site was inundated on a daily basis for 49.3% of the growing season. Appendix A contains a plot of data recorded at the surface gauge on the Bridge Maintenance Site. Since the site is a tide-driven system, groundwater and rain gauges were not installed.

The surface gauge indicated inundation (daily) for 49.3% of the growing season; therefore, it did not technically meet the 56% inundation criteria (due to interruptions in the data collection). The data interruptions were caused by limitations in the storage capabilities of the surface gauge. Currently, the surface gauge is set to record hourly water levels. Future downloads will reflect 3-hour intervals, thus alleviating the data interruption problem.
