ANNUAL REPORT FOR 2001

**Colington Cut Mitigation Site
Dare County
TIP No. B-2024**

Prepared By:
Natural Systems Unit & Roadside Environmental Unit
North Carolina Department of Transportation
December 2001

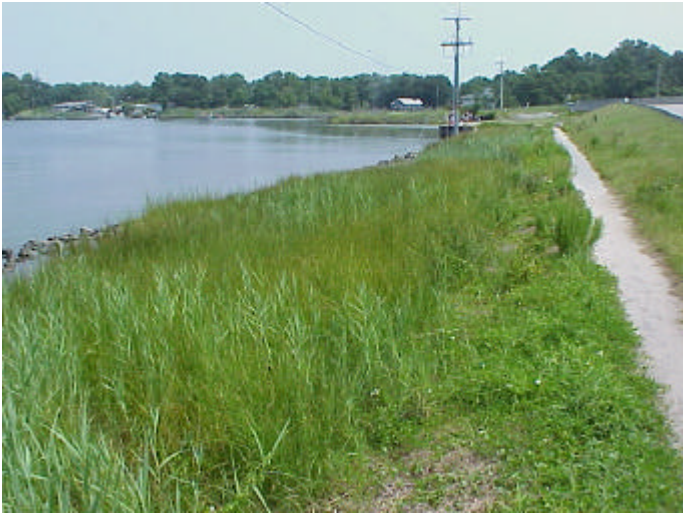
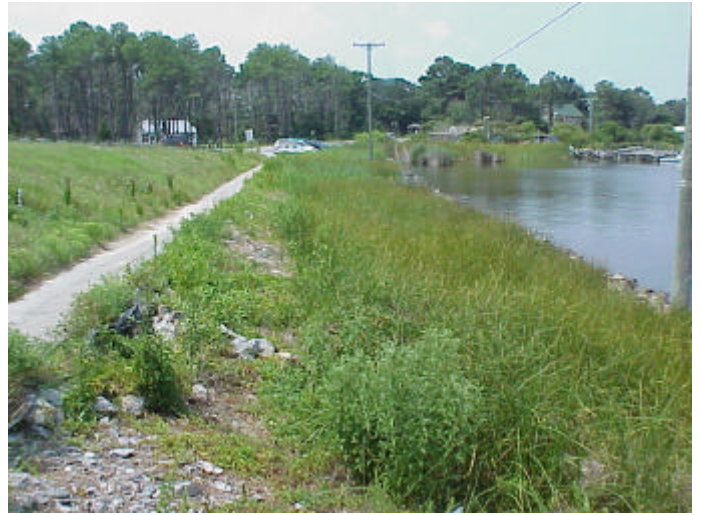
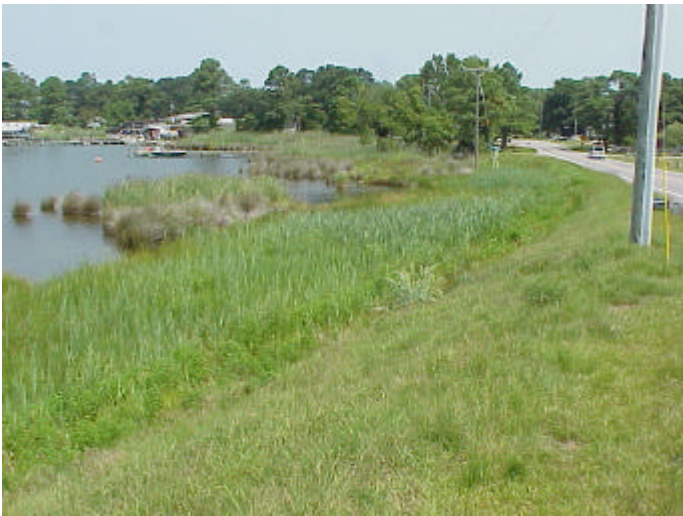
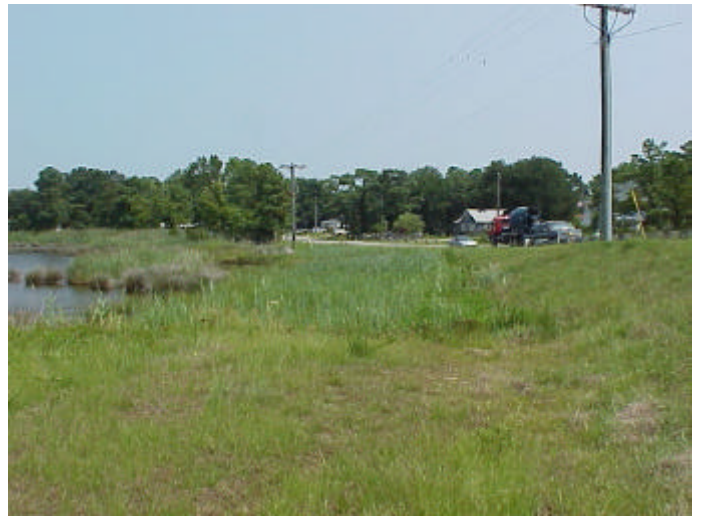
There were approximately 1.27 acres of marsh planted both on site and off site. There were no plots established on either site. By visual observation the Colington Cut Site had an aerial coverage of 95% with 90% survival rate, exceeding the minimum 50% area coverage and 50% survival rate.

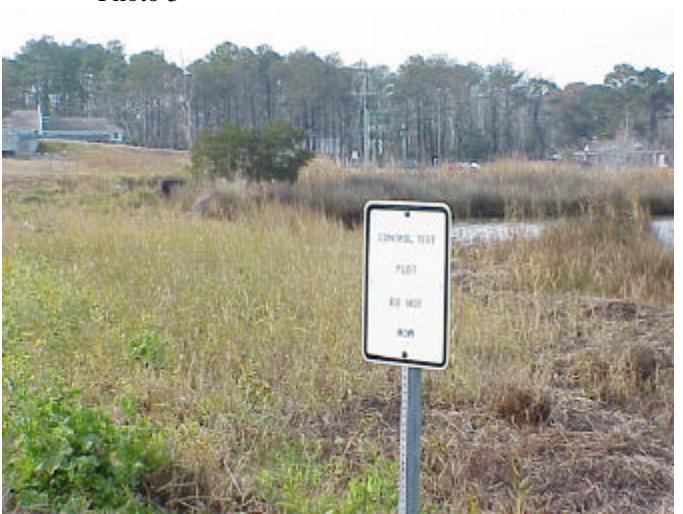
Photo 5 (Installed no mowing sign)

A portion of the Colington Cut Site was hand-mowed in 2000. Both the telephone company and the power company were contacted about the mowed, but denied responsibility. NCDOT's Division Roadside Environmental Unit, as well as NCDOT's Division and County Maintenance Offices were also contacted. There is evidence that on one occasion NCDOT County Maintenance did some selective hand mowing on site at the request of local citizens. All personnel have been notified as to the limits of the mitigation site, and requested not to initiate any mowing or clearing within these limits. Also two "No mowing" signs were posted in January 2002 (see photos), to prevent future mowing activities.
