ANNUAL REPORT FOR 2001

Gurley Mitigation Site
Greene County
Project No. 8.T340306
TIP No. R-1023WM

Natural Systems Unit & Roadside Environmental Unit
North Carolina Department of Transportation
December 2001

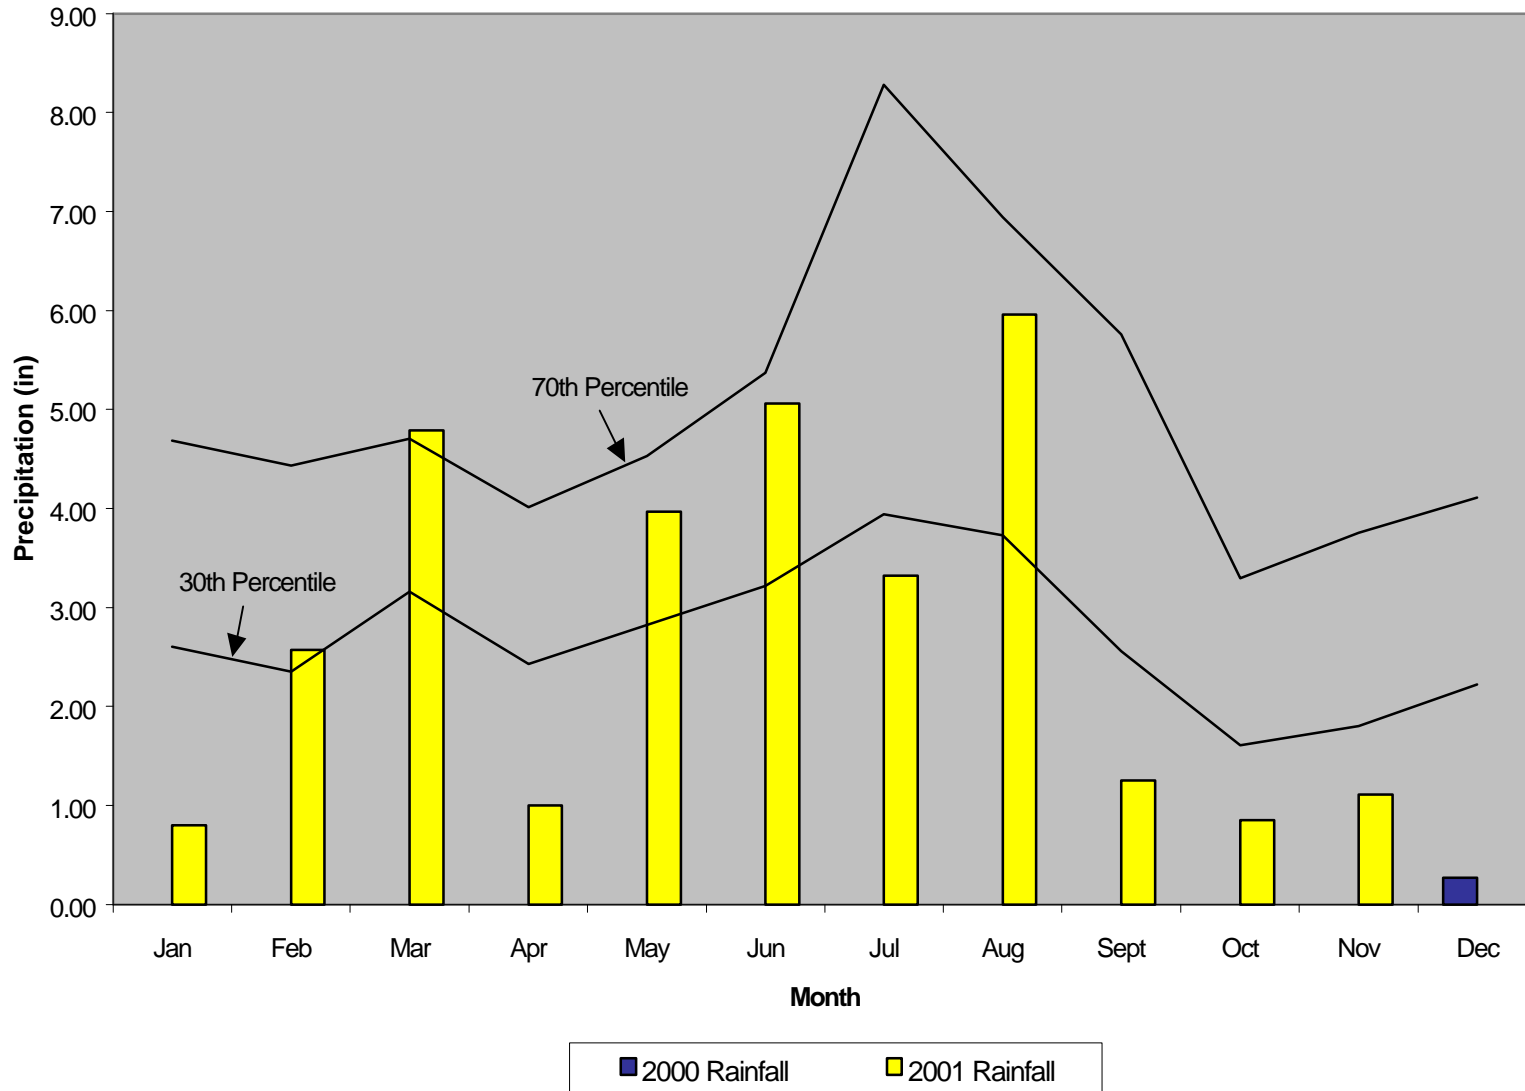
Figure 4. Gurley 30-70 Percentile Graph

Figure 4 is a comparison of 2001 monthly rainfall to historical precipitation for the area. The two lines represent the 30th and 70th percentiles of monthly precipitation for Goldsboro, NC. The bars are the monthly rainfall totals for 2001. The historical data was collected by the National Climatic Data Center; the on site rain gauges provided the recent rainfall data.

The site received average rainfall in February, May, June, and August. The site received slightly above average rainfall in March. December (2000), January, April, July, September, October, and November were below average rainfall months. Overall, the site experienced below normal rainfall in 2001.

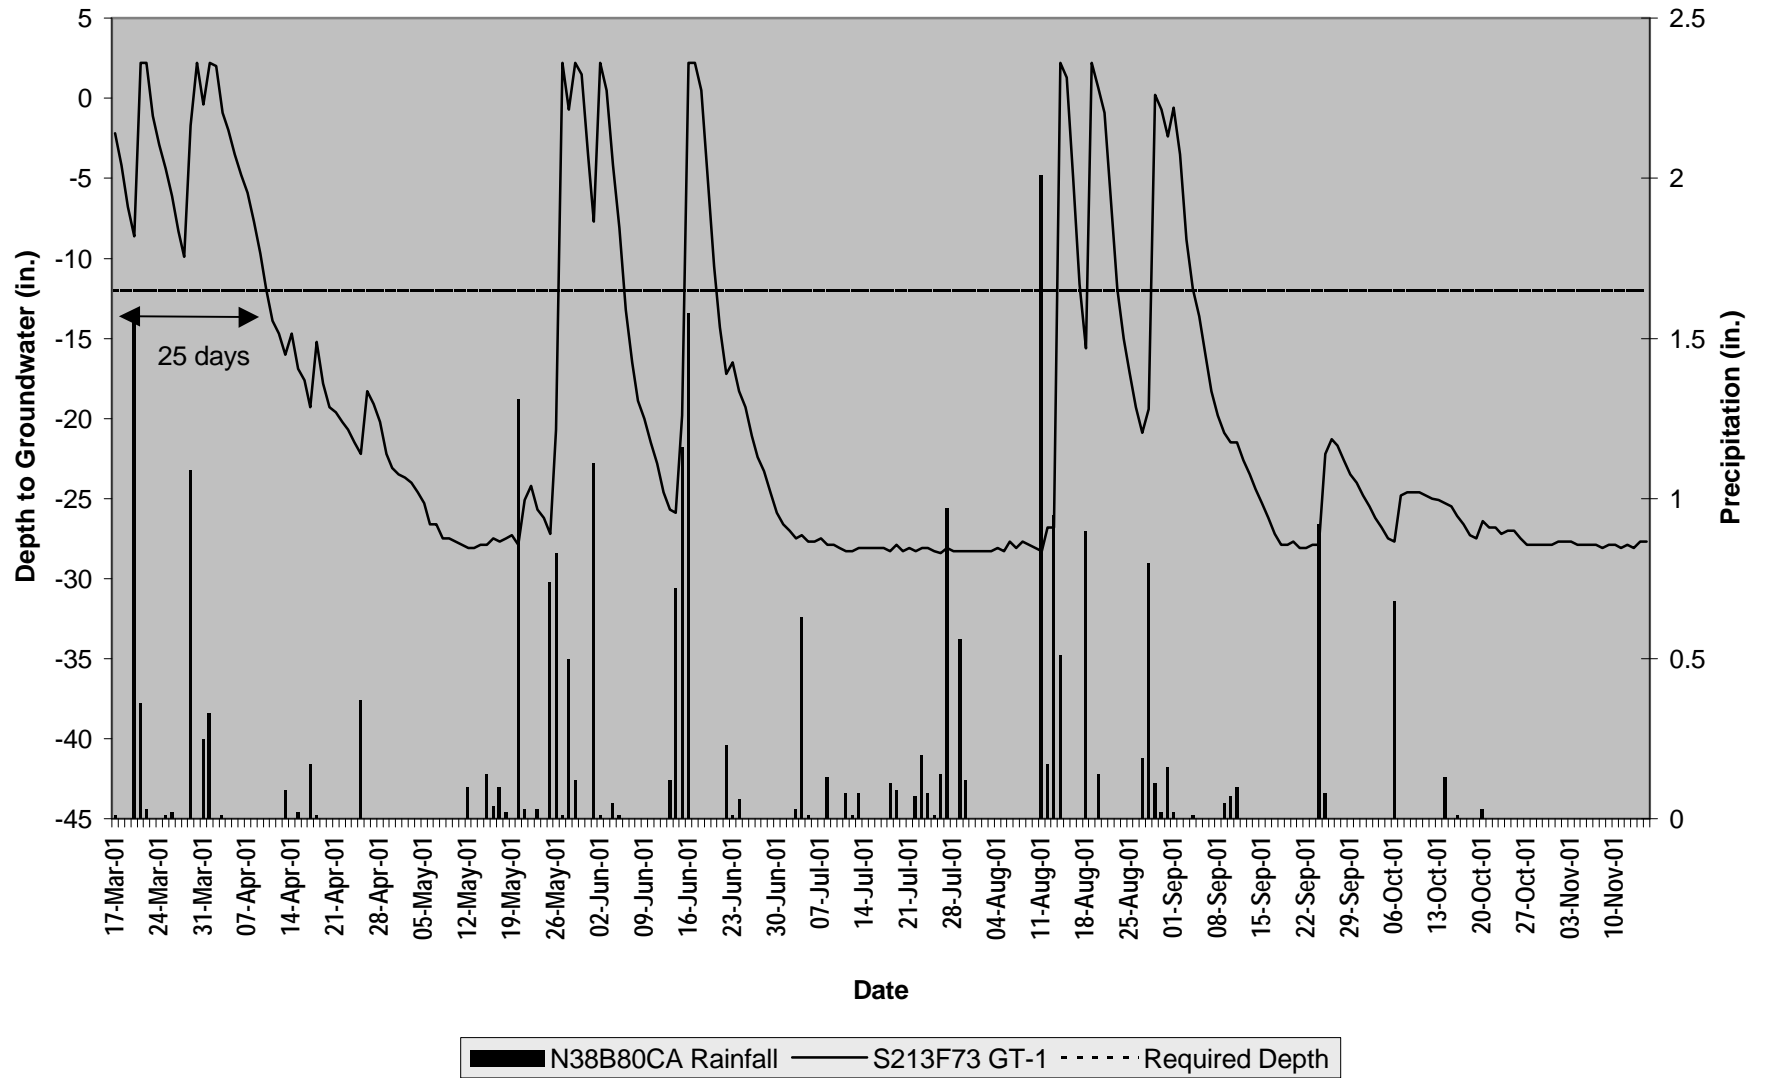
Gurley Tract GT-1

Appendix A contains a plot of the water depth for each of the monitoring gauges and surface gauge for 2001. Precipitation events are included on each graph as bars. Historical precipitation data represents that of a North Carolina State Climate Office rain gauge in Goldsboro (AG), North Carolina. This was the closest gauge with current rainfall data to the mitigation site. 2001 rainfall data came from an onsite rain gauge.

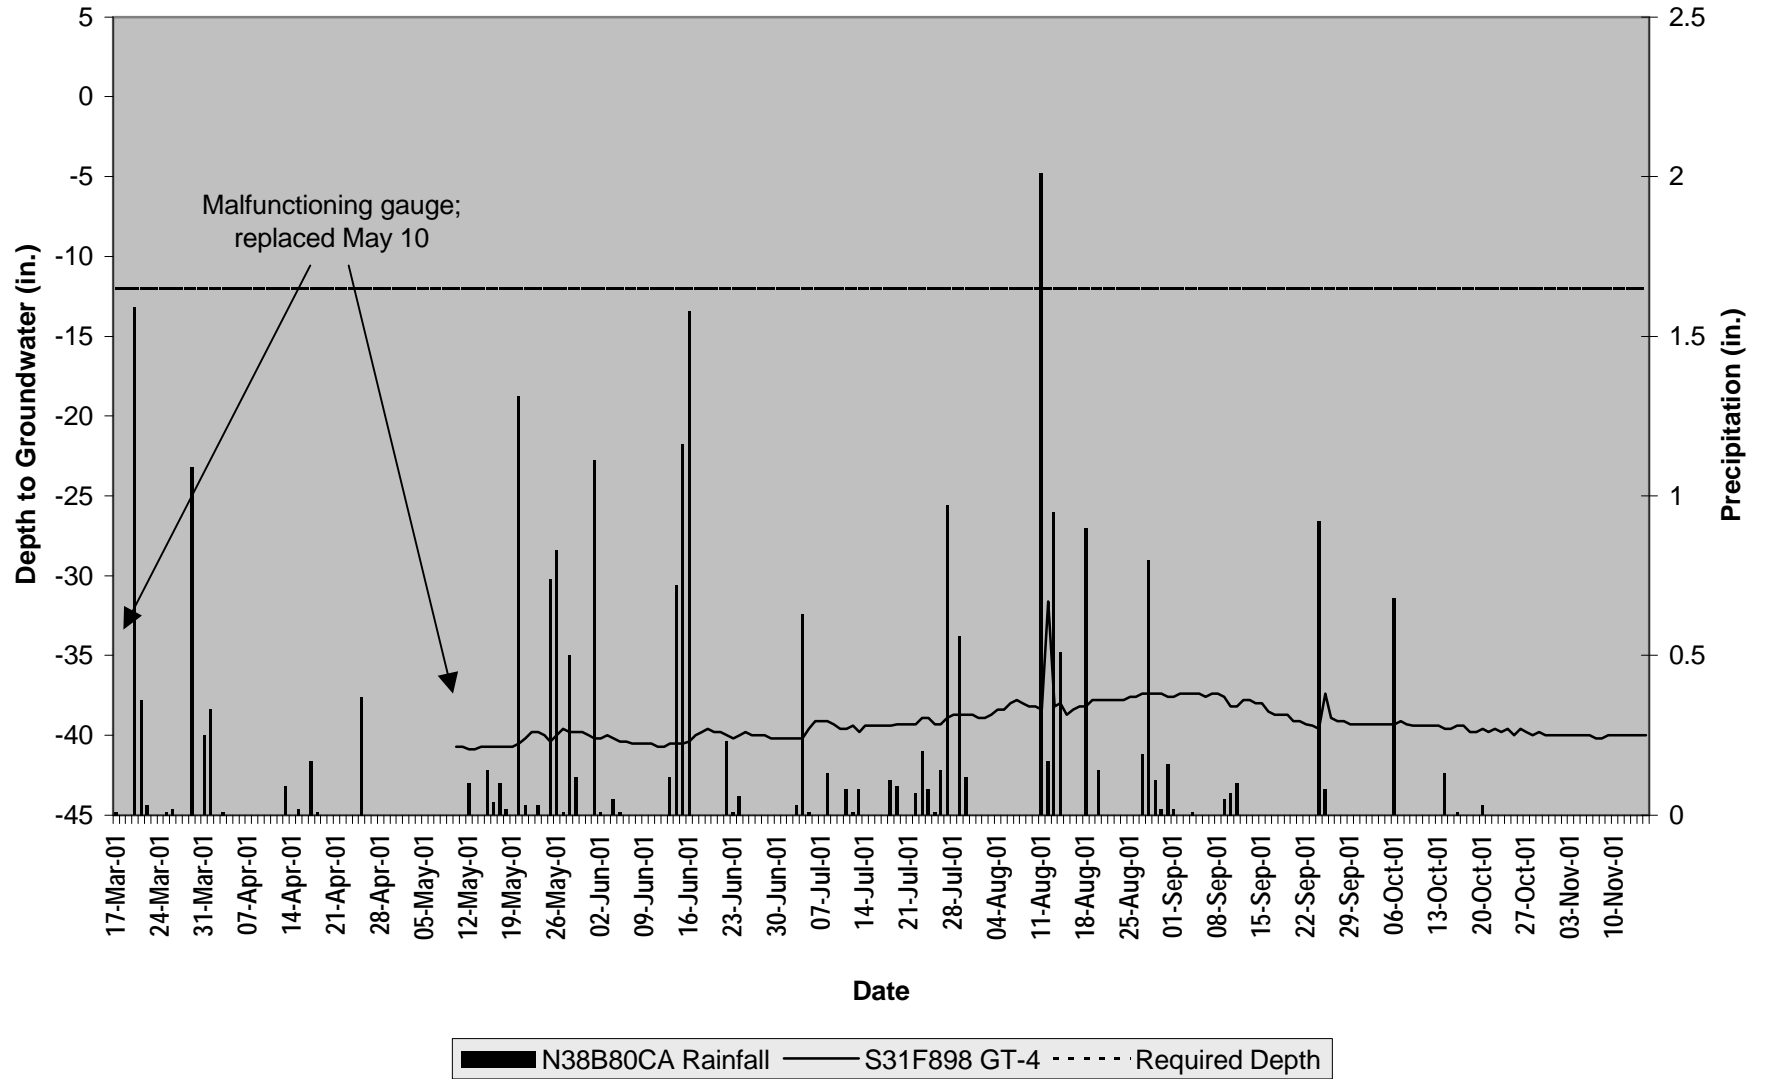
Gurley Tract GT-4

Specific Monitoring Gauge Problems: Gauge 4, 5, 11, and 14 malfunctioned from March 17 until replaced May 10. Gauge 11 still showed saturation greater than 12.5% of the growing season. Gauge 10 had a dead battery from June 13 to July 14. Gauge 13 had a dead battery from May 13 to June 5; however, still showed saturation greater than 12.5% of the growing season.
