ANNUAL REPORT FOR 2001

**Lengyel Mitigation Site
Craven County
Project No. 8.1170806
TIP No. B-2531WM**

Natural Systems Unit & Roadside Environmental Unit
North Carolina Department of Transportation
December 2001

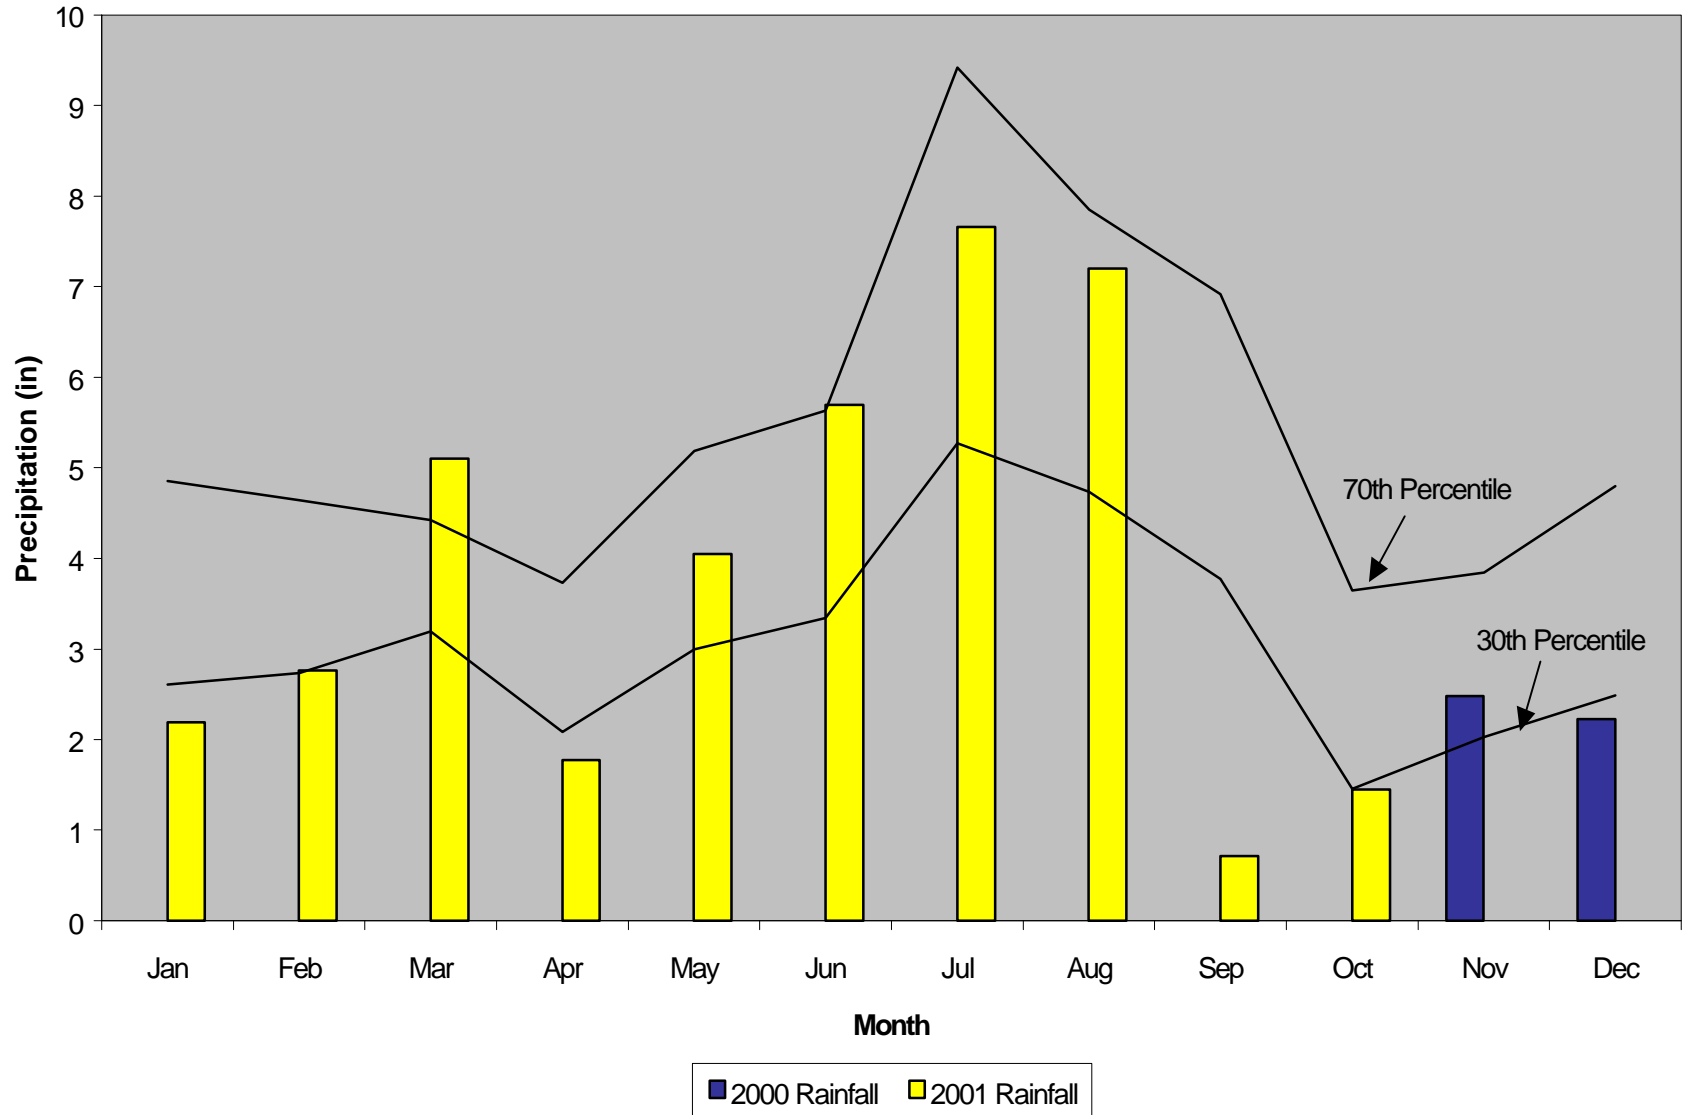
Figure 4. Lengyel Site 30-70 Percentile Graph, New Bern, NC

Figure 4 is a comparison of the 2001 monthly rainfall to the historical precipitation (collected between 1931 and 2000) for New Bern, North Carolina. This comparison gives an indication of how 2001 relates to historical data in terms of climate conditions. All off site data was provided by the NC State Climate Office. Data for November and December 2001 was unavailable at the time this report was published.

This graph is used to indicate the general precipitation conditions for the surrounding area. The data obtained indicates lower than normal precipitation for January, February, April, September, and October and above average precipitation for March in the year 2001. May, June, July, and August experienced normal rainfall. The sum precipitation measured from November 1, 2000 through October 31, 2001 was 43.3 inches, which is below the normal 30 year (1961-1990) average rainfall for the New Bern area of 53 inches. Overall, the site maintained excellent hydrologic results while experiencing normal to below normal rainfall in 2001.

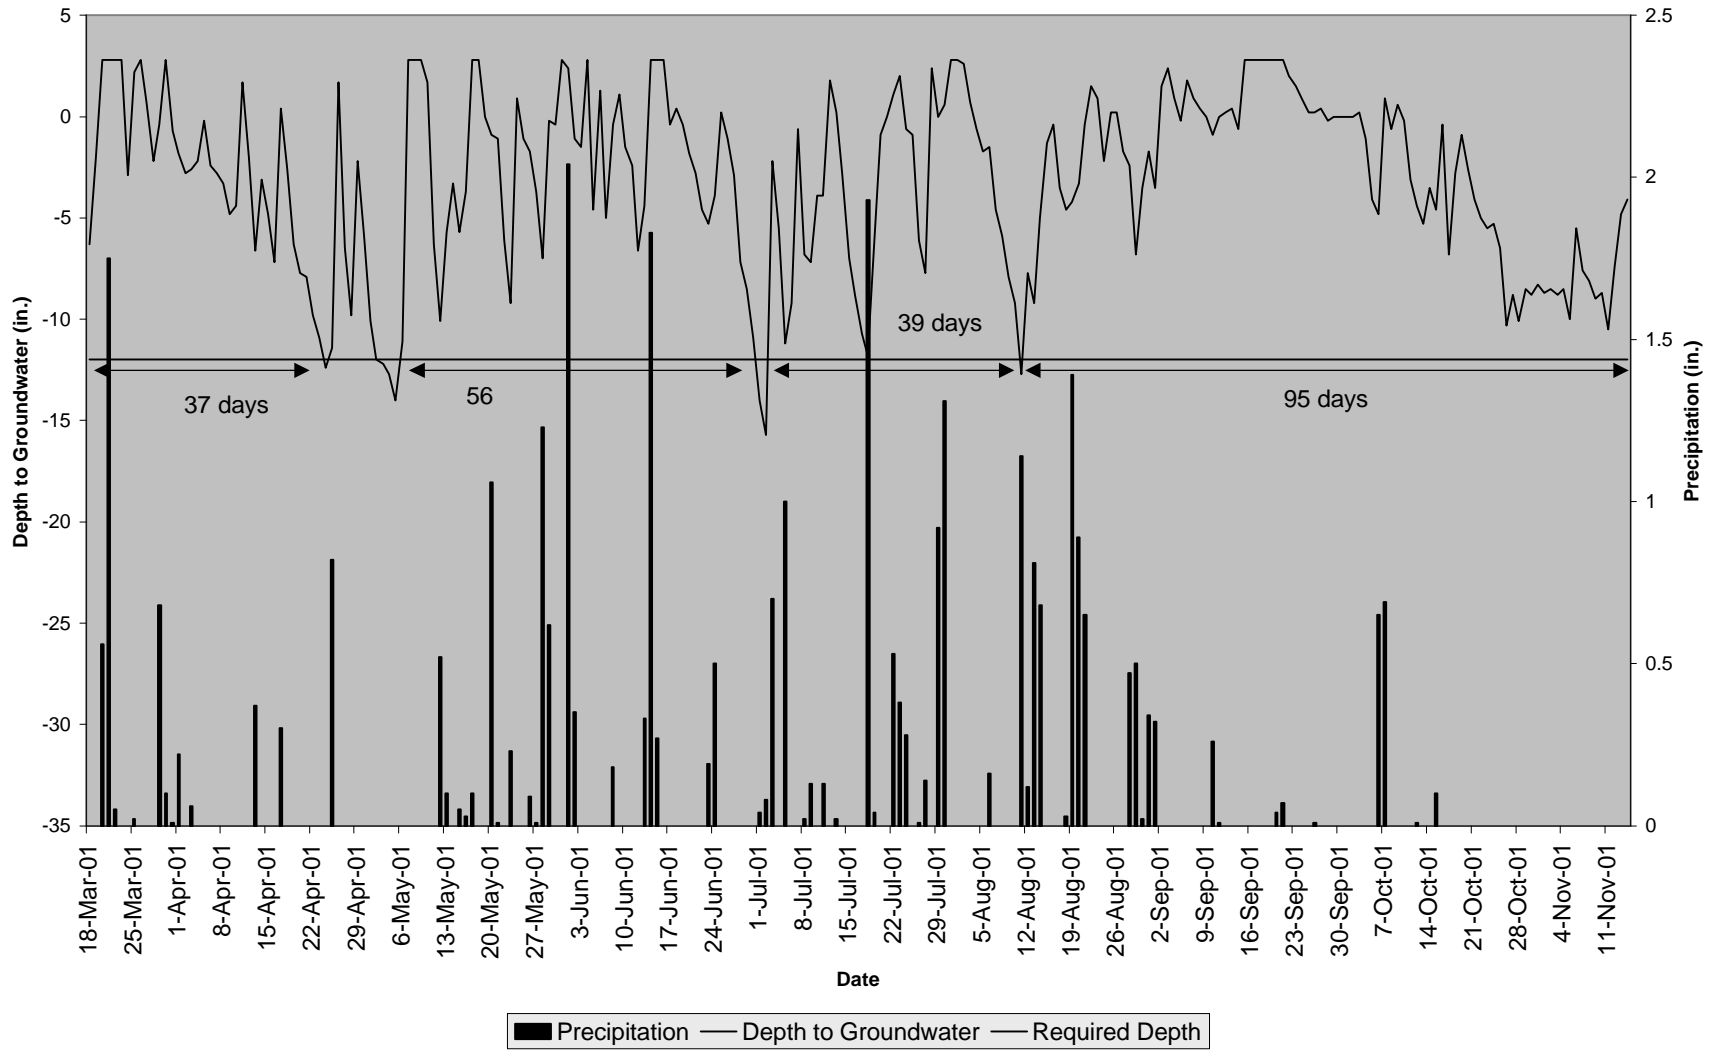
Lengyel LSGW-1

Appendix A contains charts of the water depth for each surface and groundwater gauge during 2001. These monitoring gauge graphs are designed to show the reaction of groundwater to specific rainfall events. If the gauge shows above 12” for greater than 5% of the growing season, the maximum number of consecutive days is noted on each graph. Daily precipitation events, shown on each monitoring gauge graph, represent data from the New Bern rain gauge.

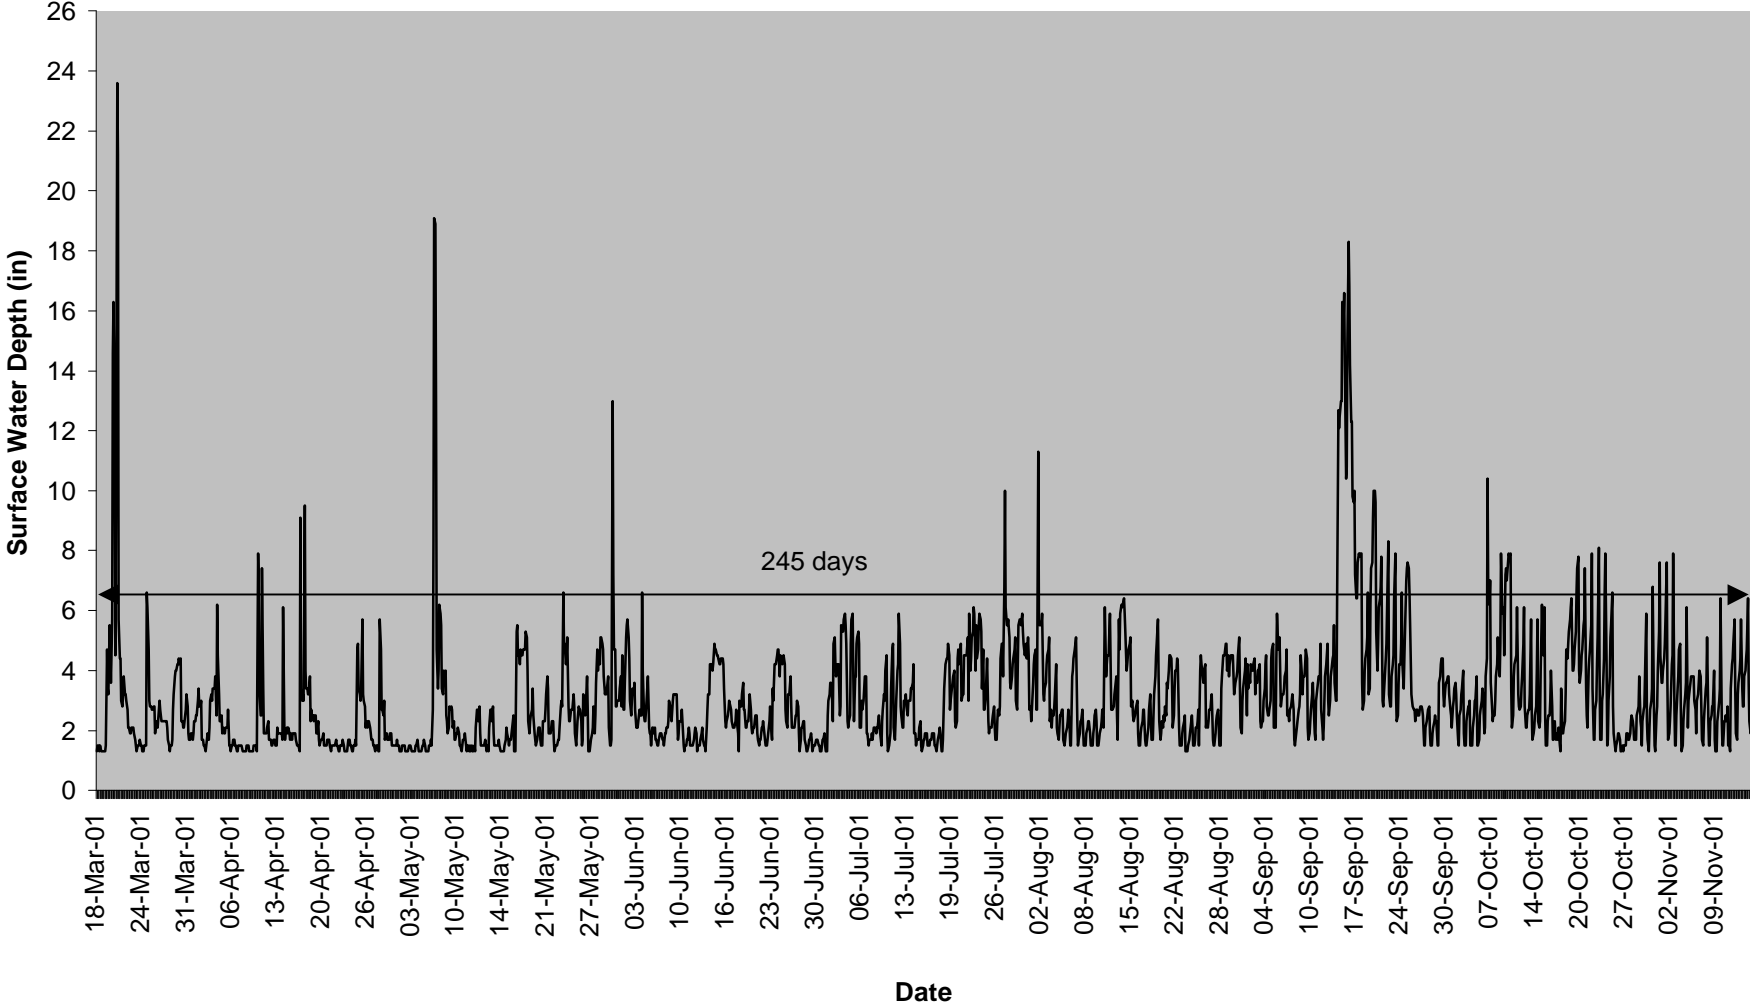
Surface Water Gauge (LSG-2)

— Surface Water depth

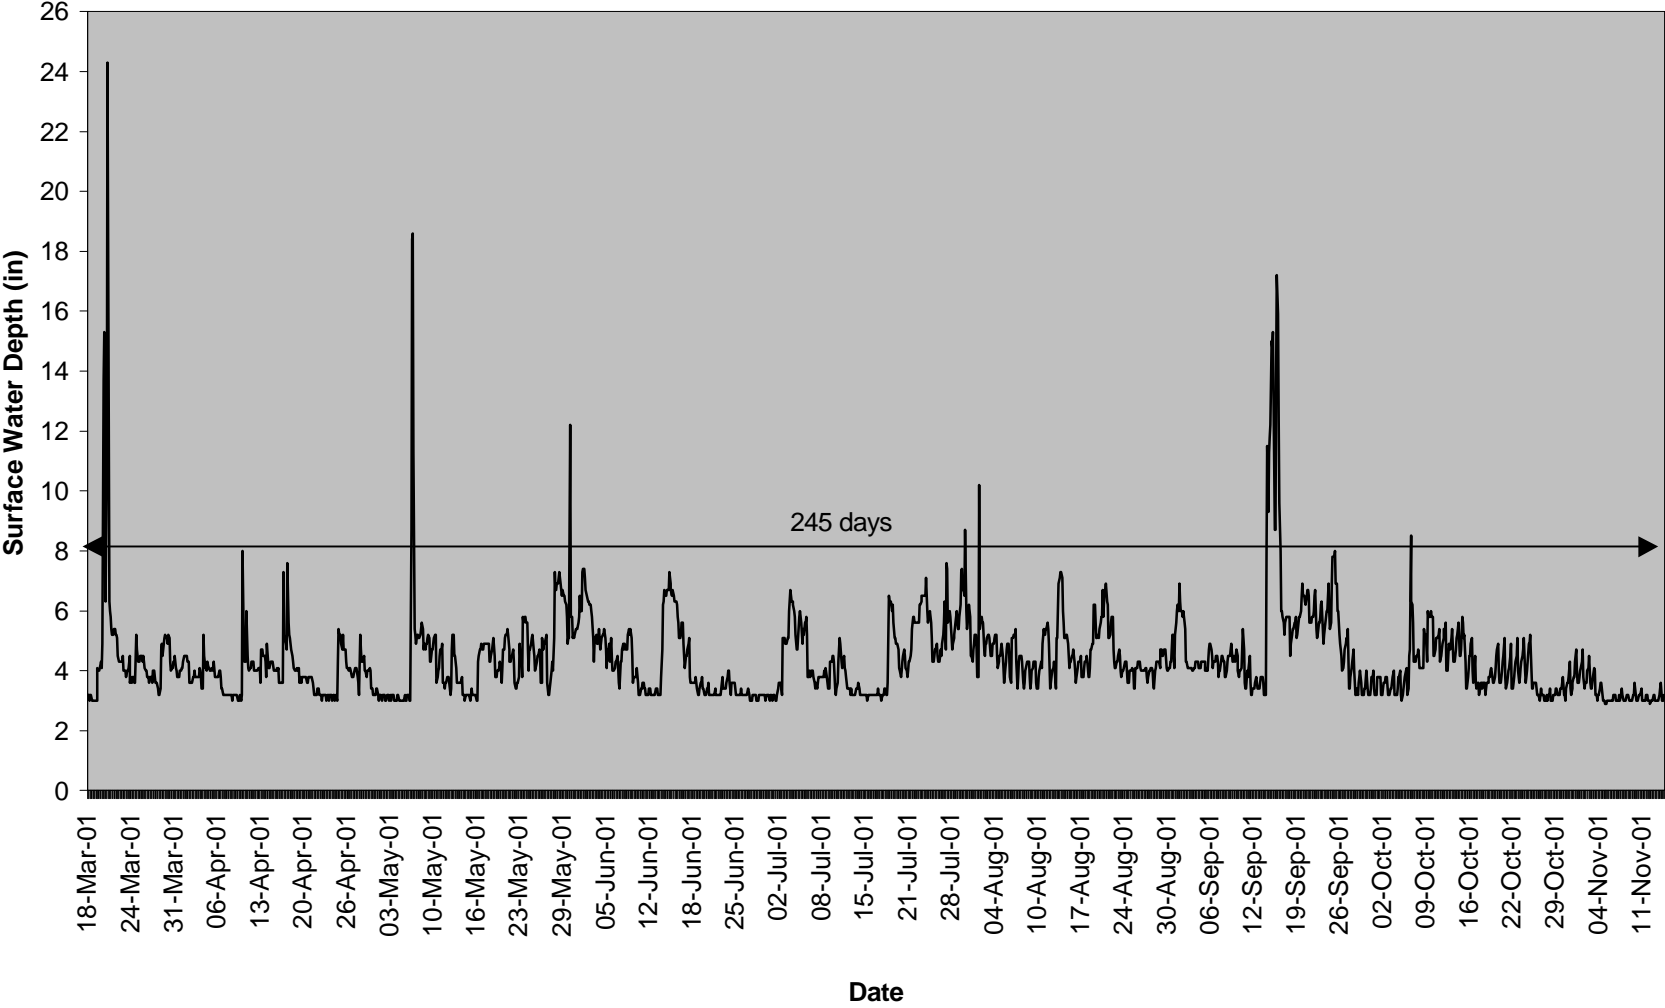
Surface Water Gauge (LSG-4)

— Water depth (in)

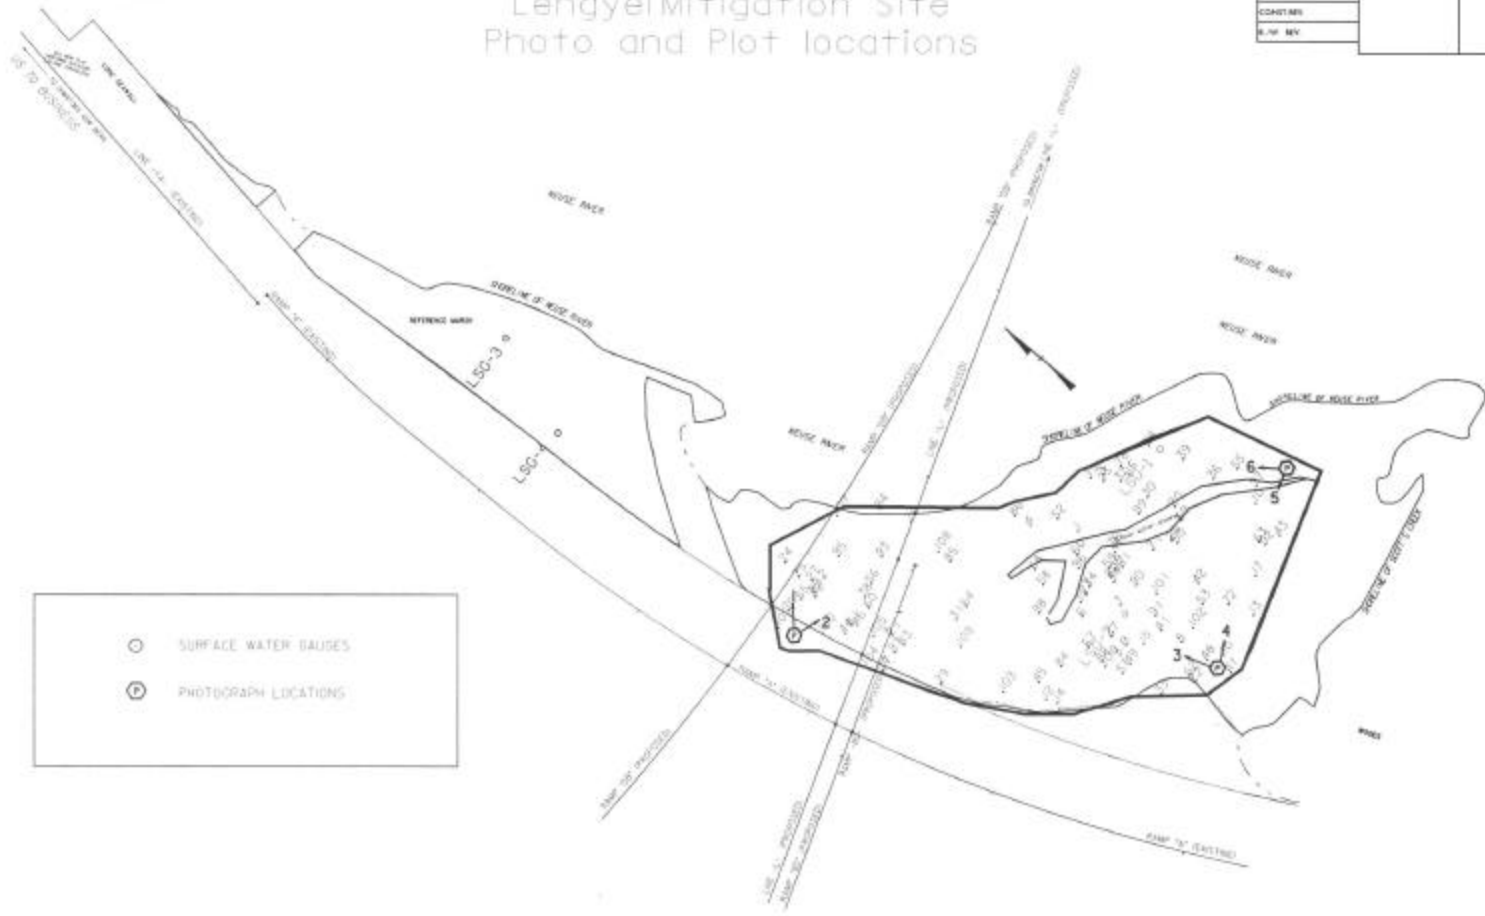
Lengyel Mitigation Site Photo and Plot locations

The open water channel within the site was measured with GPS equipment and is shown on the attached map.
