ANNUAL REPORT FOR 2001

Little Sugar Creek Mitigation Site

Project No. 8.U670122

Natural Systems Unit & Roadside Environmental Unit
North Carolina Department of Transportation
December 2001

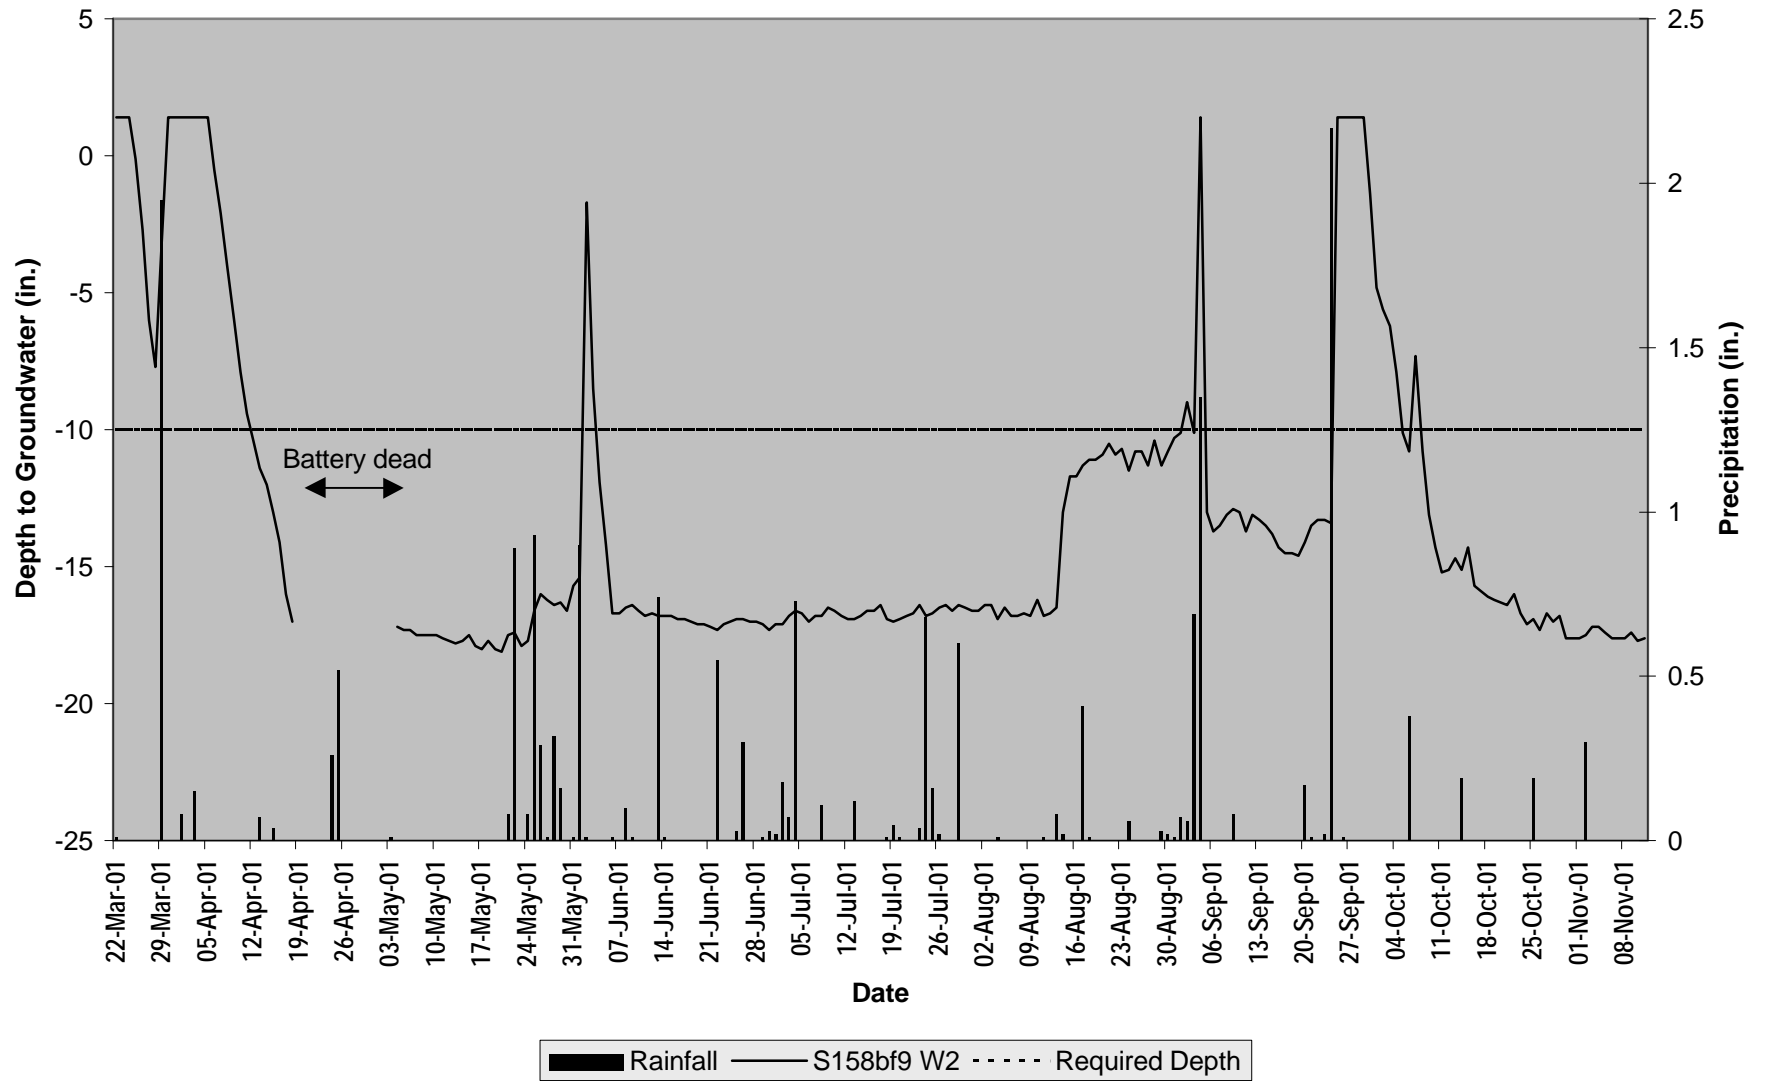
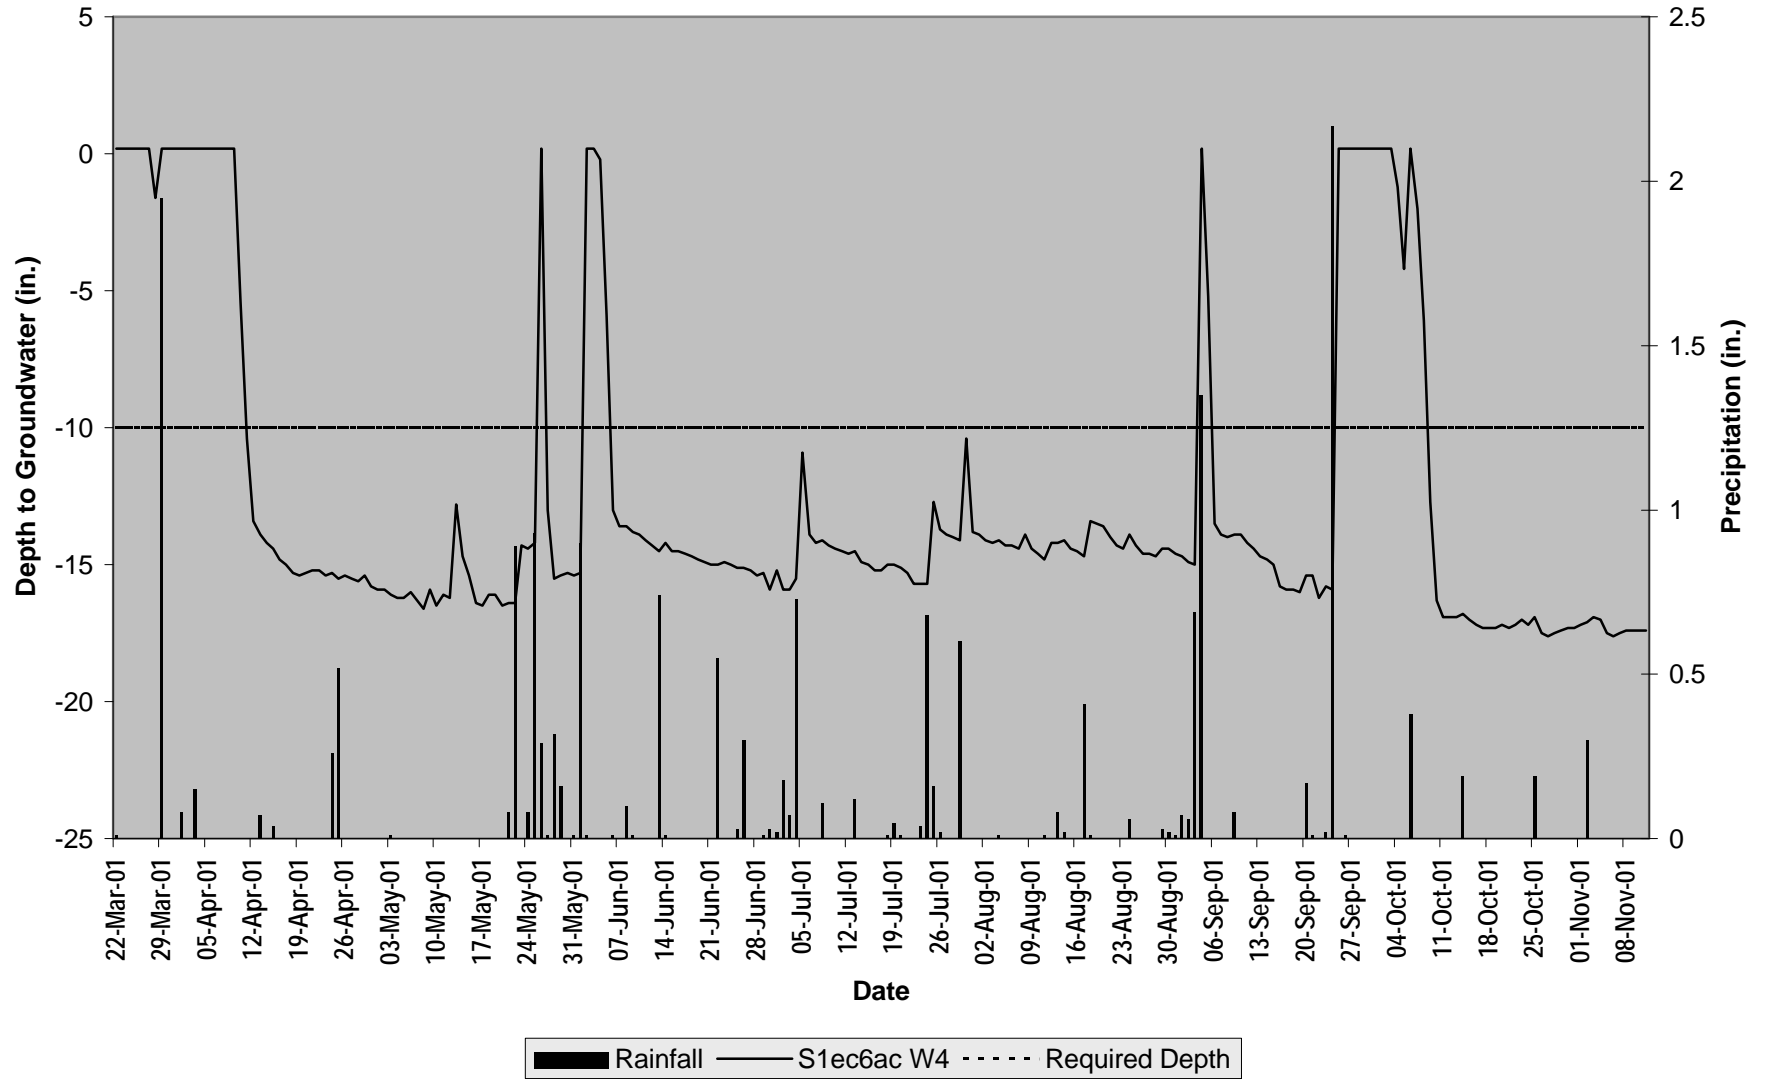
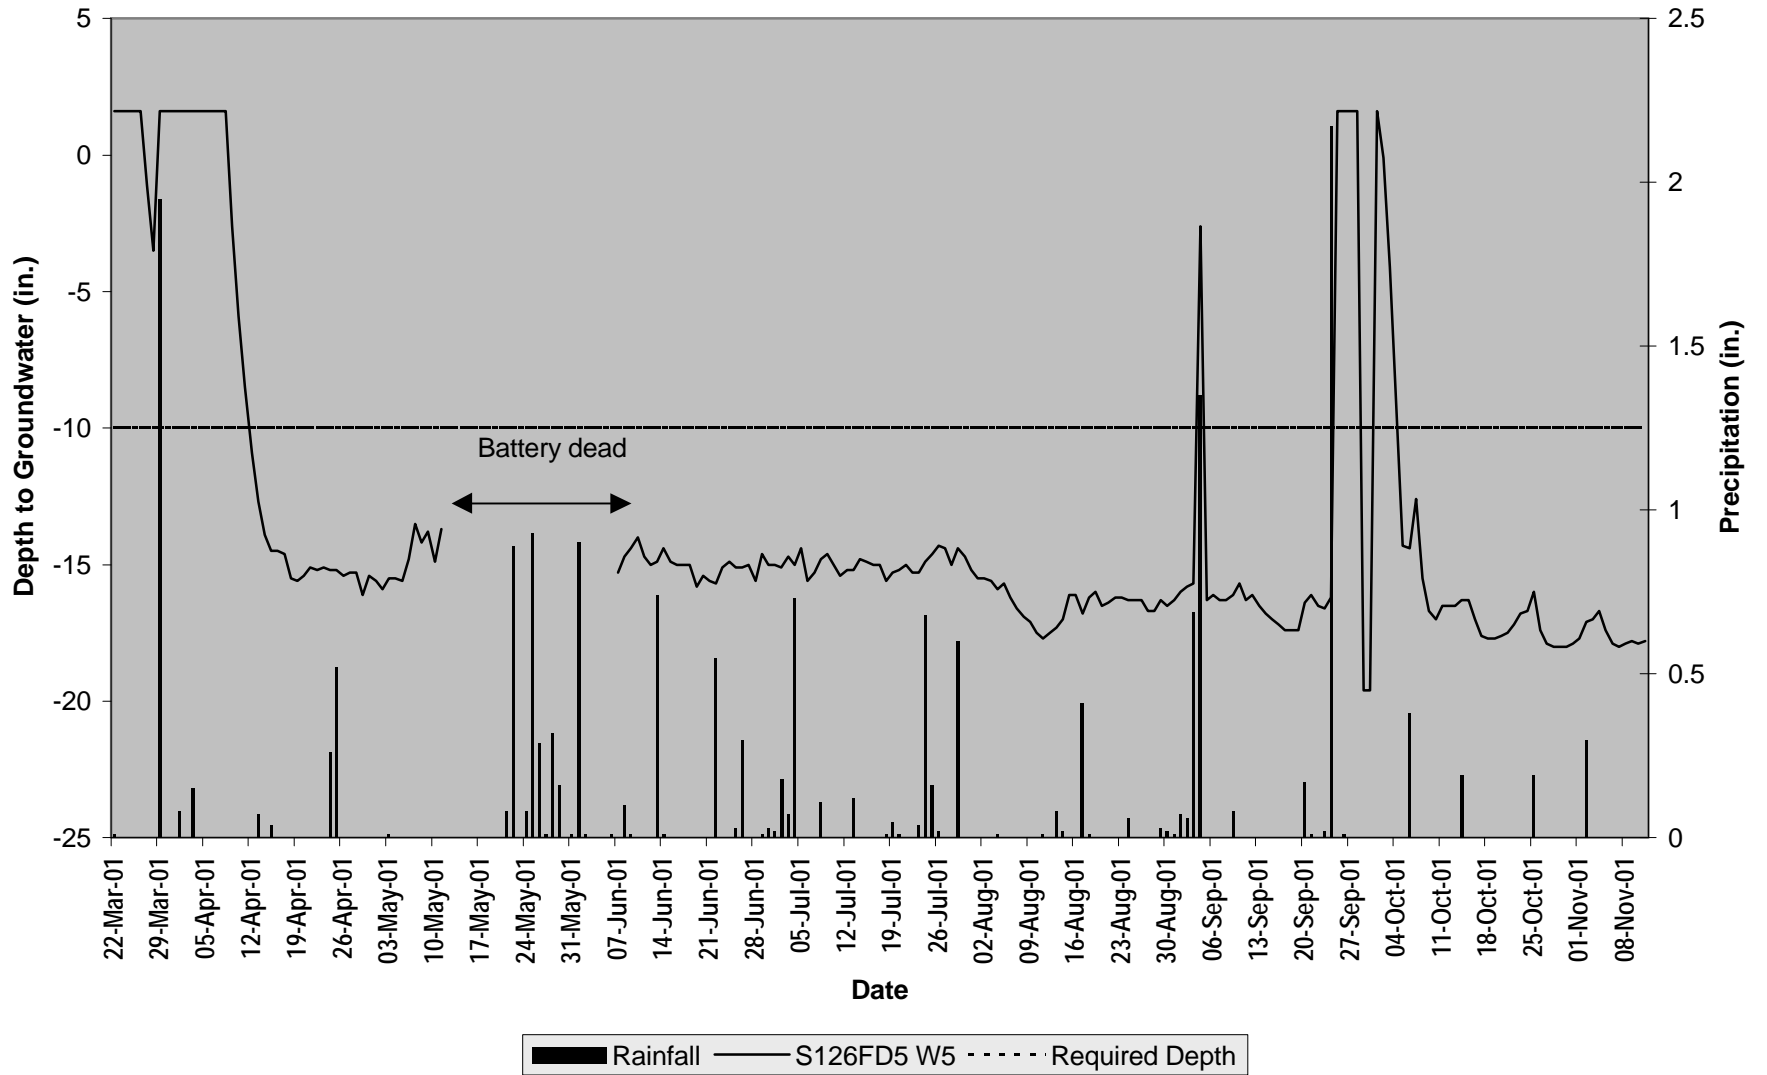
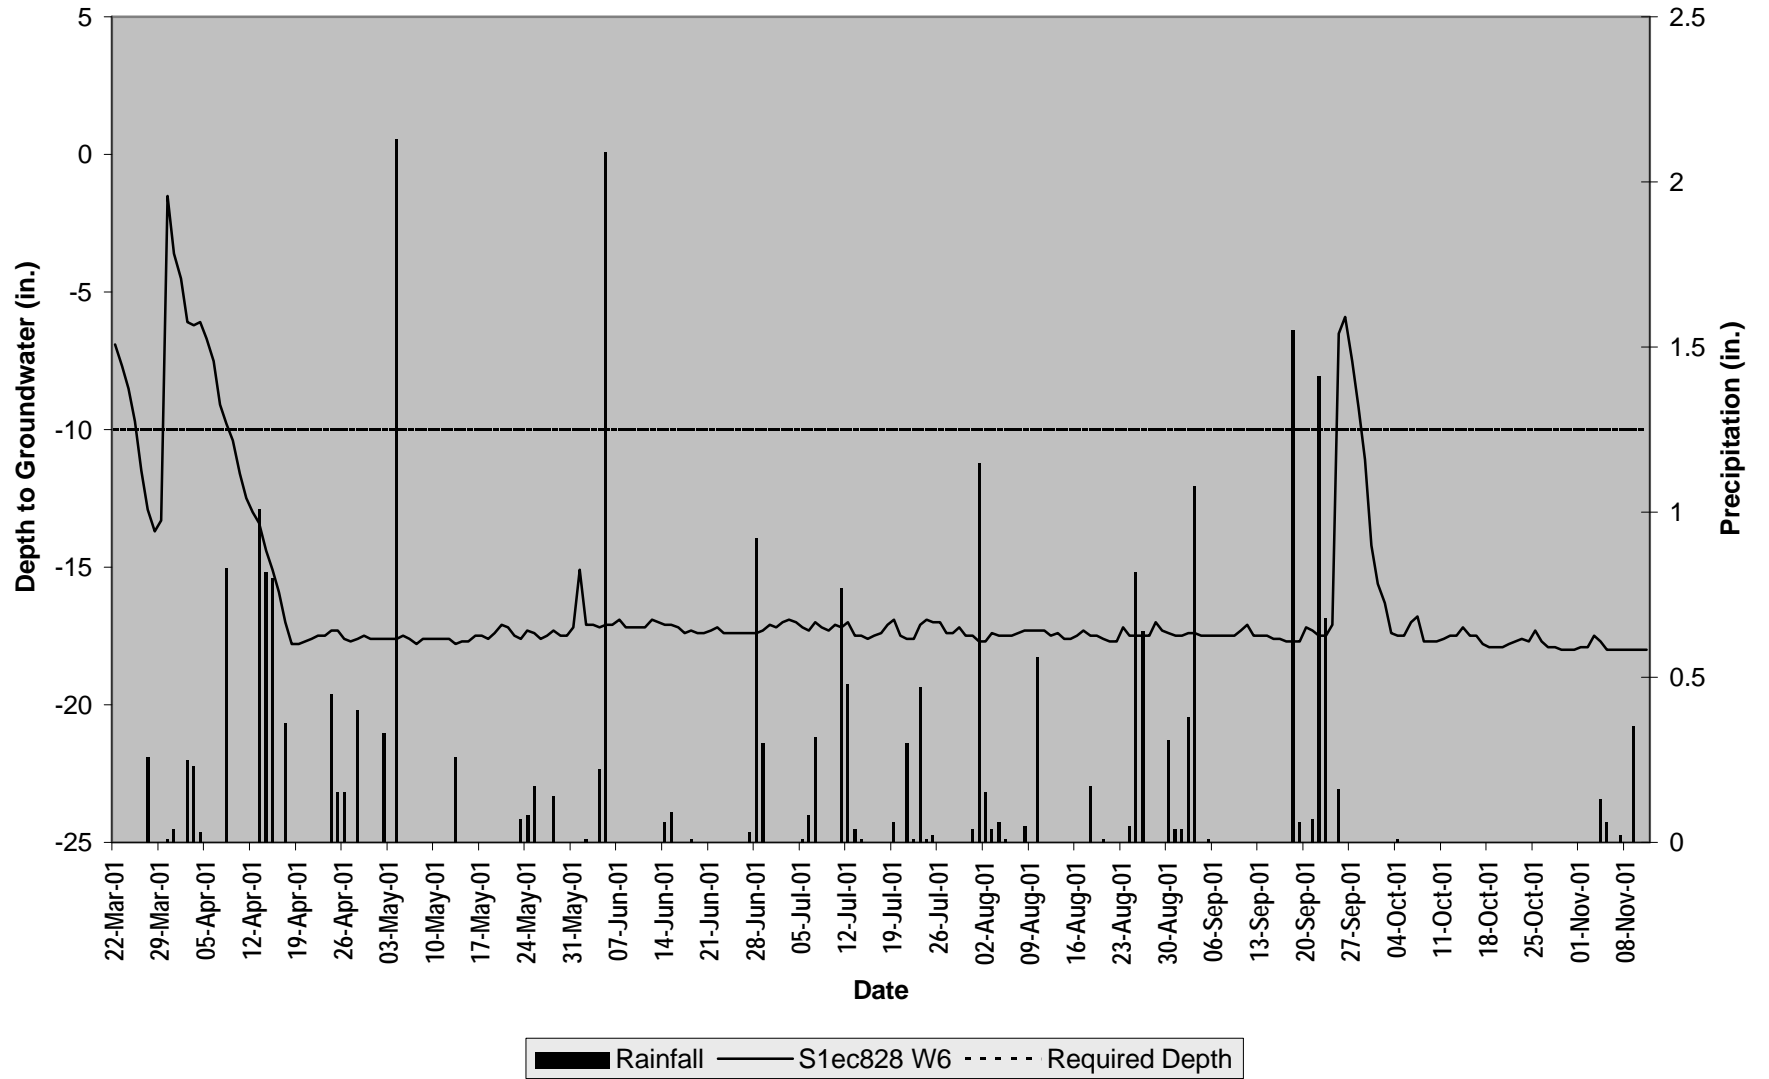
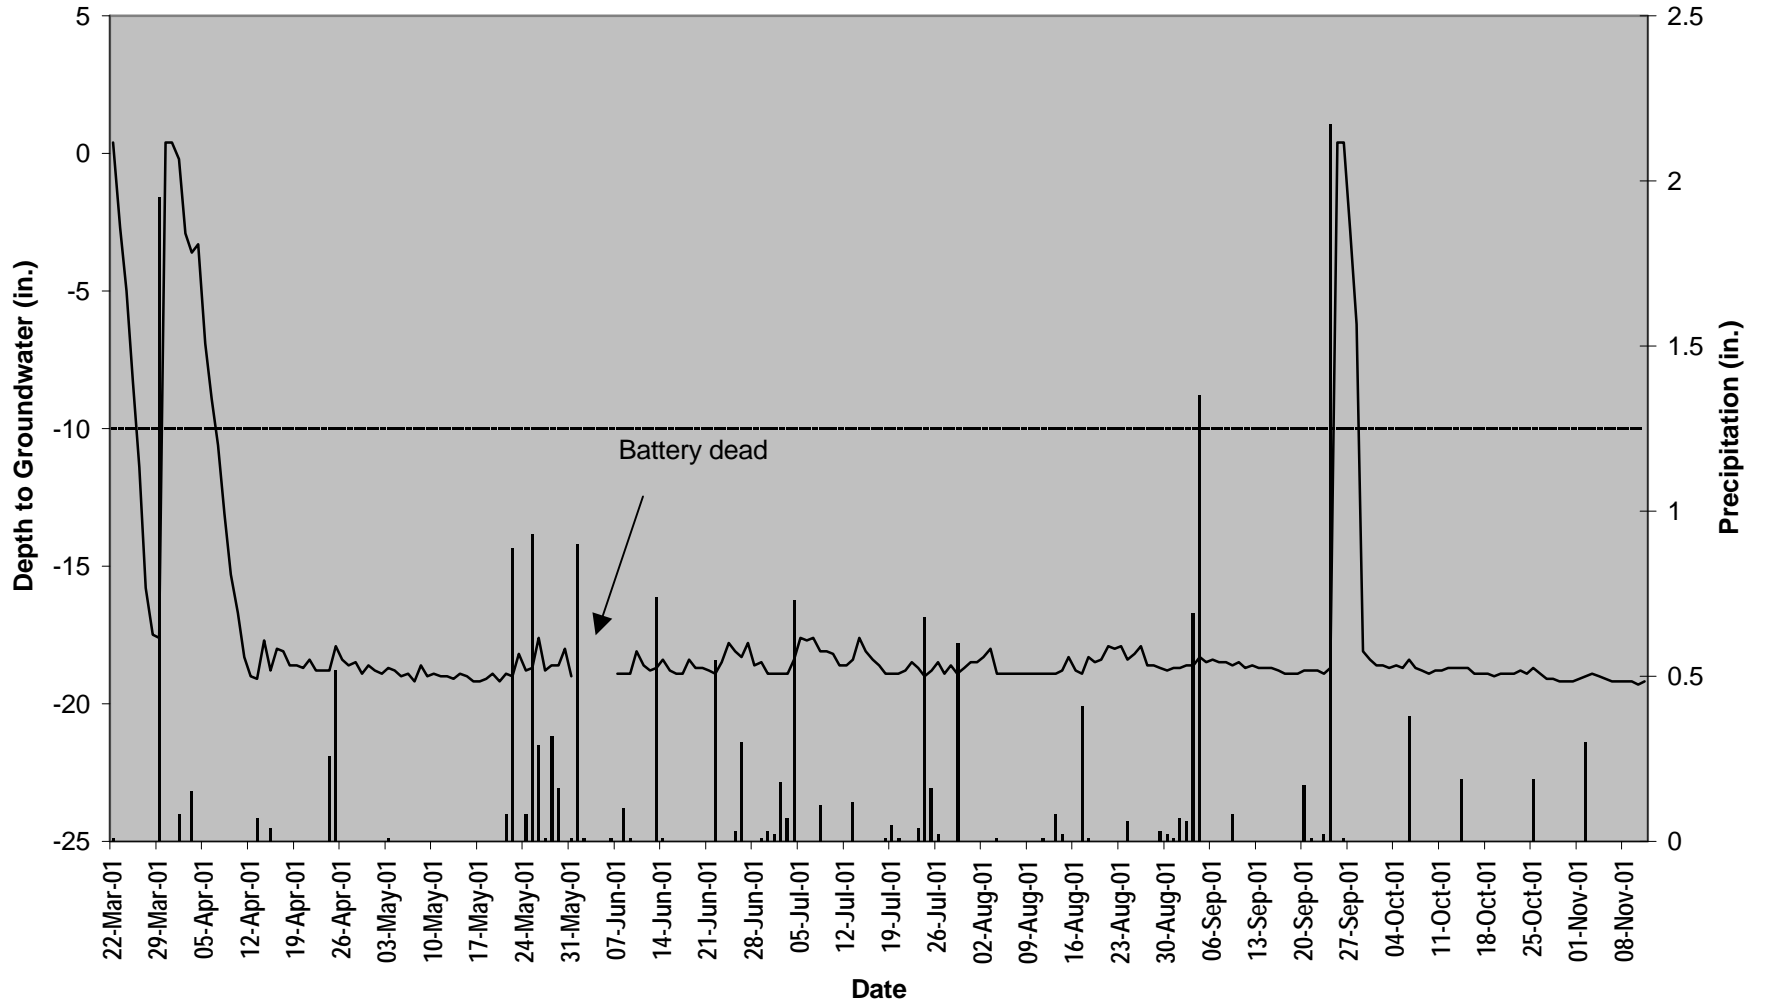
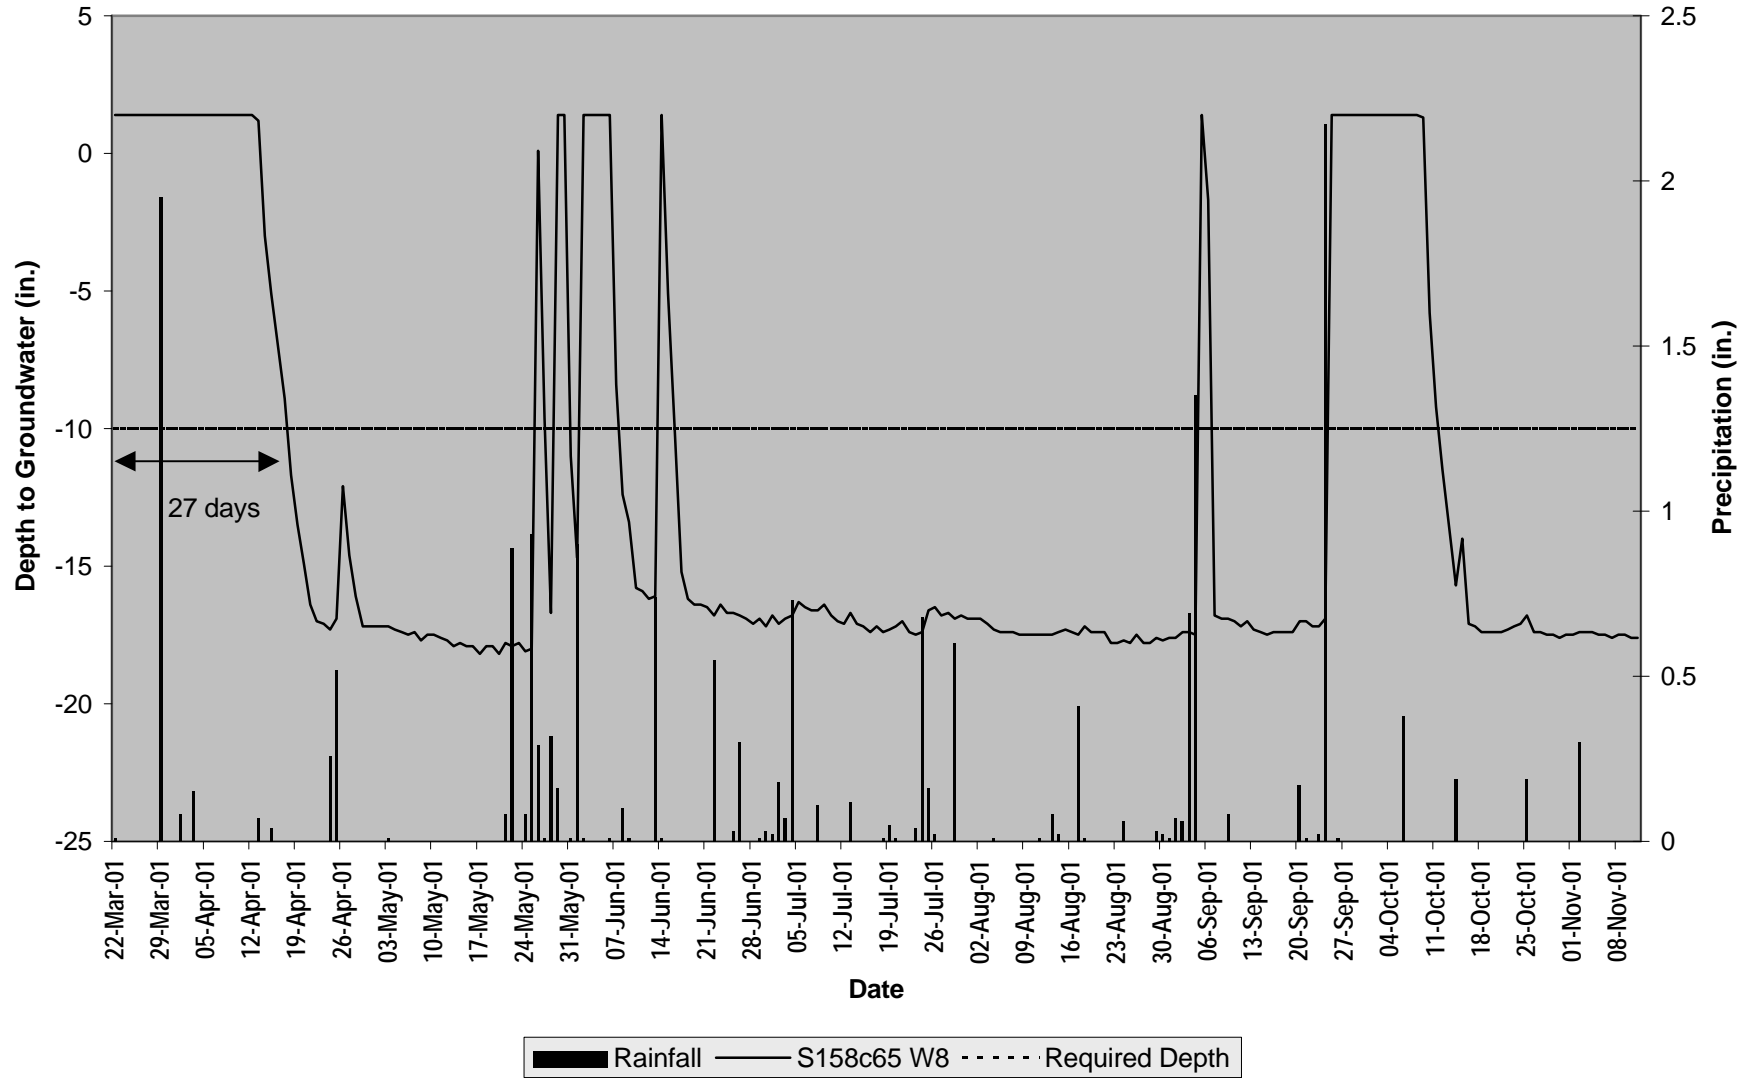
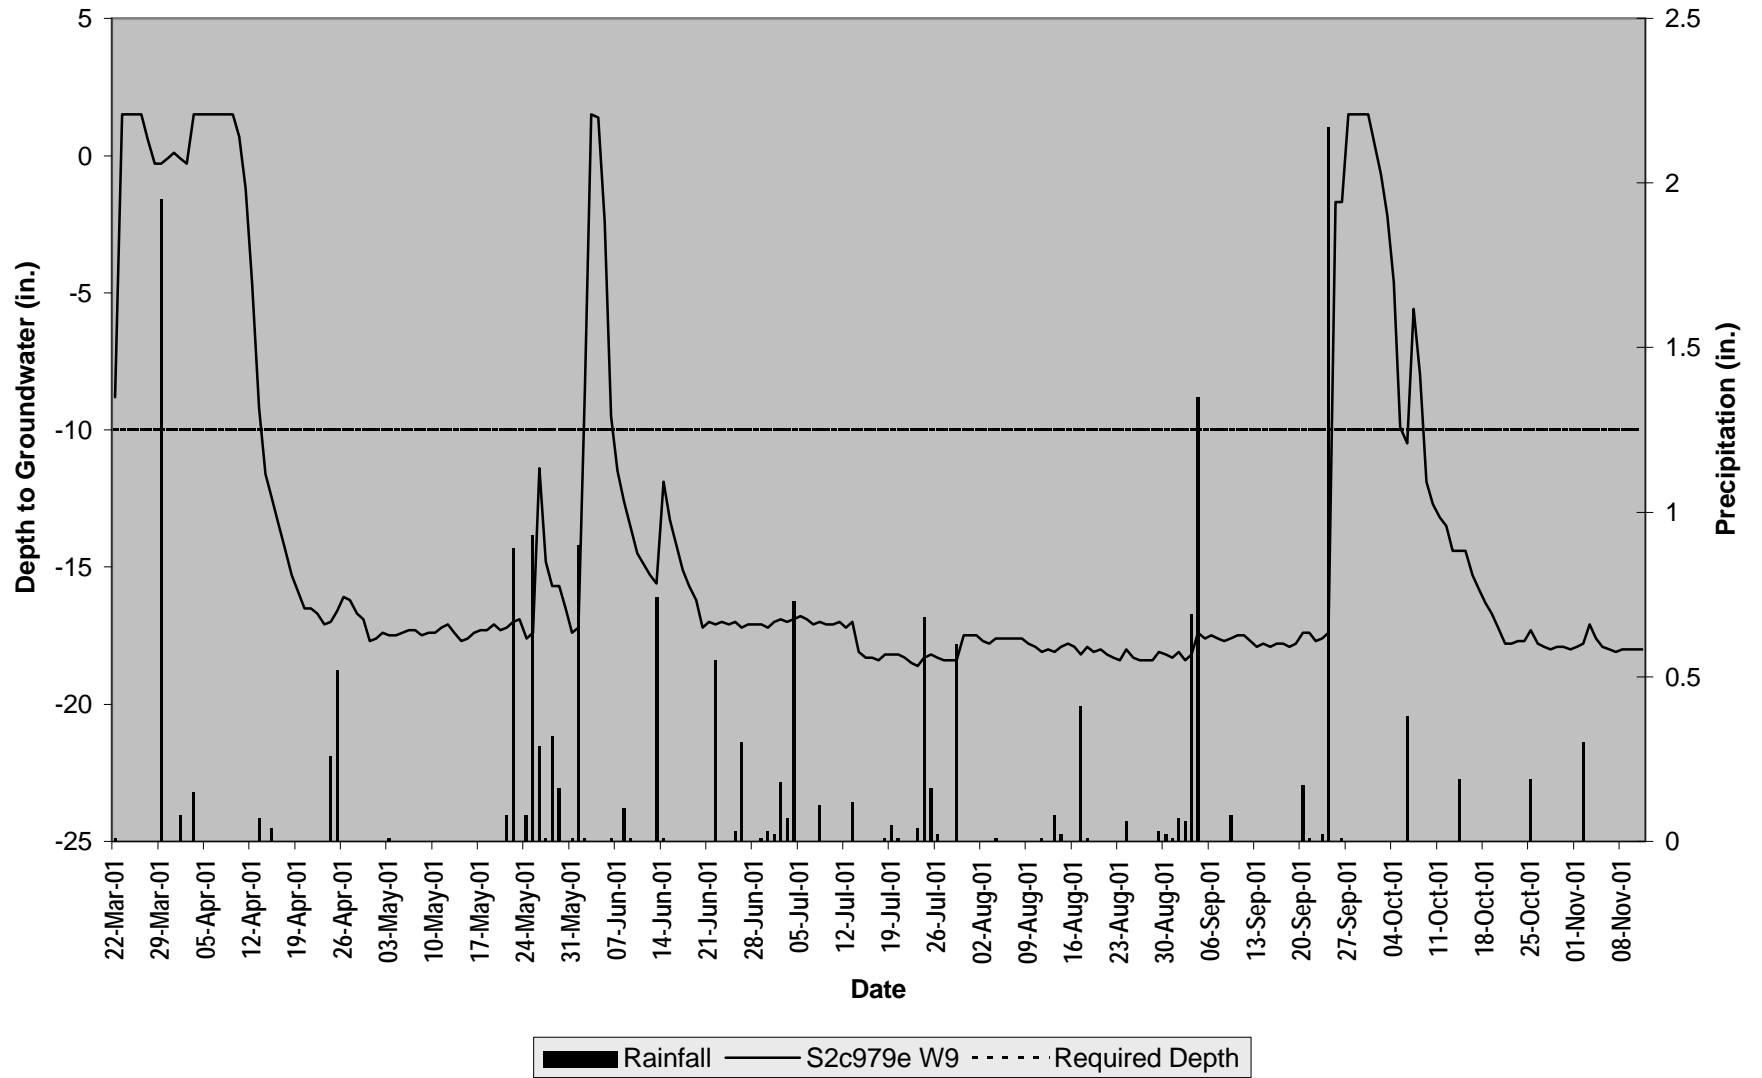
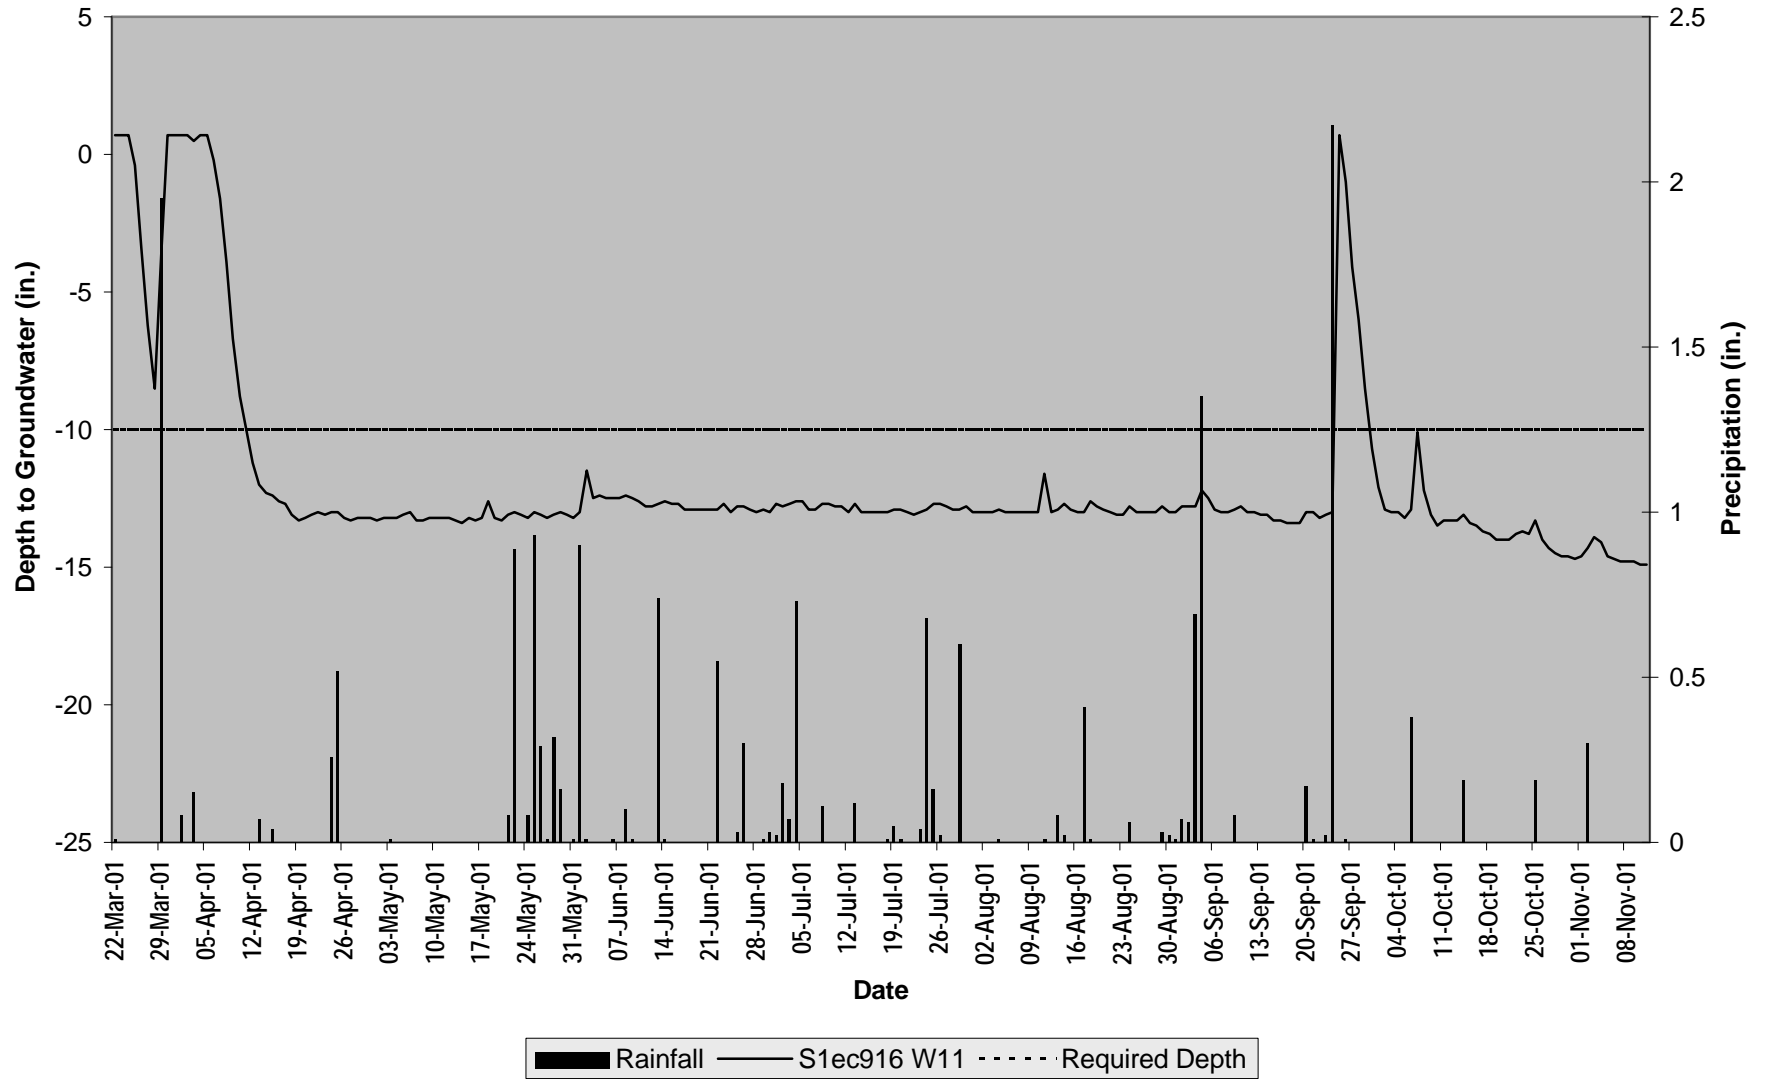
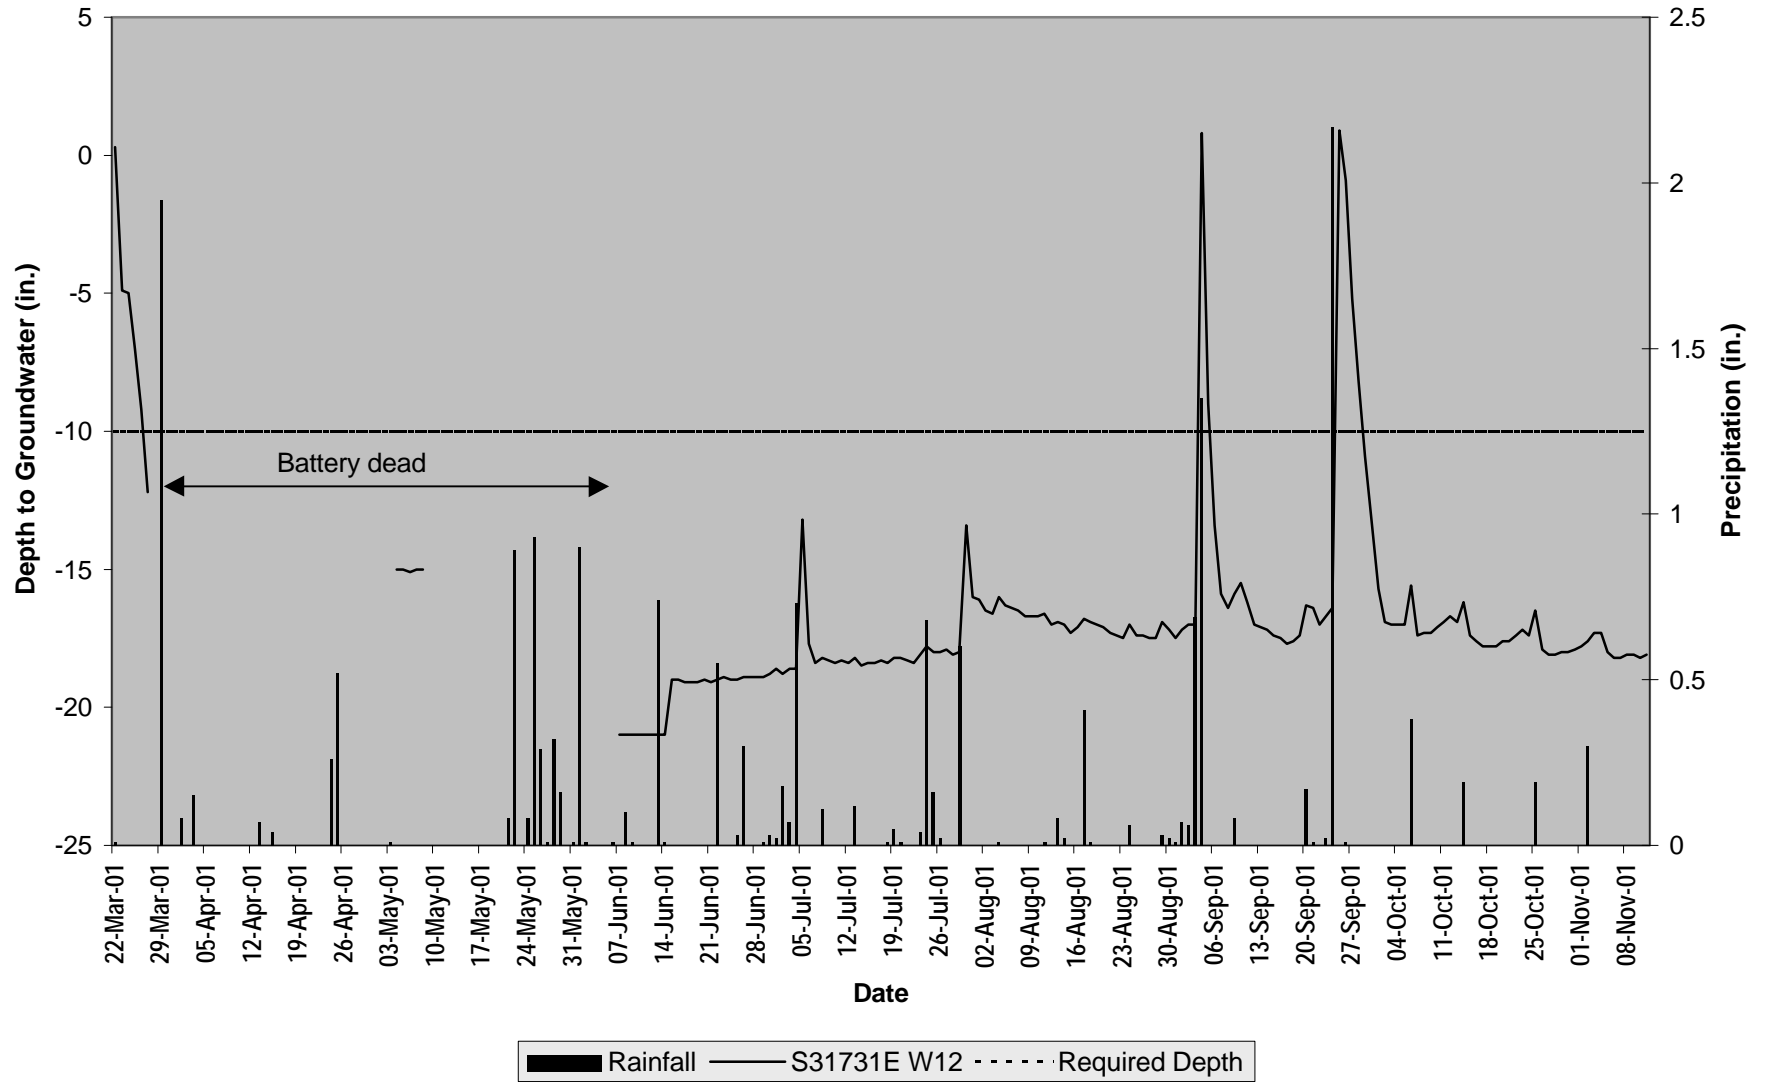
To determine if the site met the permit conditions, “saturation within 10 inches of the surface, ponded or flooded for at least 26 consecutive days of the growing season,” the maximum number of consecutive days that the groundwater was within ten inches of the surface was determined for each gauge. The results are presented in Table 2.

Appendix A contains a plot of the groundwater and surface water depth for each groundwater and surface gauge, respectively. The individual precipitation events, shown on the monitoring gauge graphs as bars, represent data collected from the on-site rain gauge or from a Charlotte weather station (provided by the NC State Climate Office). If the gauge shows saturation for 5% or greater of the growing season, the maximum number of consecutive days is noted on each graph. The rain gauge on the site was replaced with a more accurate measuring device prior to the beginning of the 2000 monitoring season.

The surface water gauges have indicated consistent surface water in the channels throughout the growing season. None of the groundwater gauges registered success for a consecutive 12.5% of the growing season, although 6 of the 9 gauges registered above 8% of the growing season.

Monitoring Gauge	< 26 days	26 days	Actual # of days	Success Dates
LSC-2	✓		21	Mar 22 – Apr 11
LSC-4	✓		20	Mar 22 – Apr 26
LSC-5	✓		21	Mar 22 – Apr 17
LSC-6	✓		10	Mar 22 – Apr 10
LSC-7	✓		8	Mar 30 – Apr 8
LSC-8		✓	27	Mar 30 – Apr 6
LSC-9	✓		23	Mar 22 – Apr 11
LSC-11	✓		21	Mar 22 – Apr 11
LSC-12	✓		5	Mar 22 – Apr 13

It should be noted that three of the groundwater gauges (W2, W5, and W7) lost data during a short portion of the growing season due to battery failure. Gauge 12 lost data from March 28 through June 6 due to a series of battery failures.
