ANNUAL REPORT FOR 2001

Little Sugar Creek Mitigation Site

Project No. 8.U670122

Natural Systems Unit & Roadside Environmental Unit
North Carolina Department of Transportation
December 2001

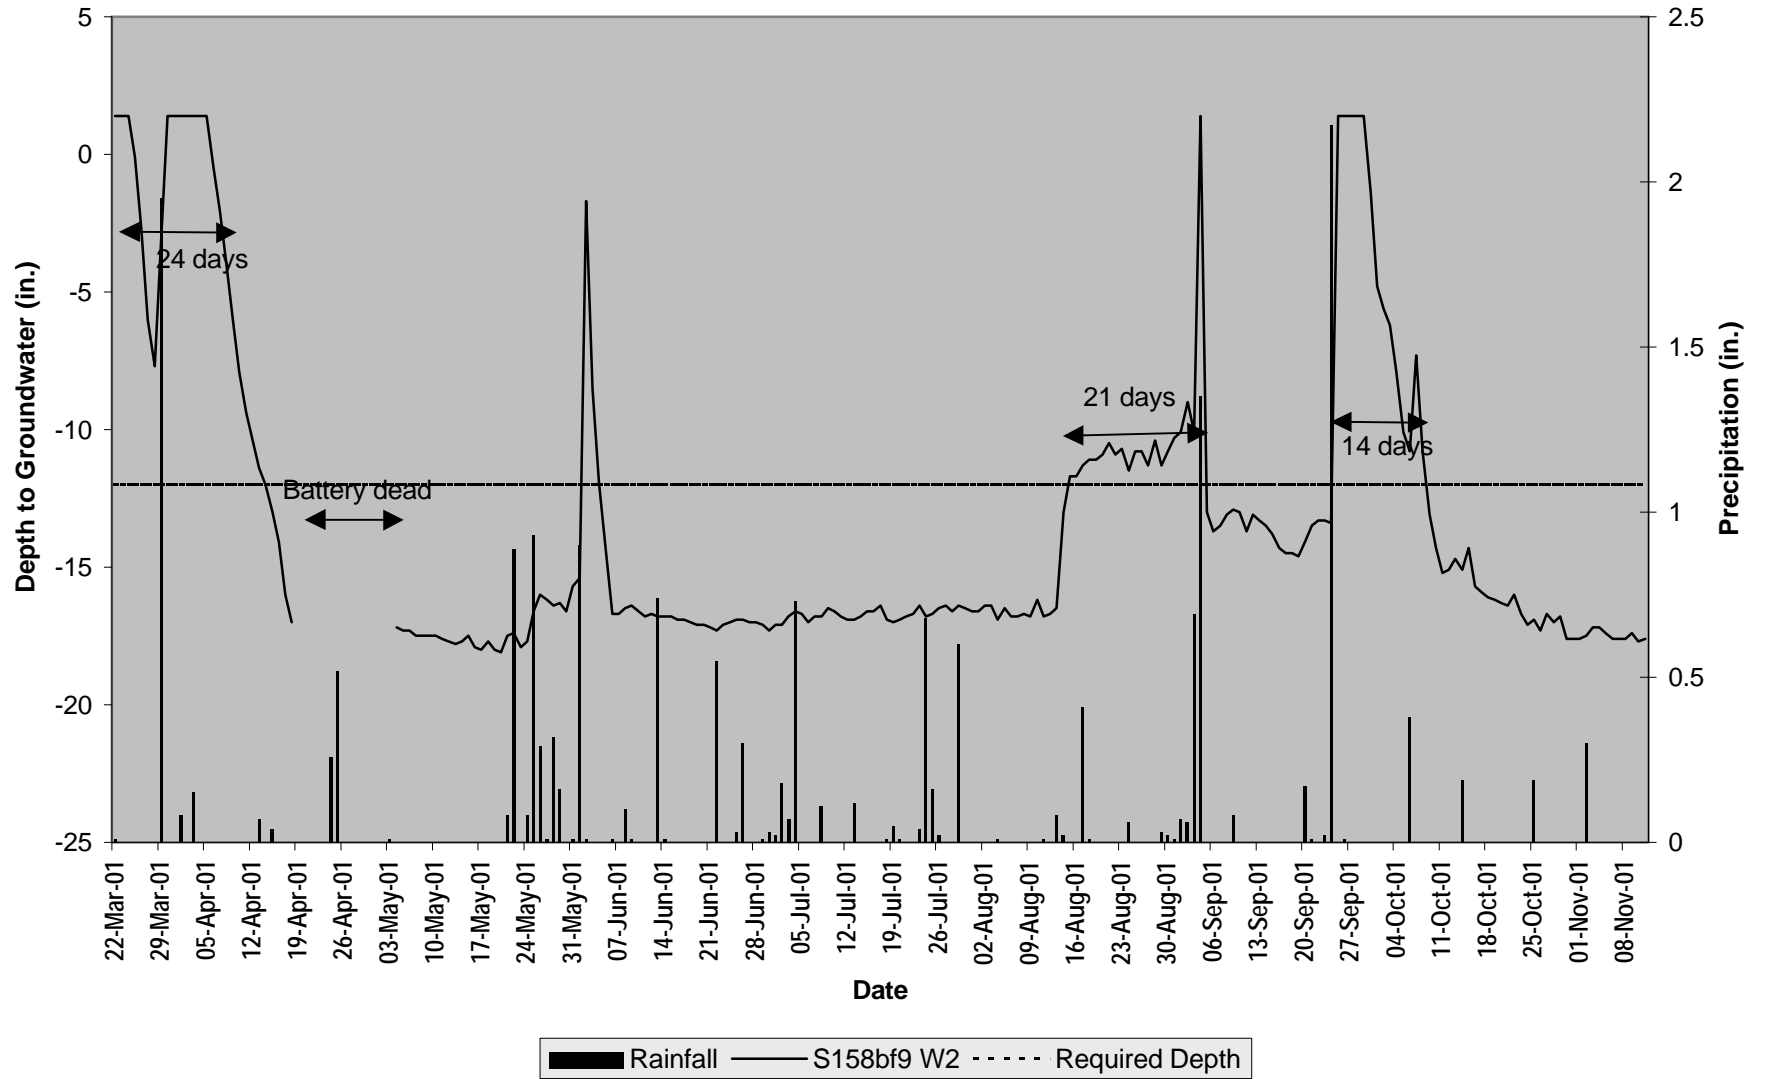
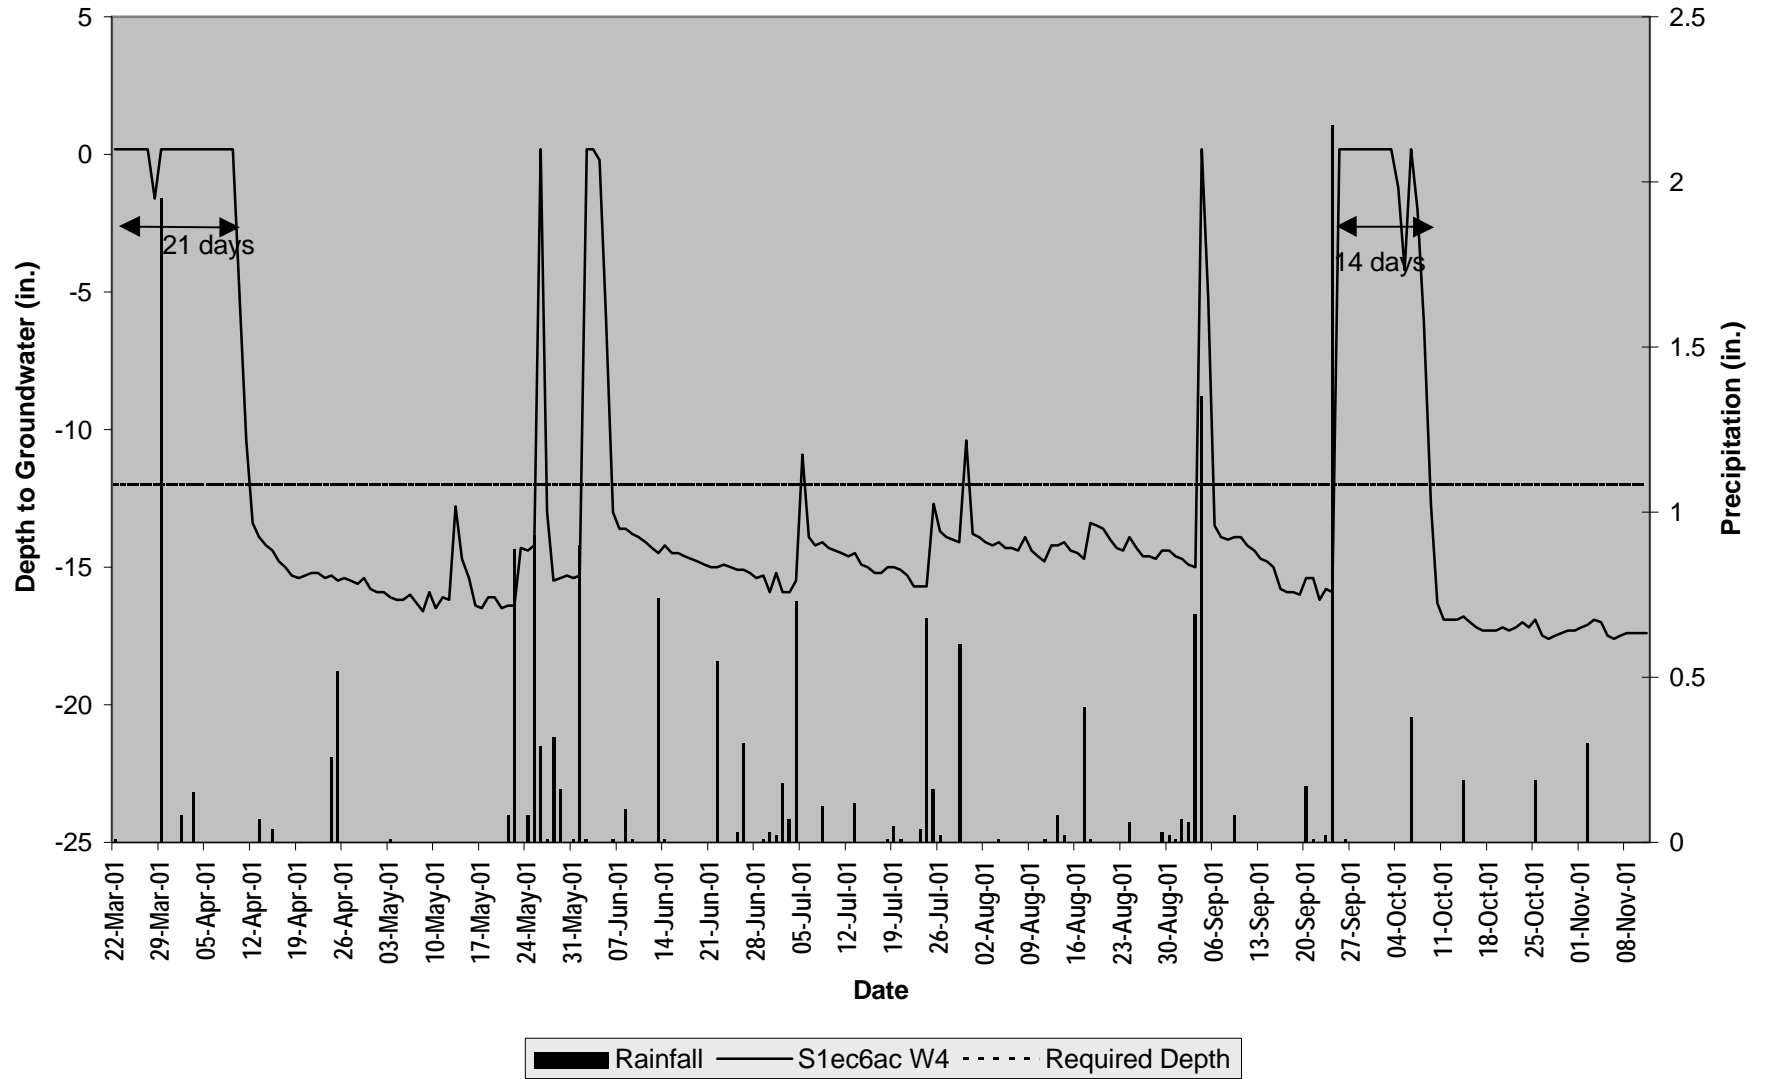
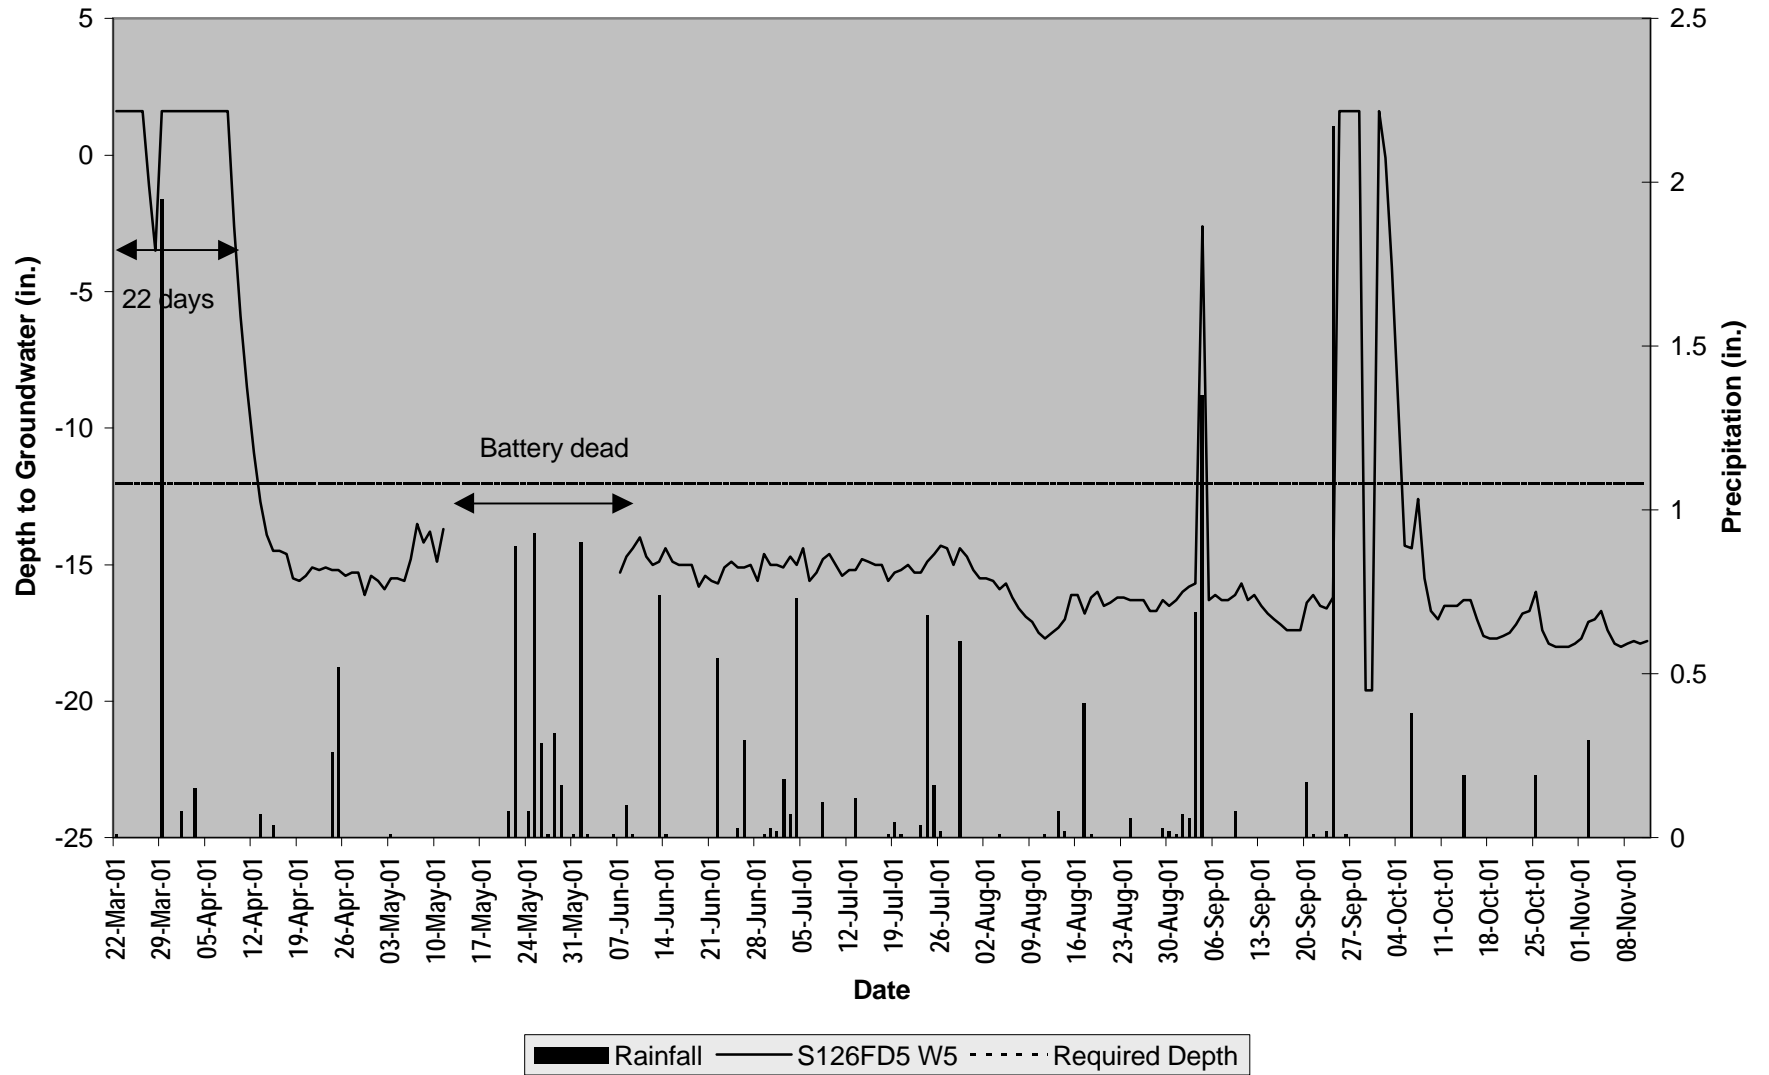
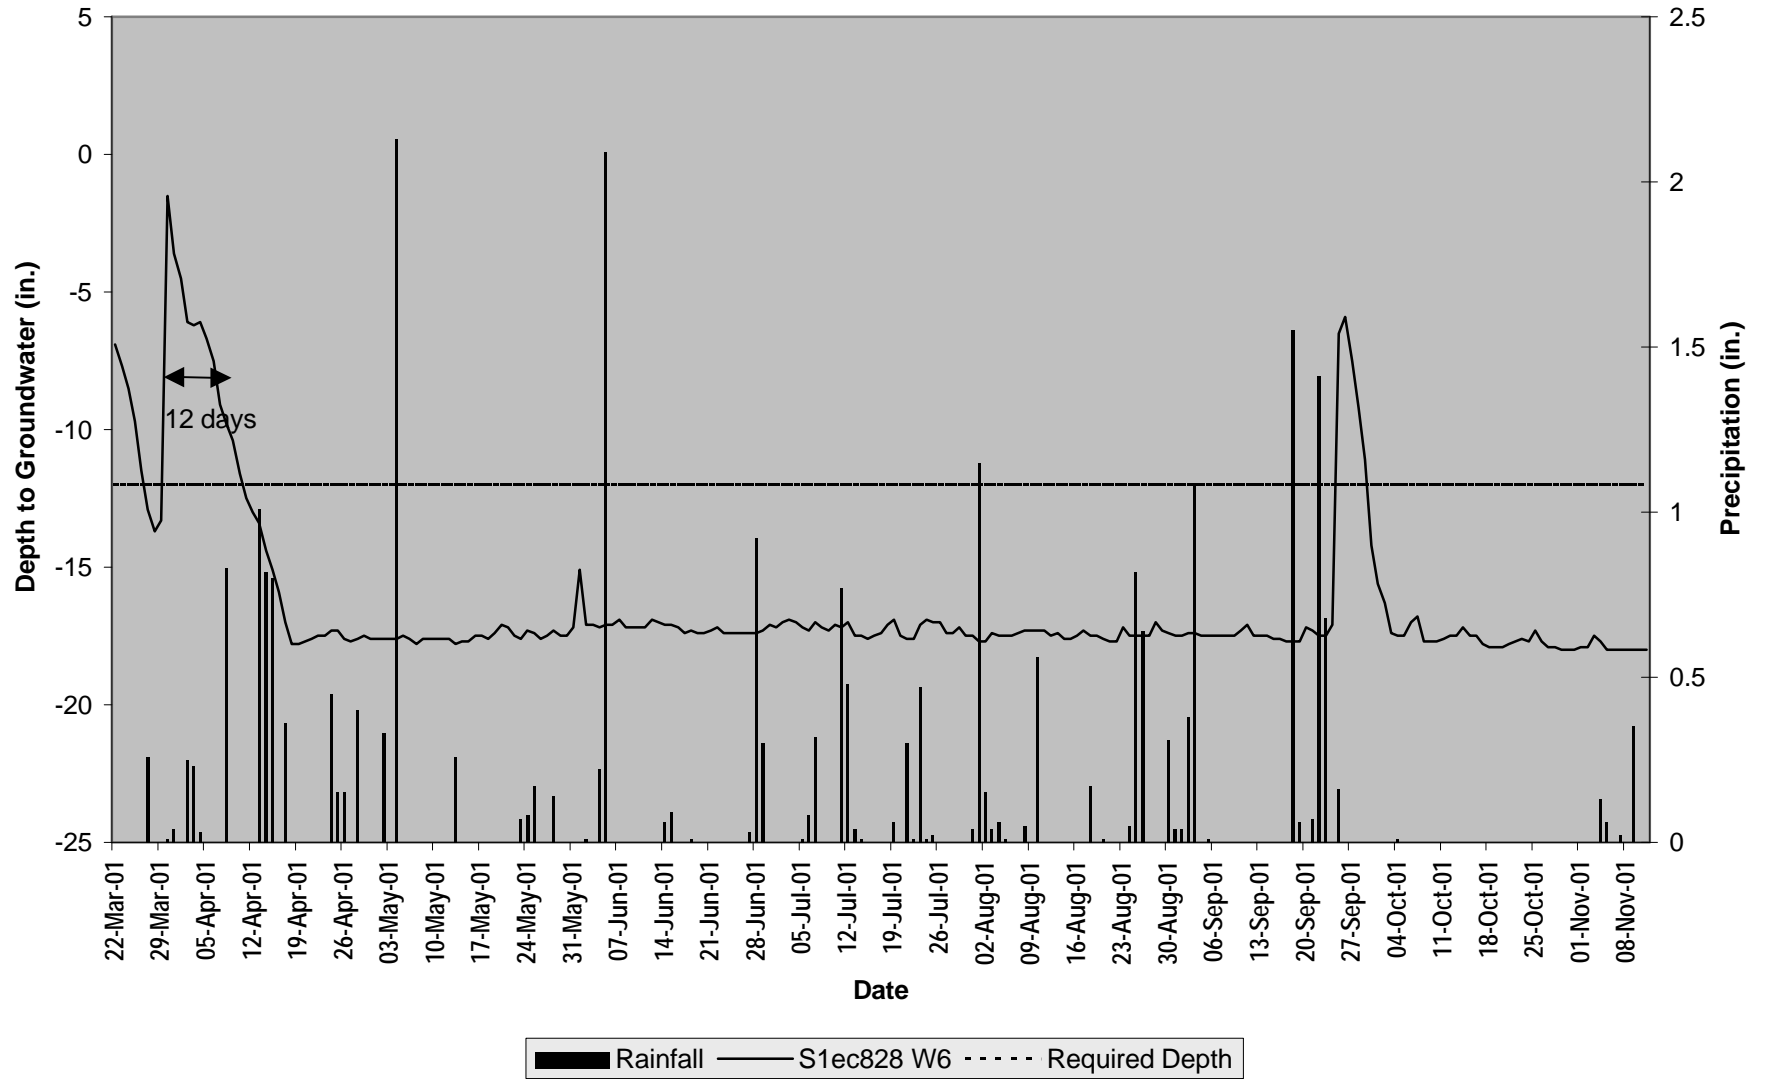
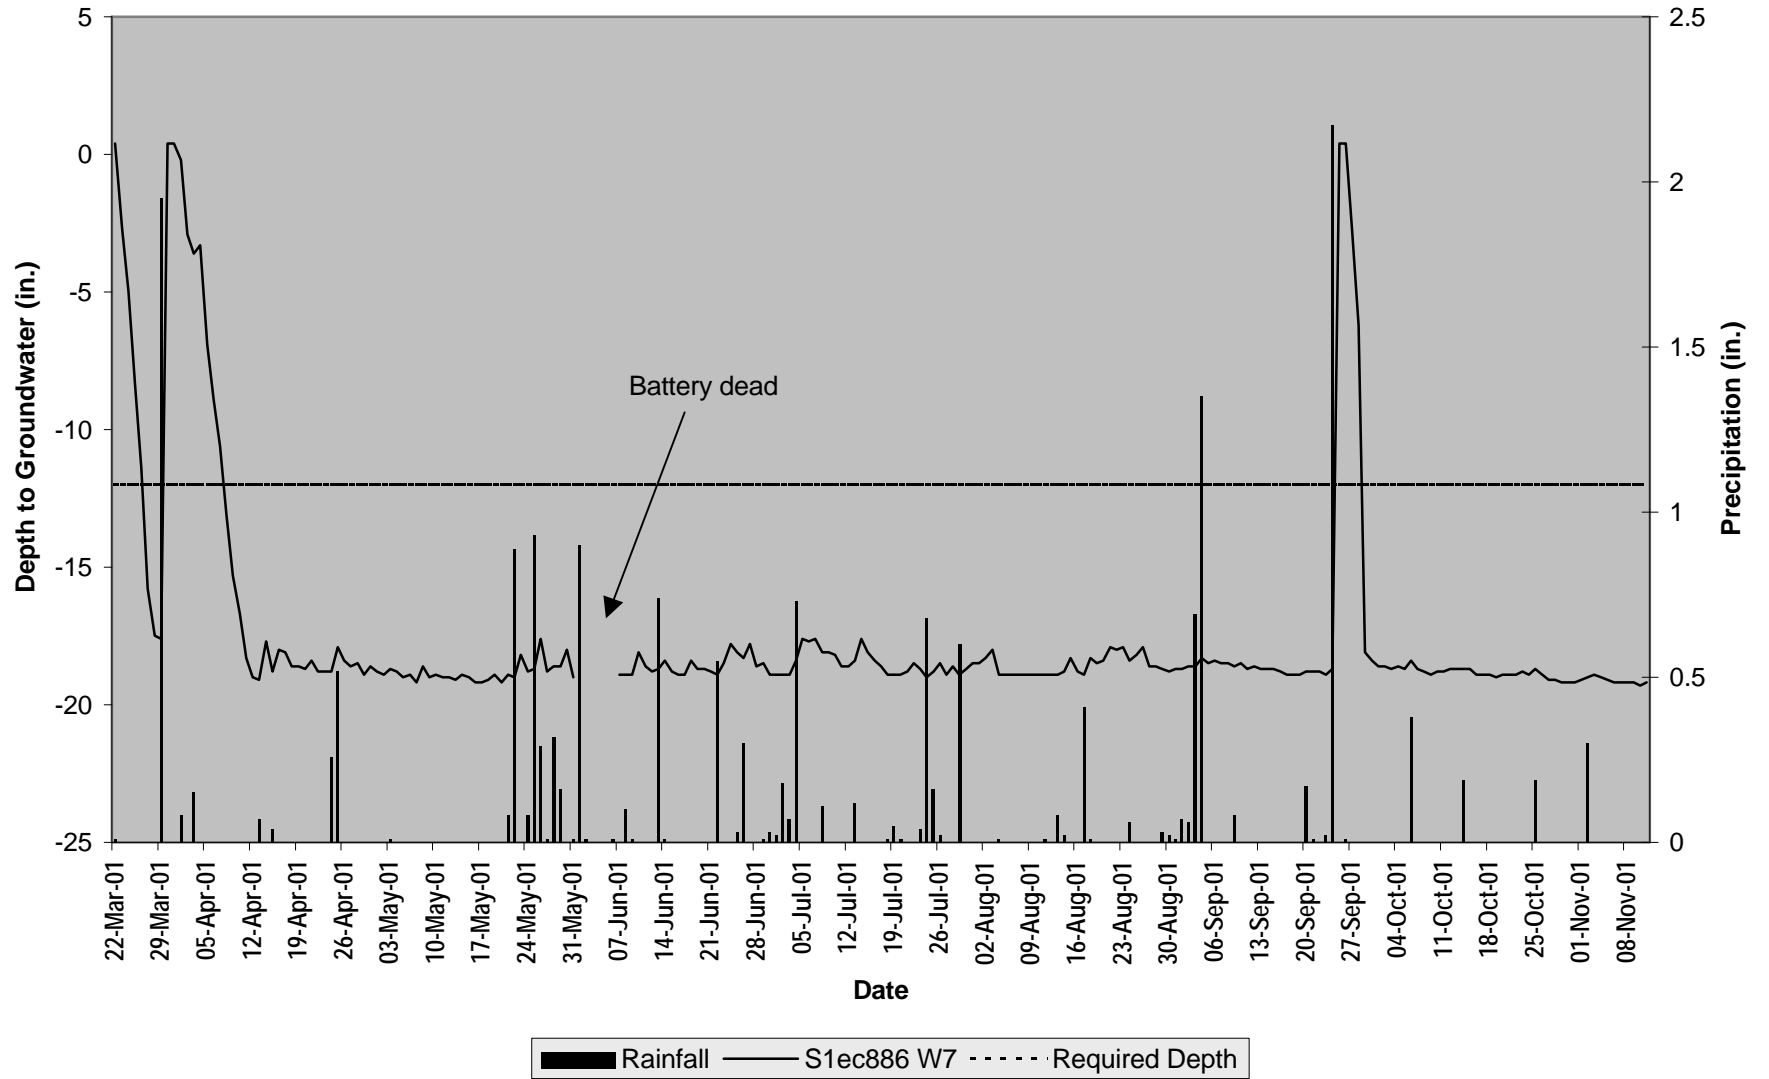
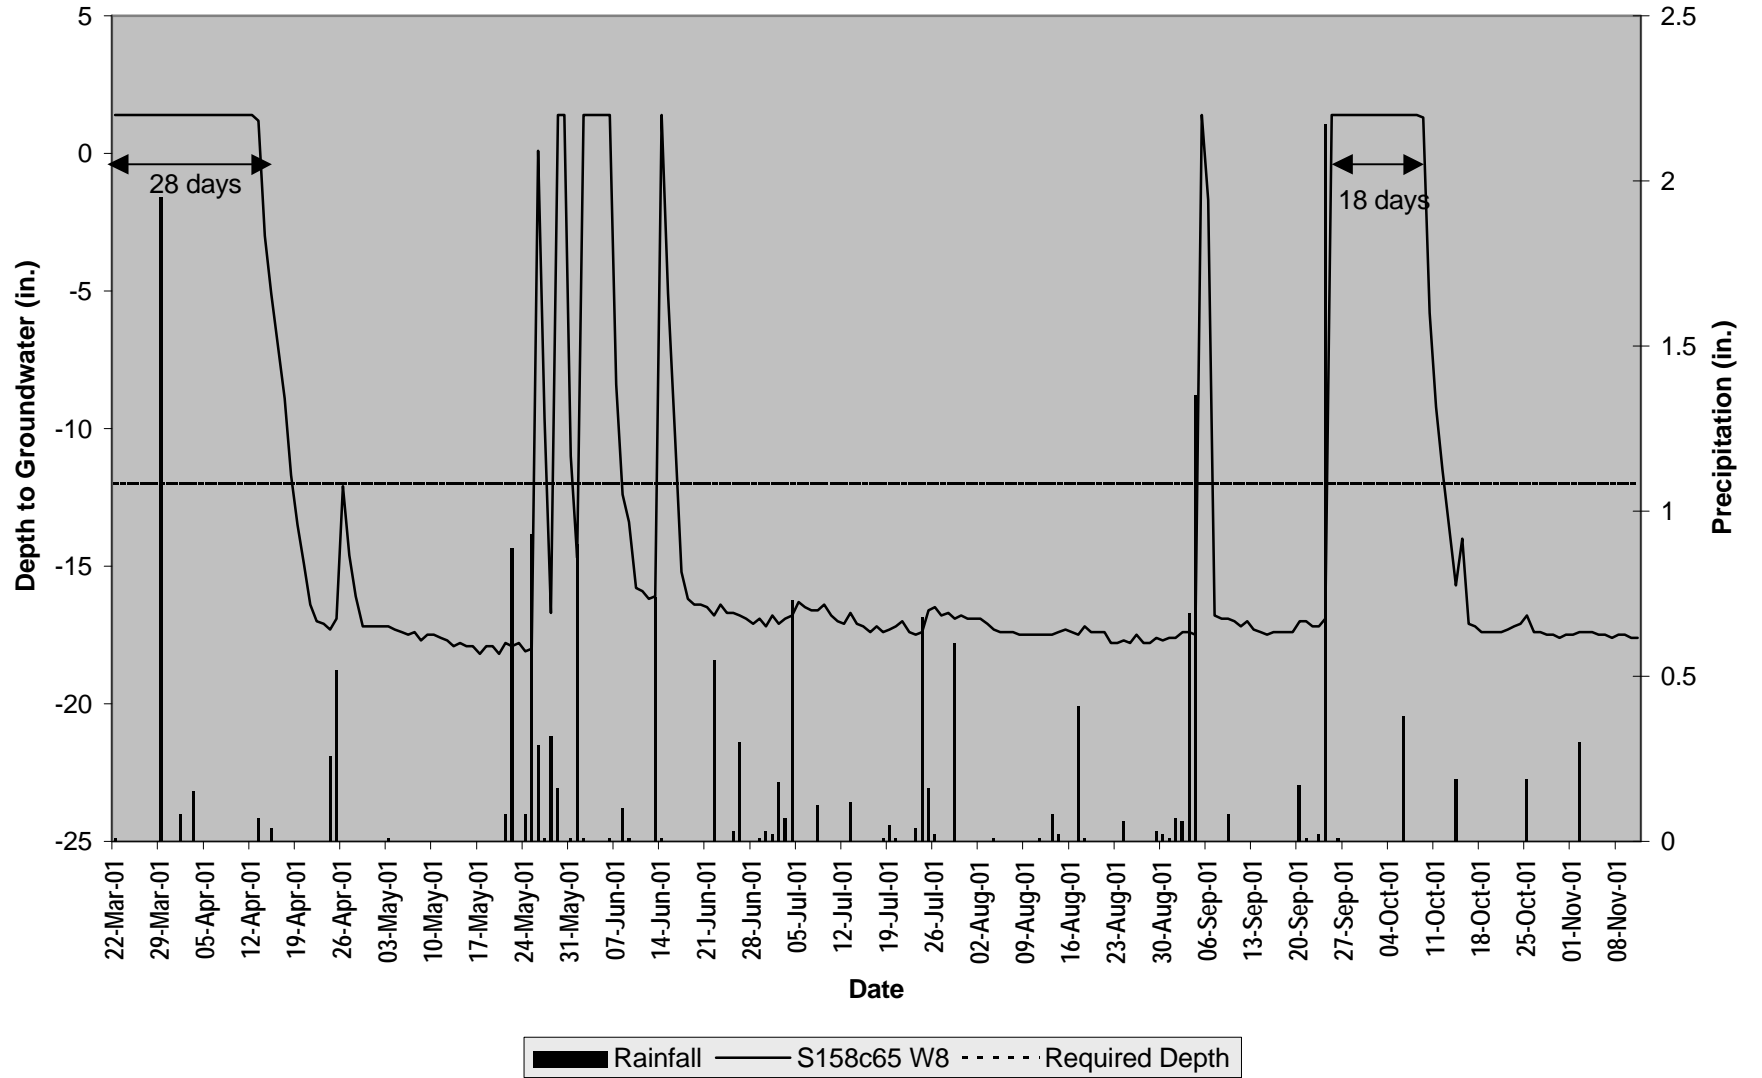
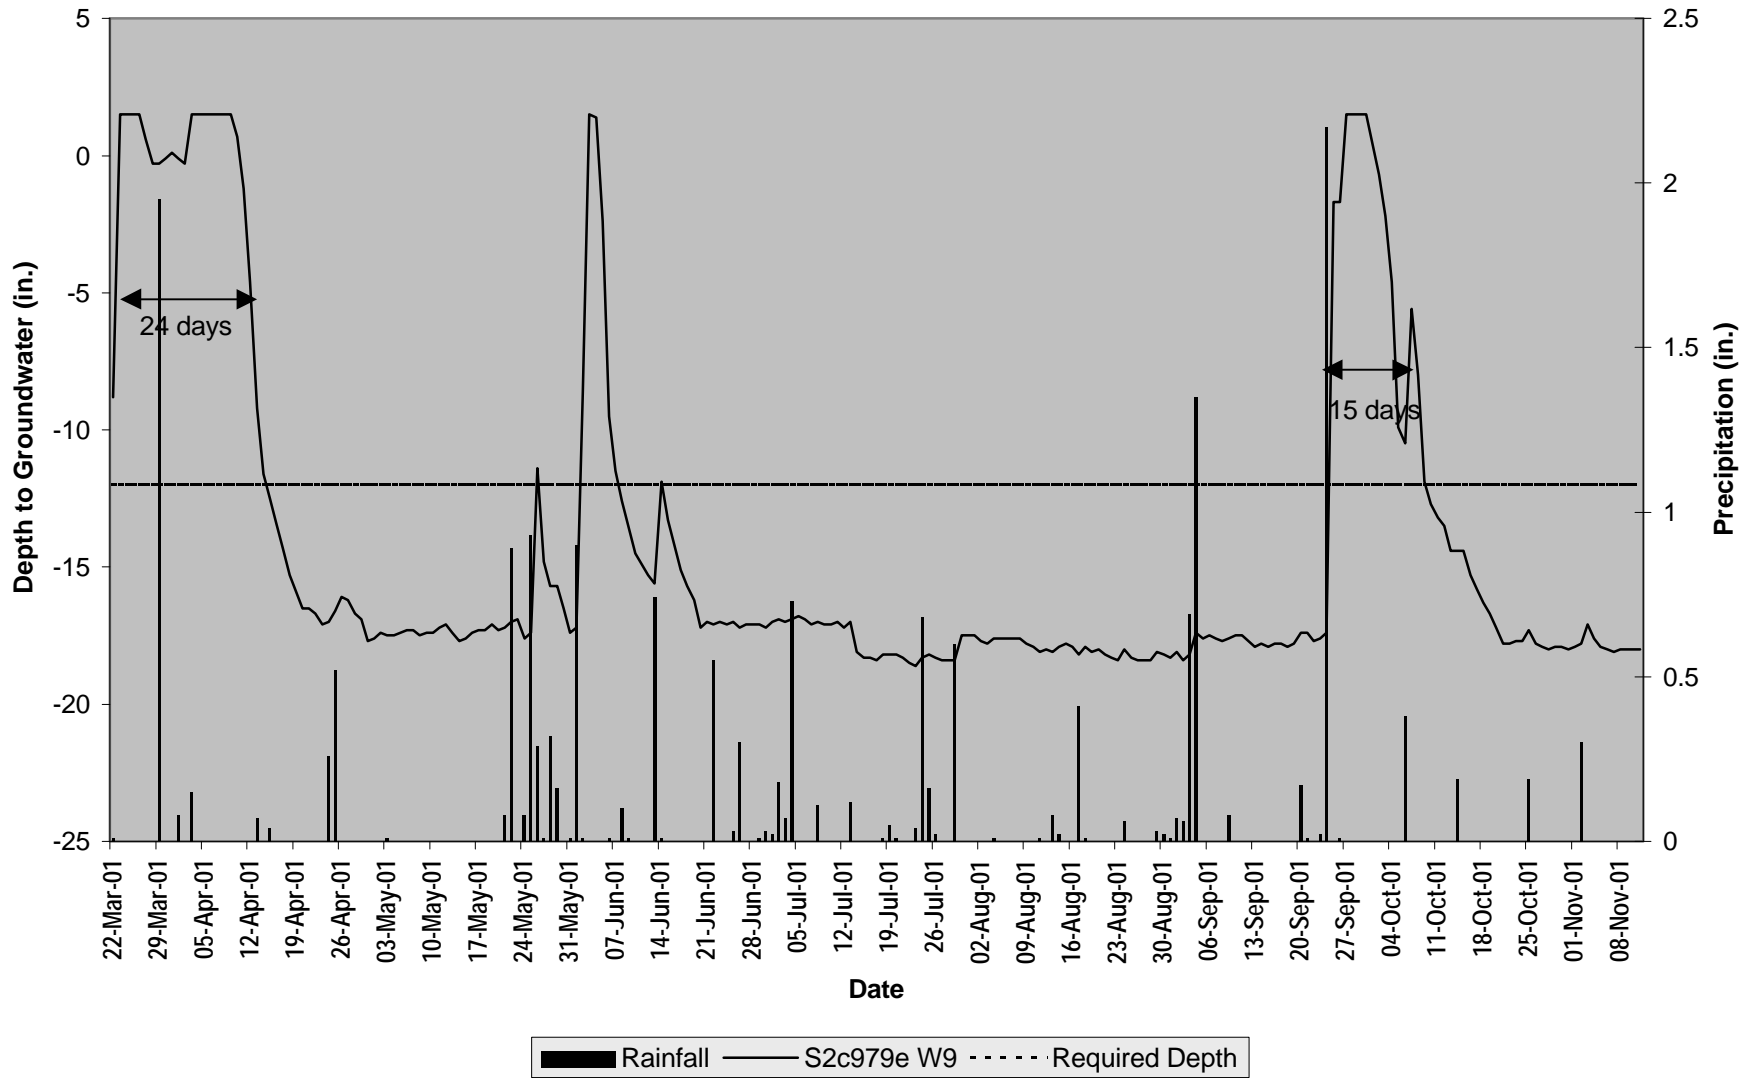
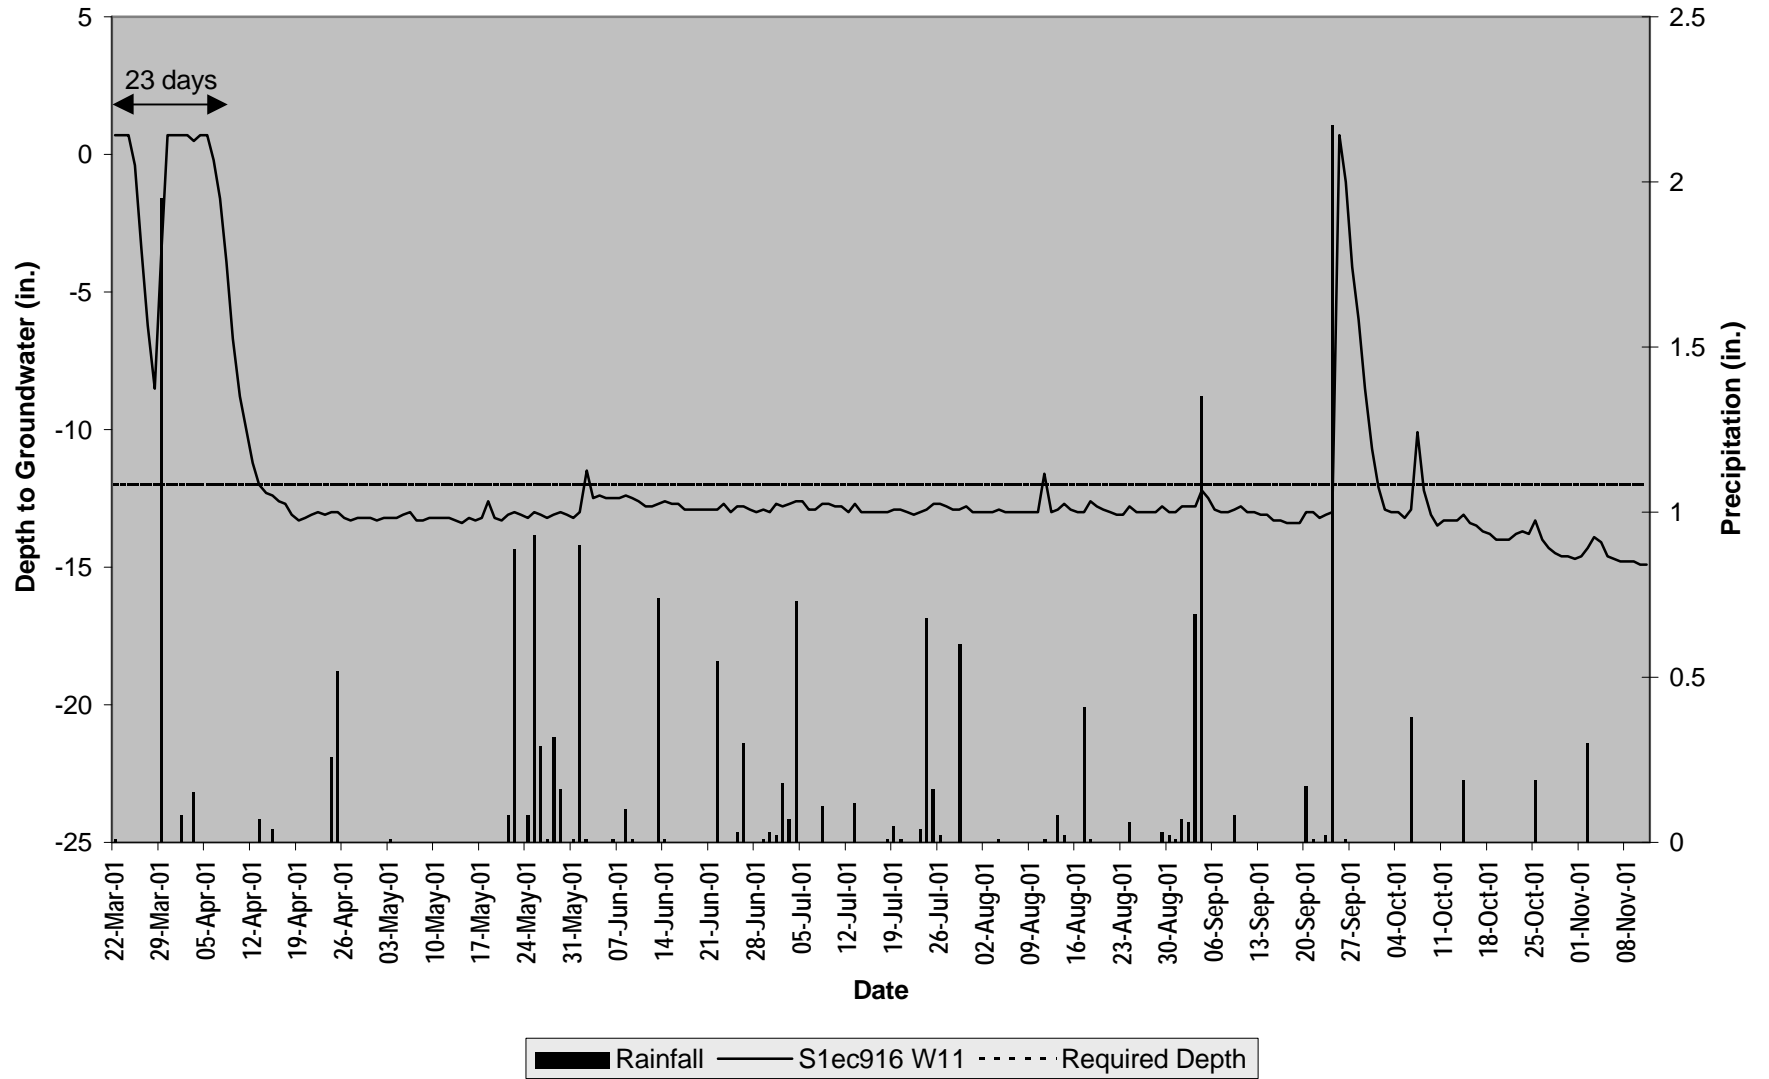
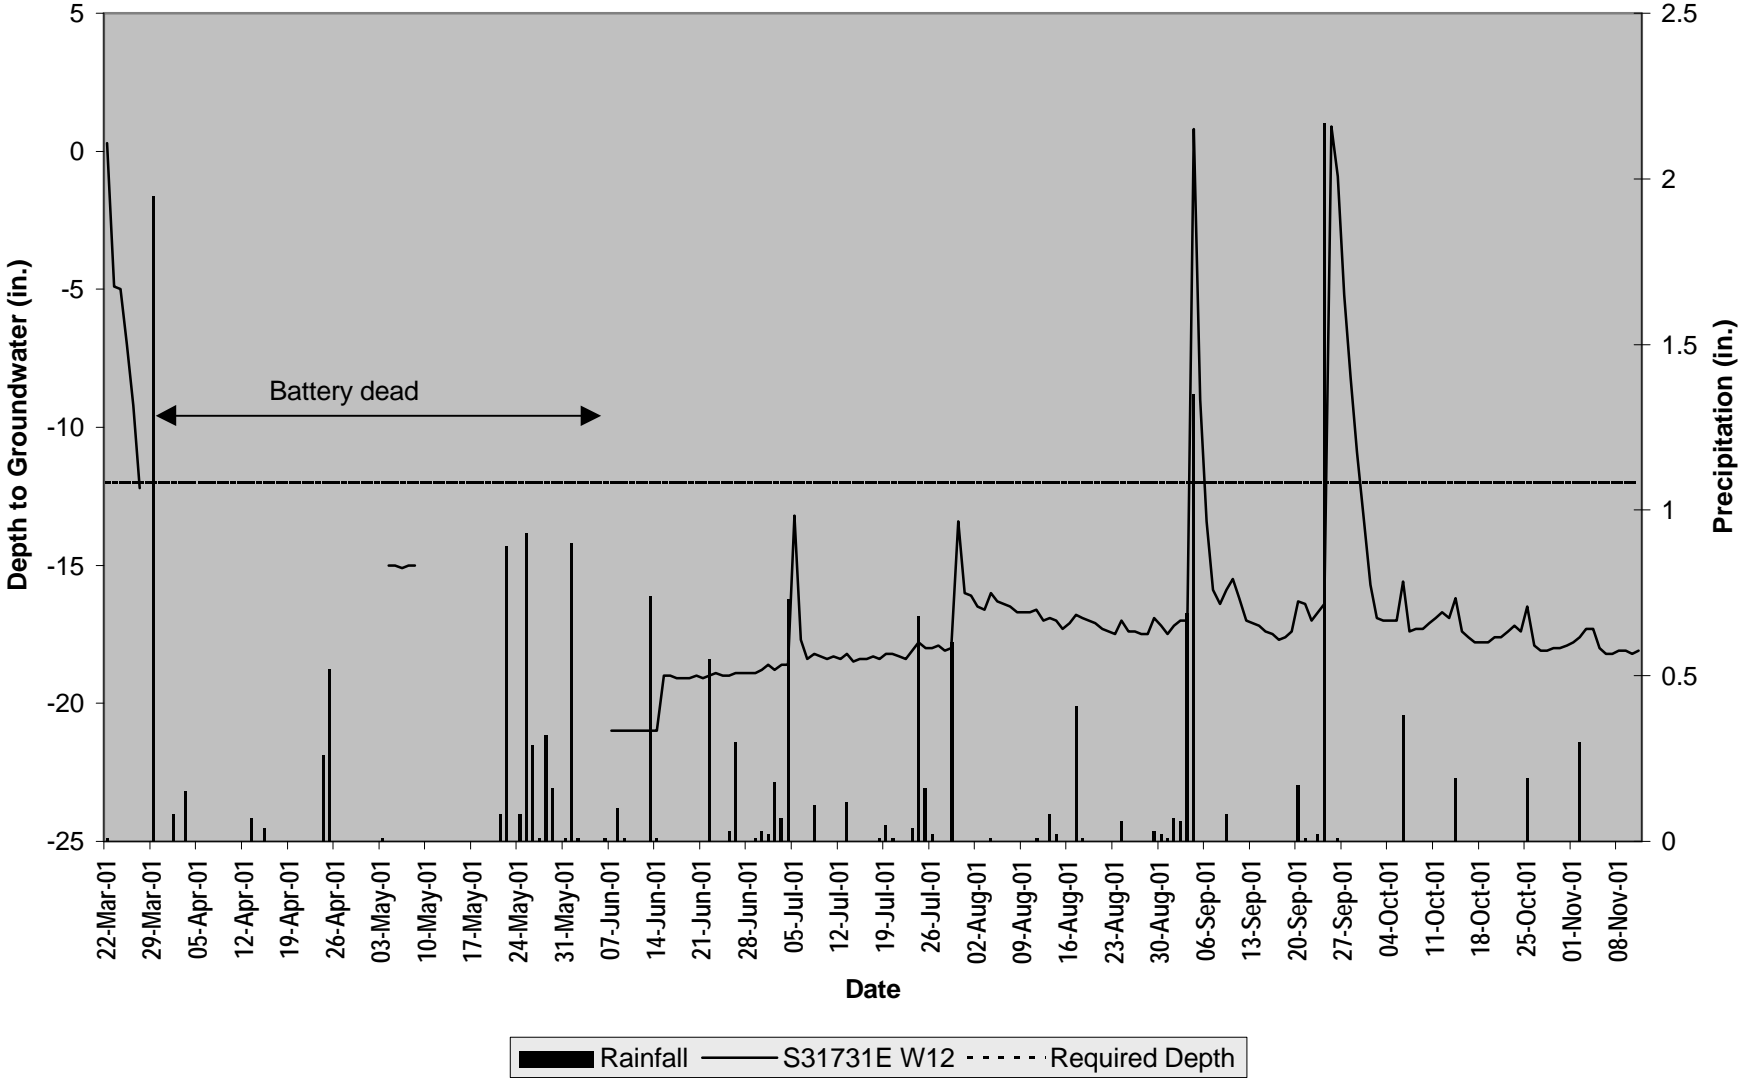
To determine if the site met the Federal guidelines, saturation within 12 inches of the surface for at least 12.5% of the growing season, the maximum number of consecutive days that the groundwater was within twelve inches of the surface was determined for each gauge. This number was converted into a percentage of the 235-day growing season. The results are presented in Table 3.

Appendix A contains a plot of the groundwater and surface water depth for each groundwater and surface gauge, respectively. The individual precipitation events, shown on the monitoring gauge graphs as bars, represent data collected from the on-site rain gauge or from a Charlotte weather station (provided by the NC State Climate Office). If the gauge shows saturation for 5% or greater of the growing season, the maximum number of consecutive days is noted on each graph. The rain gauge on the site was replaced with a more accurate measuring device prior to the beginning of the 2000 monitoring season.

The surface water gauges have indicated consistent surface water in the channels throughout the growing season. None of the groundwater gauges registered success for a consecutive 12.5% of the growing season, although 6 of the 9 gauges registered above 8% of the growing season.

Monitoring Gauge	< 5%	5-8%	8-12.5%	> 12.5%	Actual %	Dates of Success
LSC-2			✓		10.21	Mar 22 – Apr 14
LSC-4			✓		8.94	Mar 22 – Apr 11
LSC-5			✓		9.36	Mar 22 – Apr 12
LSC-6		✓			5.11	Mar 30 – Apr 10
LSC-7	✓				3.83	Mar 30 – Apr 7
LSC-8			✓		11.91	Mar 22 – Apr 18
LSC-9			✓		10.21	Mar 22 – Apr 14
LSC-11			✓		9.79	Mar 22 – Apr 13
LSC-12	✓				2.12	Mar 22 – Mar 26

It should be noted that three of the groundwater gauges (W2, W5, and W7) lost data during a short portion of the growing season due to battery failure. Gauge 12 lost data from March 28 through June 6 due to a series of battery failures.
