# ANNUAL REPORT FOR 2001

**South Buffalo Creek Mitigation Site  
Guilford County  
Project No. 8.U493501  
TIP No. I-2402 WM**

Prepared By:  
Natural Systems Unit & Roadside Environmental Unit  
North Carolina Department of Transportation  
December 2001

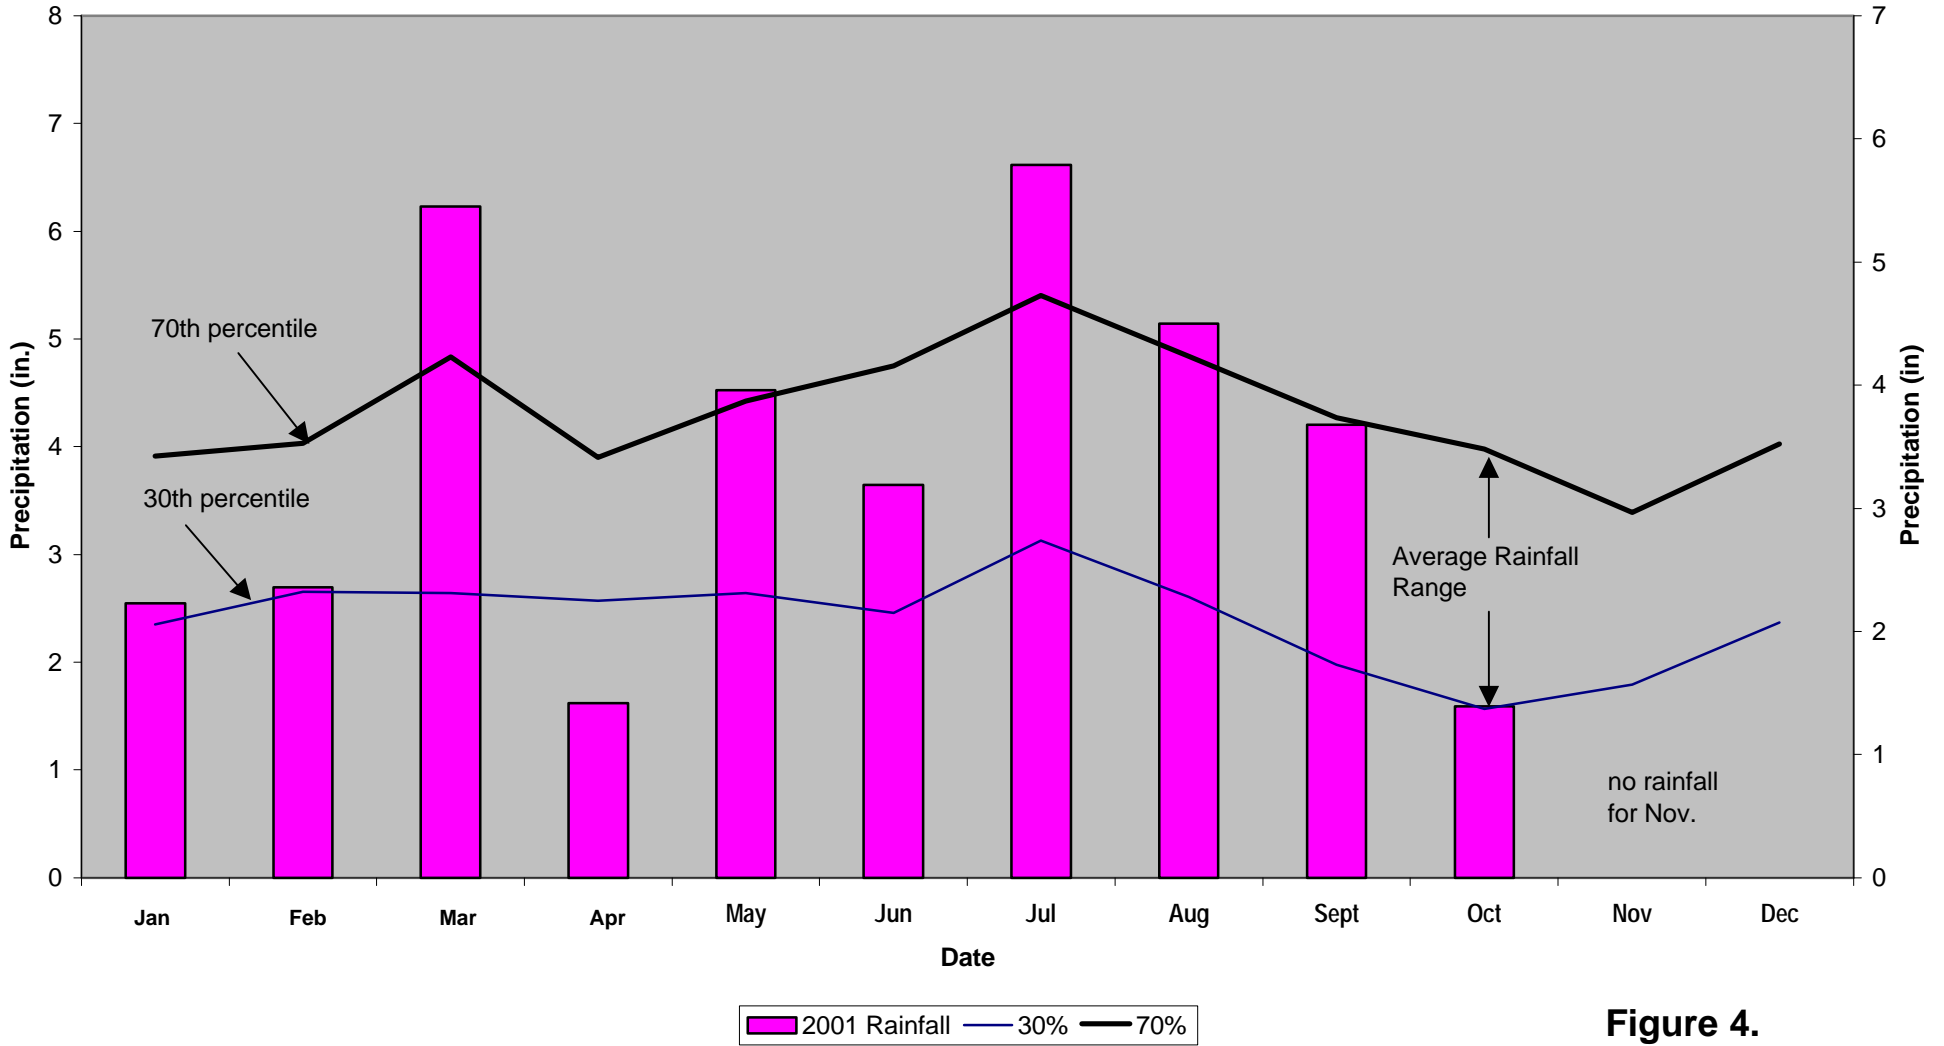
Figure 4.

Figure 4 represents an examination of the onsite rainfall in comparison with local historical data to determine if 2001 rainfall occurs within the average rainfall range of the area. The historical data was provided by the National Climatic Data Center; the recent rainfall data was provided using the onsite Infinities rain gauge.

Precipitation on the South Buffalo Creek site began with a dry late winter/early spring (with the exception of an exceptionally wet March) and a wet summer during the months of July, August and September. Peaks and dips in rainfall did follow historic trends with March and July peaking in precipitation and autumn exhibiting the driest conditions.

2001 South Buffalo Creek 30 - 70 Percentile Graph  
Greensboro, NC

Overall rainfall was uncharacteristic when compared with specific months, however, wet and dry periods generally correspond to historical trends. Four of six gauges as well as the reference gauge met hydrologic success criteria. During field inspection, G4 appeared to be located on a slight hummock, which might explain why it did not meet hydrological requirements. Gauge G10 appeared to be in a low wetland area, near the subsurface wall and it almost met requirements, recording 28 days of inundation. Climatic data showed a wetter than normal March followed by a drier than normal April, and the gauges that met the success criteria did so during this time period. A site visit is warranted to reexamine the locations of Gauges G4 and G10.

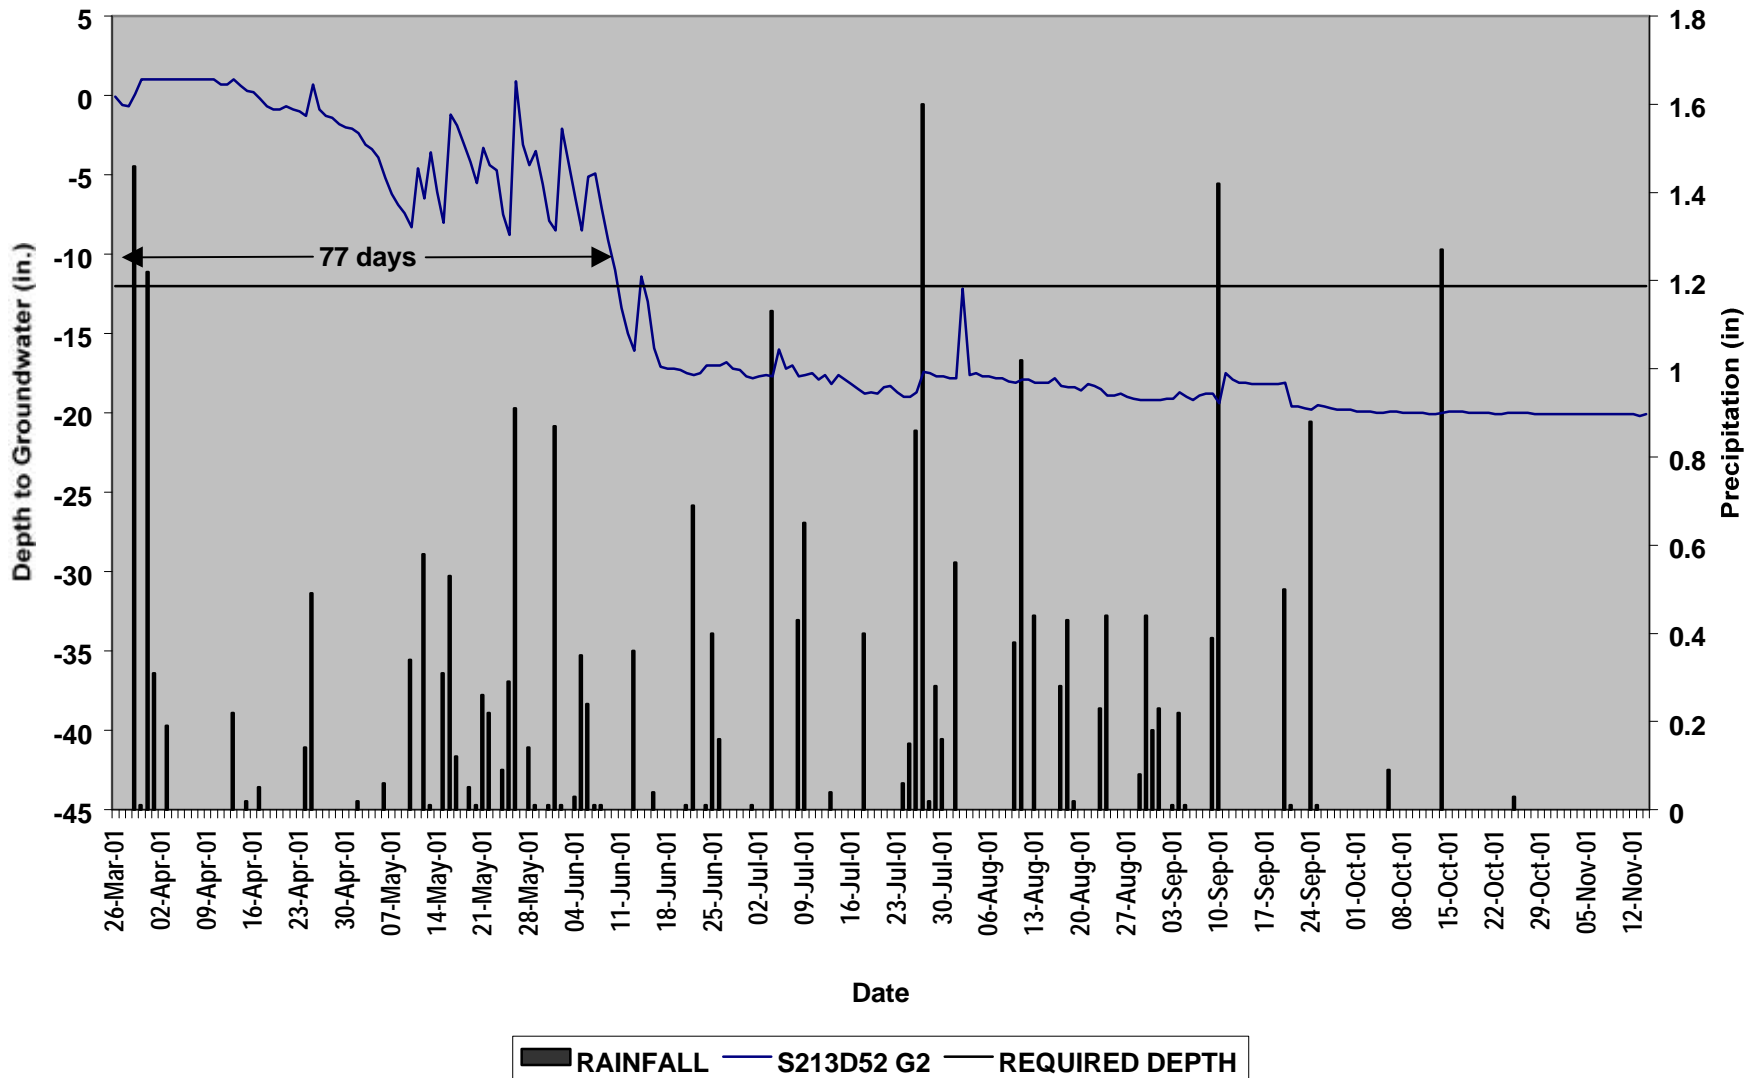
### South Buffalo Creek G2

Groundwater	< 5%	5% - 8%	8% - 12.5%	> 12.5%	Actual %	Dates
G2 (reference)				✓	34.3	Mar 26 - Jun 10
G3				✓	18.3	Mar 26-May 5
G4			✓		8.9	Mar 26 - Apr 14
G6				✓	17.4	Mar 26-May 3
G8				✓	16.9	Mar 26-May 2
G9				✓	16.5	Mar 26-May 6
G10			✓		12.5	Mar 26 - Apr 22

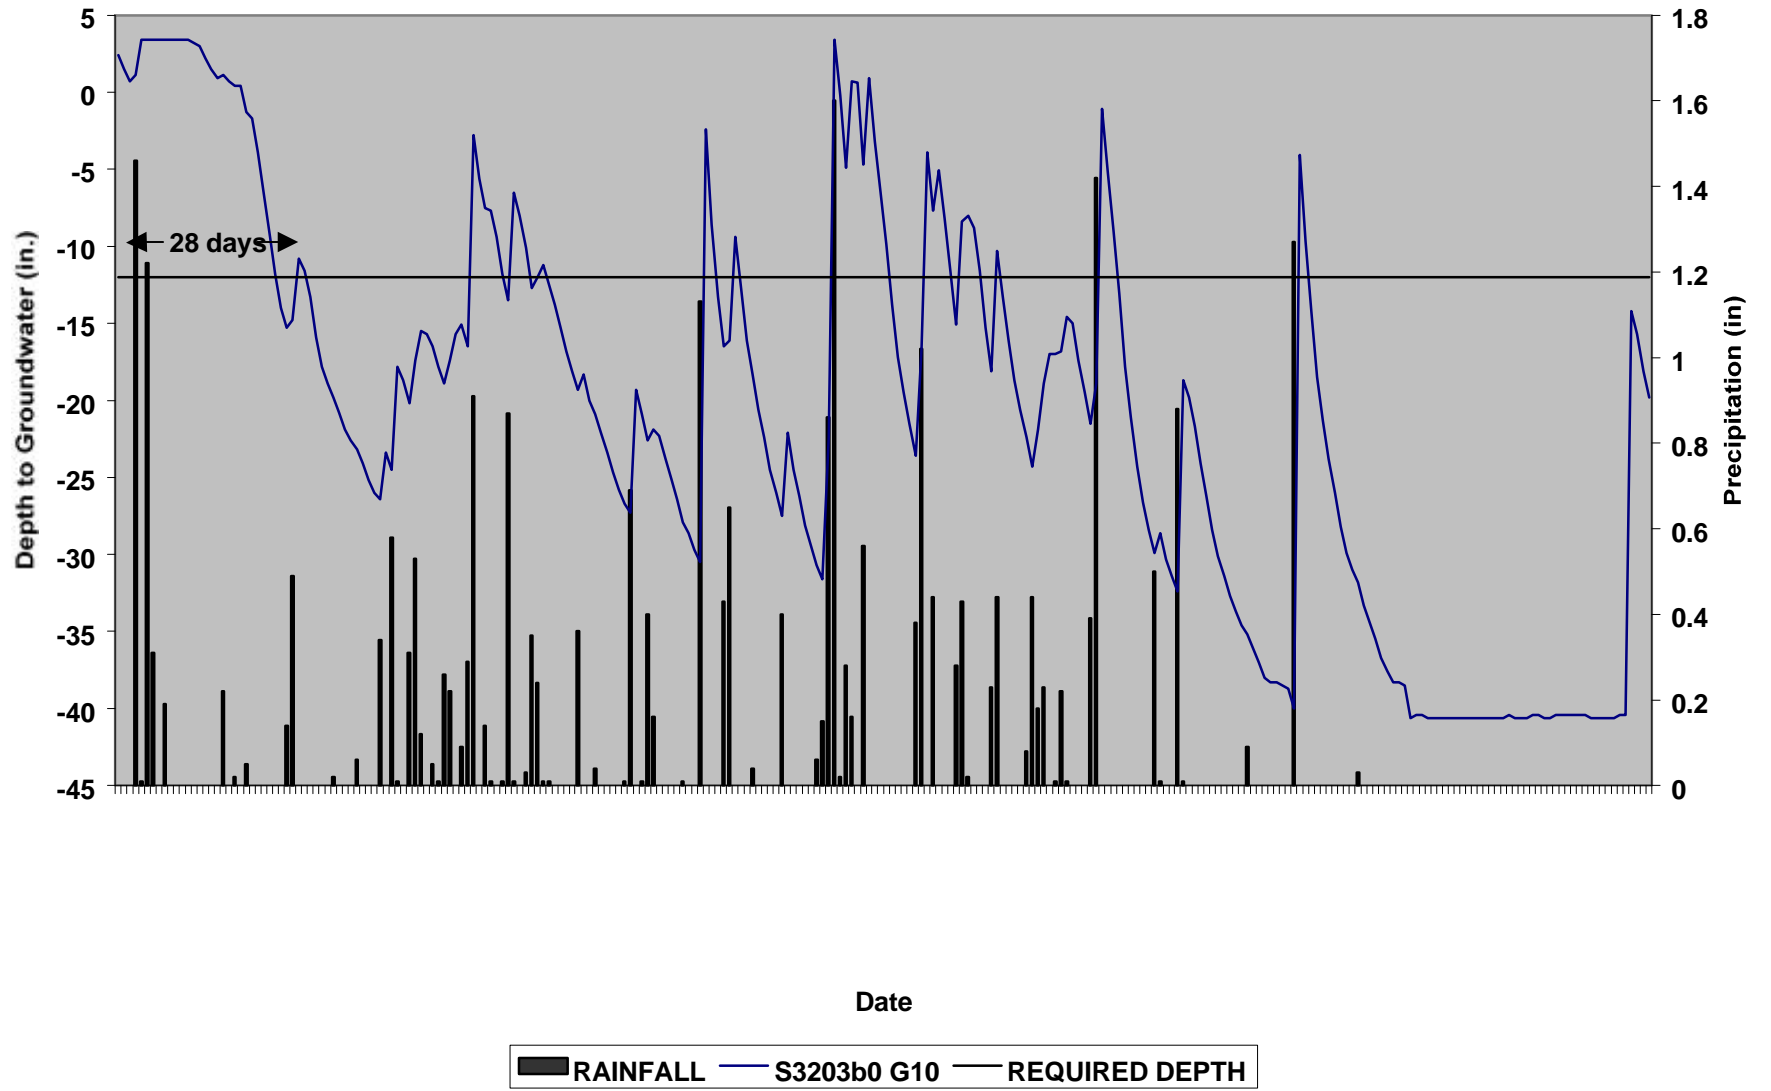
# South Buffalo Creek G10

Hydrologic monitoring resulted in five of the seven monitoring gauges recording the groundwater within 12 inches of the soil surface for more than 12.5 % of the growing season. Monitoring Gauges, G4 and G10, located in close proximity did not record sufficient hydrology to meet greater than the 12.5% hydrology requirement, however G10 was extremely close and met exactly 12.5% of the growing season but not greater than that amount.

Downloaded data from G4 and G10 will be examined, and if deemed necessary, additional gauges may be installed in the area to replace these gauges.
