ANNUAL REPORT FOR 2003

Crescent Road Mitigation Site

Lenoir County

Project No. 8.2200101

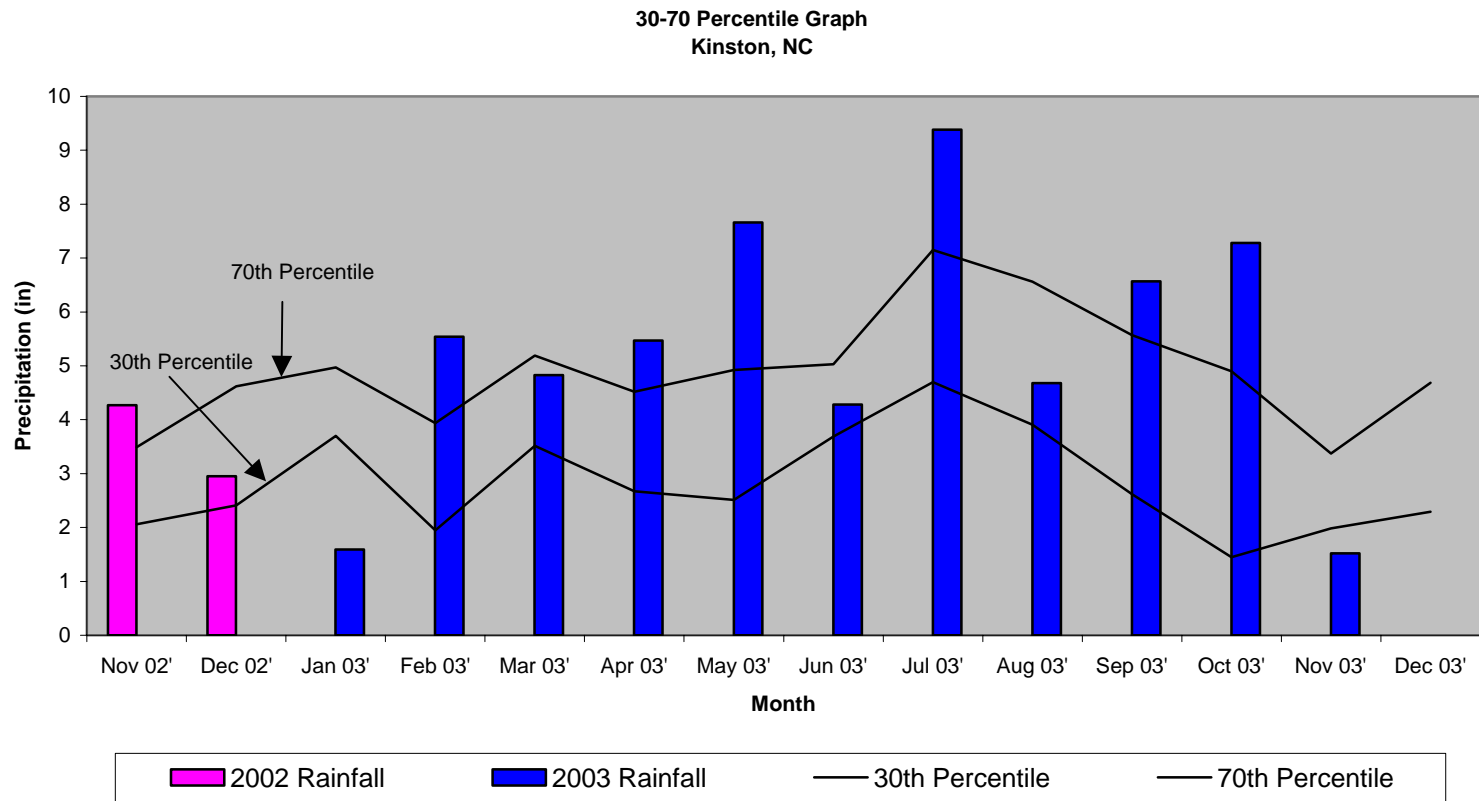
Figure 4. 30-70 Percentile Graph, Kinston, NC

Figure 4 is a comparison of monthly rainfall for the period of November 2002 through August 2003 to historical precipitation (collected between 1972 and 2003) for Kinston, North Carolina. This comparison gives an indication of how 2003 relates to historical data in terms of climate conditions. The NC State Climate Office provided all of the local rainfall information.

For the 2003-year, November (02'), February, April, May, July, September, and October experienced above average rainfall. The months of January and November recorded below average rainfall for the site. December (02'), March, June, and August experienced average rainfall. Overall, 2003 experienced an average to above average rainfall year.

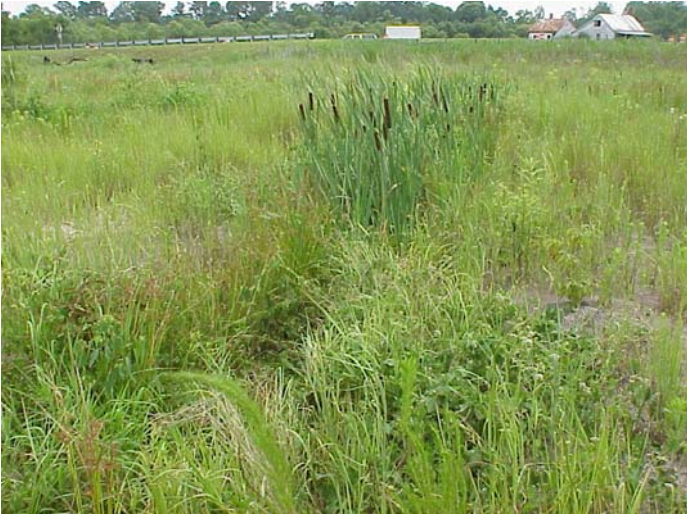
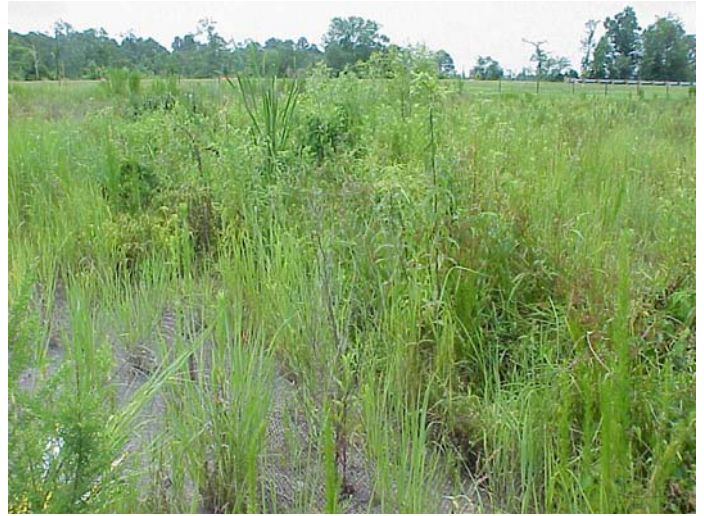
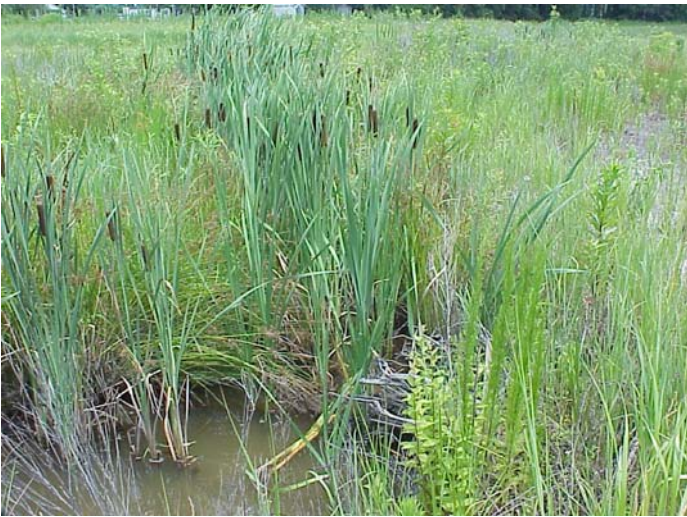
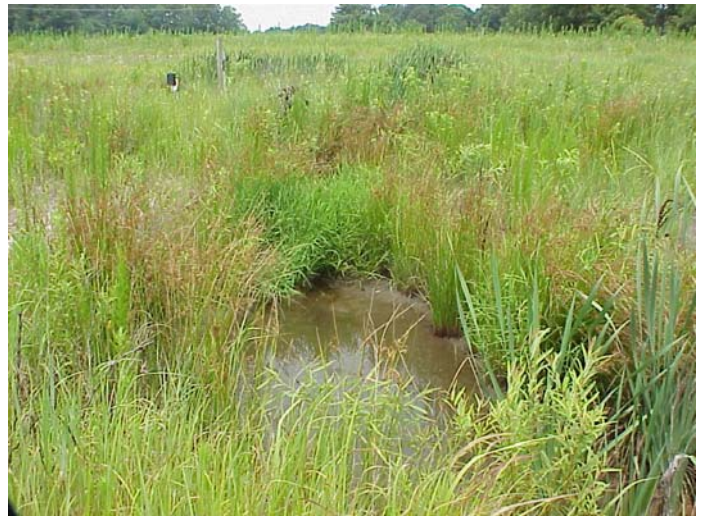
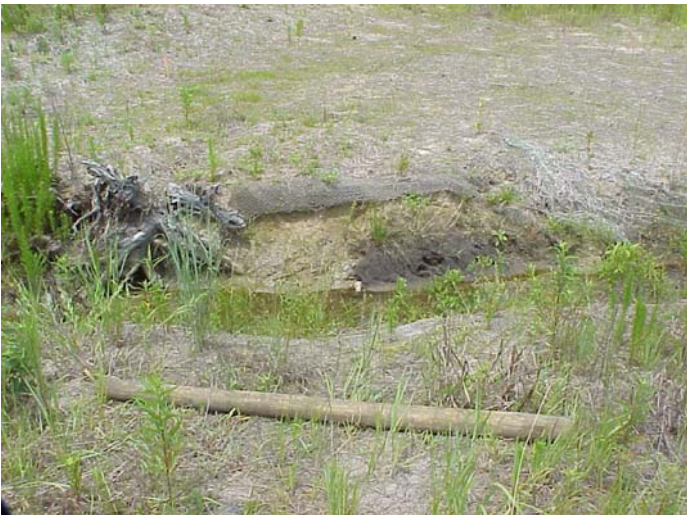
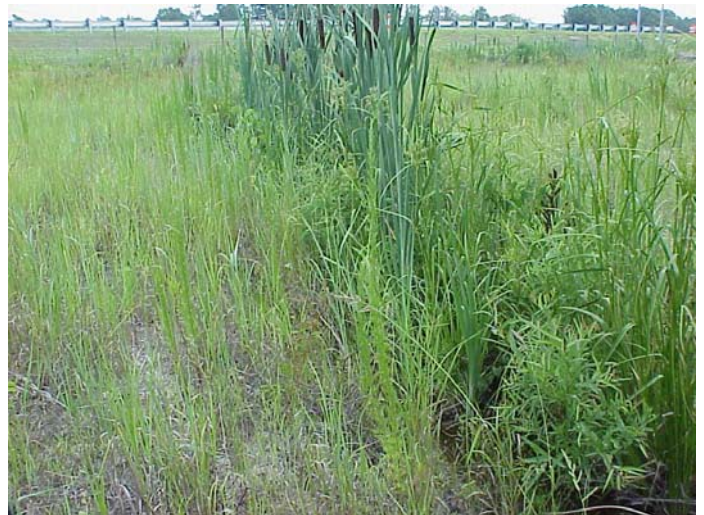
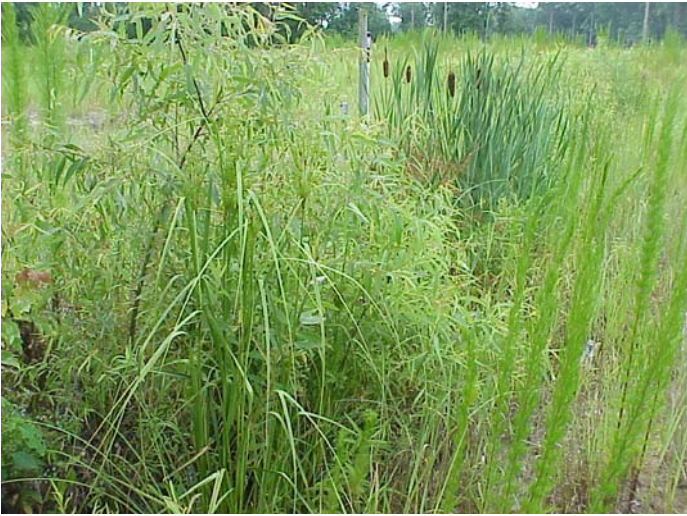
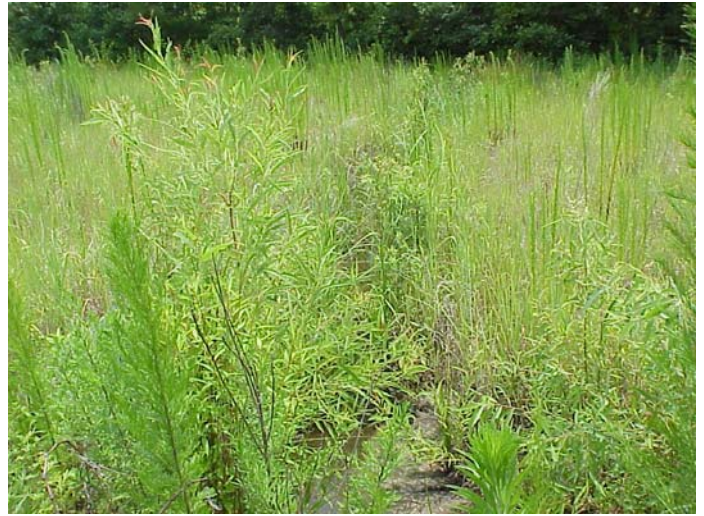
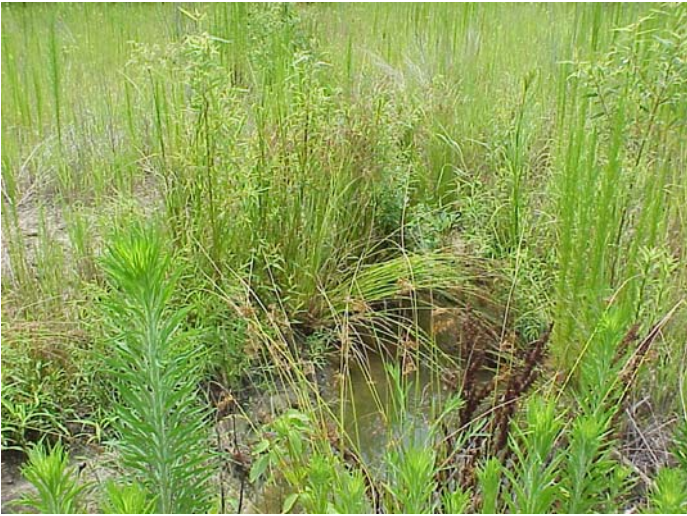
The stream channel was visually inspected during the annual vegetation monitoring of this site. The streambanks were mostly vegetated with herbaceous species and, in general, were stable throughout the site. Photos 7 through 15 depict and are representative of the stream condition.

NCDOT will continue vegetation and visual stream monitoring at the Crescent Road Mitigation Site.
