# ANNUAL REPORT FOR 2003

**Dismal Swamp Mitigation Site  
Gates / Perquimans County  
Project No. 6.129003T  
TIP No. R-2208 WM**

Prepared By:  
Office of Natural Environment & Roadside Environmental Unit  
North Carolina Department of Transportation  
December 2003

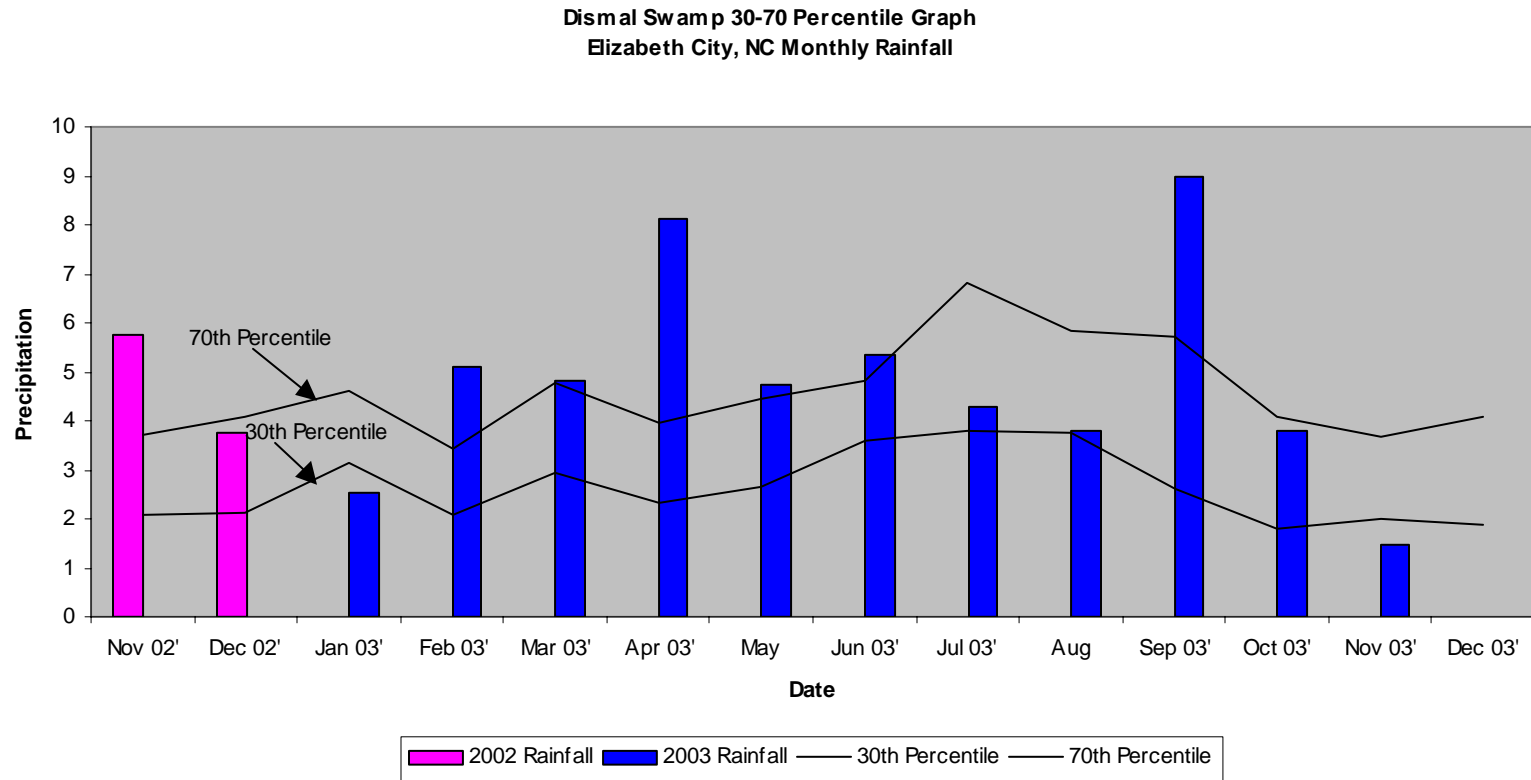
Figure 4. 30-70 Percentile Graph

Figure 4 is a comparison of monthly rainfall for the period of November 2002 through November 2003 to historical precipitation (collected between 1972 and 2003) for Elizabeth City, North Carolina. This comparison gives an indication of how 2003 relates to historical data in terms of climate conditions. The NC State Climate Office provided all offsite data.

For the 2003-year, November (02'), February, March, April, May, June, and September experienced above average rainfall. The months of January and November recorded below average rainfall for the site. December (02'), July, August, and October, experienced average rainfall. Overall, 2003 experienced an average to above average rainfall year.
