# ANNUAL REPORT FOR 2003

**Grimesland Sand Pit Phase I Site**  
**Pitt County**  
**Project No. 8.T221801**  
**TIP No. R-2510 WM**

Office of Natural Environment & Roadside Environmental Unit  
North Carolina Department of Transportation  
December 2003

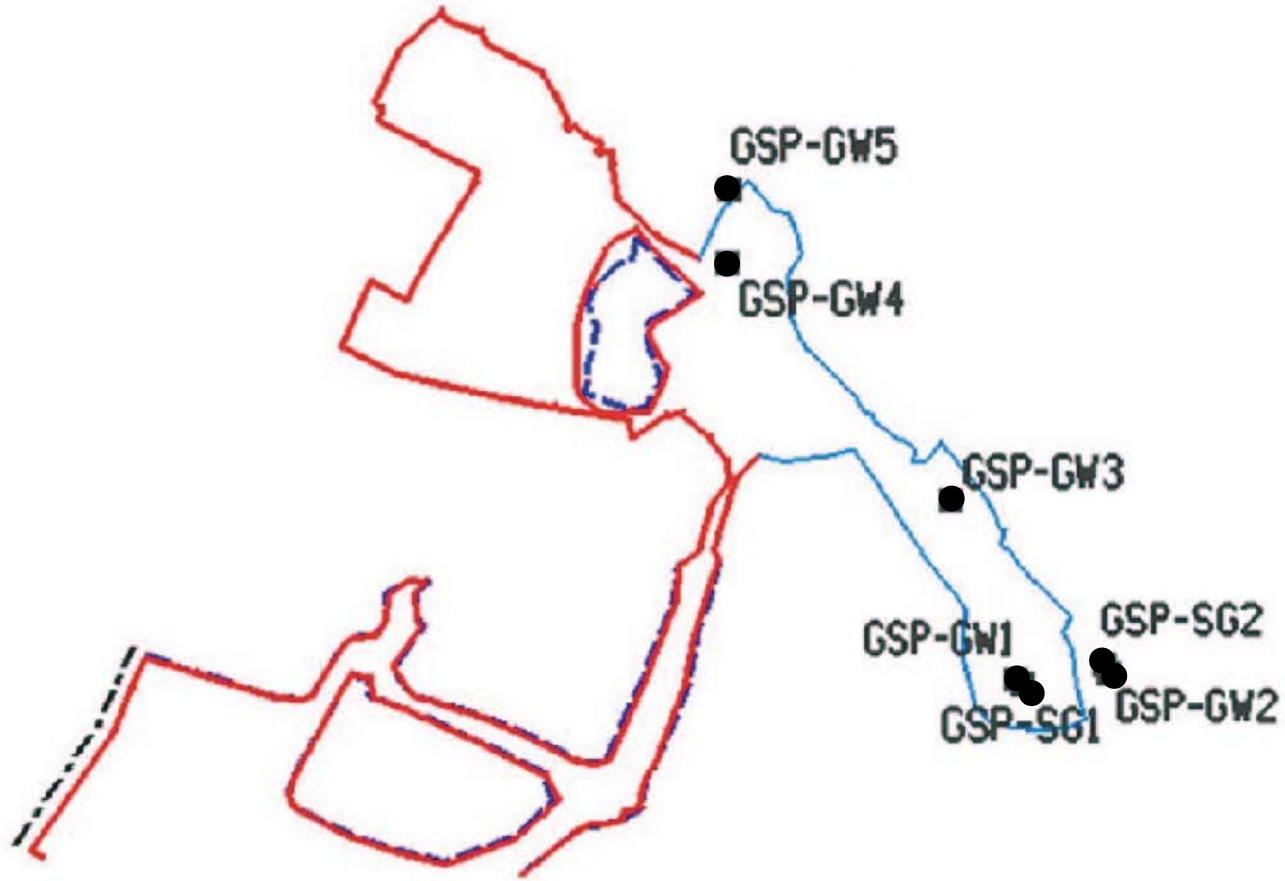
Figure 2. Gauge Location Map

Five groundwater and two surface water gauges were installed in the Phase I section in March of 2000 (Figure 2). The automatic monitoring gauges record daily readings of the groundwater depth, while the surface water gauges record water depth every three hours. A rain gauge installed onsite records daily rainfall totals; these rain events are incorporated into the monitoring results to examine how the site's groundwater level responds to rainfall.

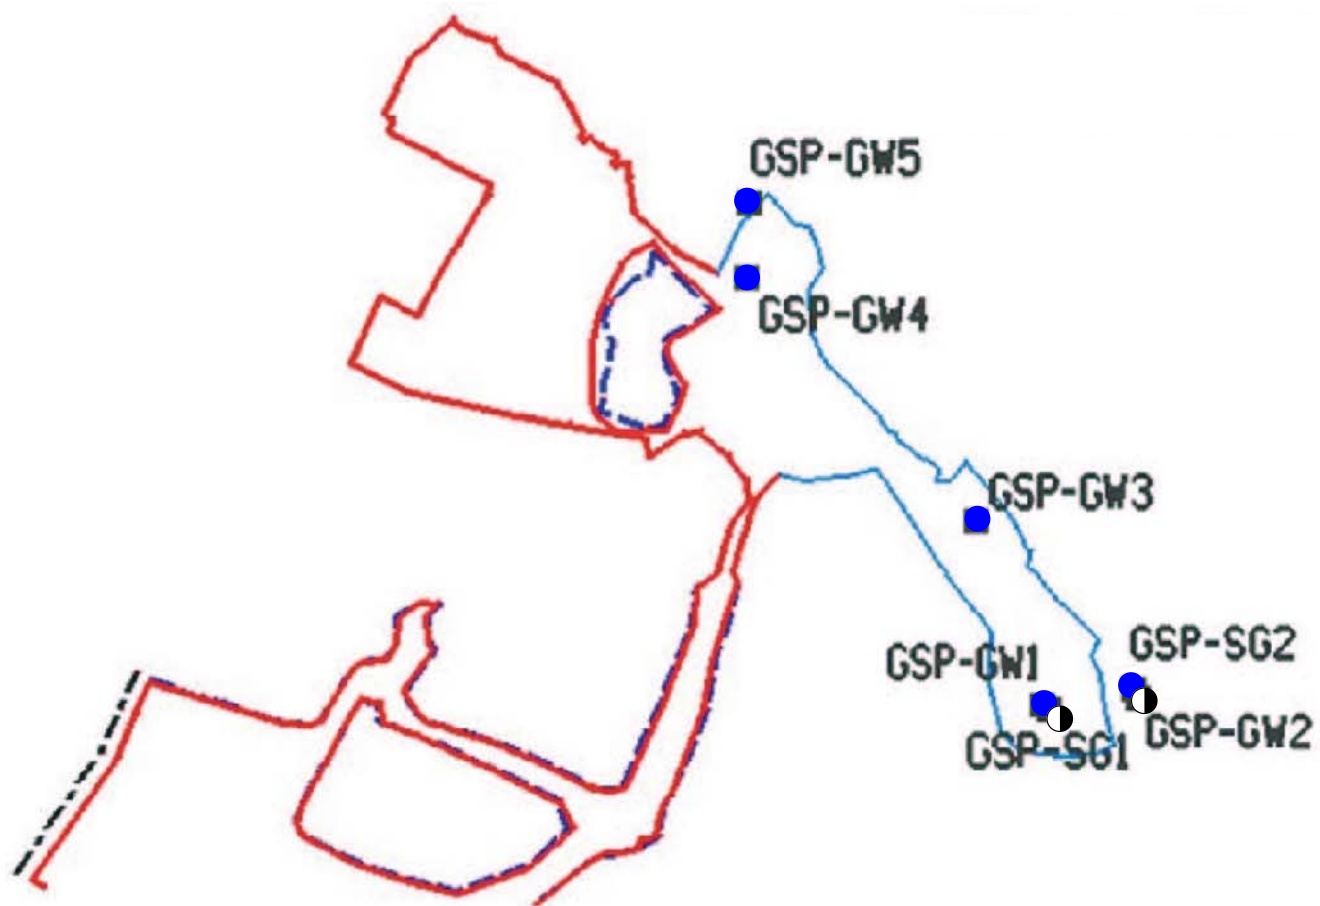
**Figure 3. 2003 Hydrologic Monitoring Gauge Results**

Table 1 shows the hydrologic results for 2003; Figure 3 is a graphical representation of these results. In Figure 3, a blue dot indicates the gauge showed success for more than 12.5% of the growing season; a red dot, between 8 and 12.5%; a green dot, between 5 and 8%, and a black dot, less than 5%.

During the growing season in 2003, all five groundwater gauges in the Phase I area experienced approximately 1”- 4” of inundation. All five groundwater gauges met the jurisdictional success criteria of 12.5% of the growing season.

In 2003, the Phase I area experienced inundation throughout the growing season with 1" - 4" of standing water observed at all gauges. All five groundwater-monitoring gauges indicated success of at least 12.5% for the 2003-monitoring year. The two surface gauges provide data showing the consistent presence of surface water throughout the growing season.

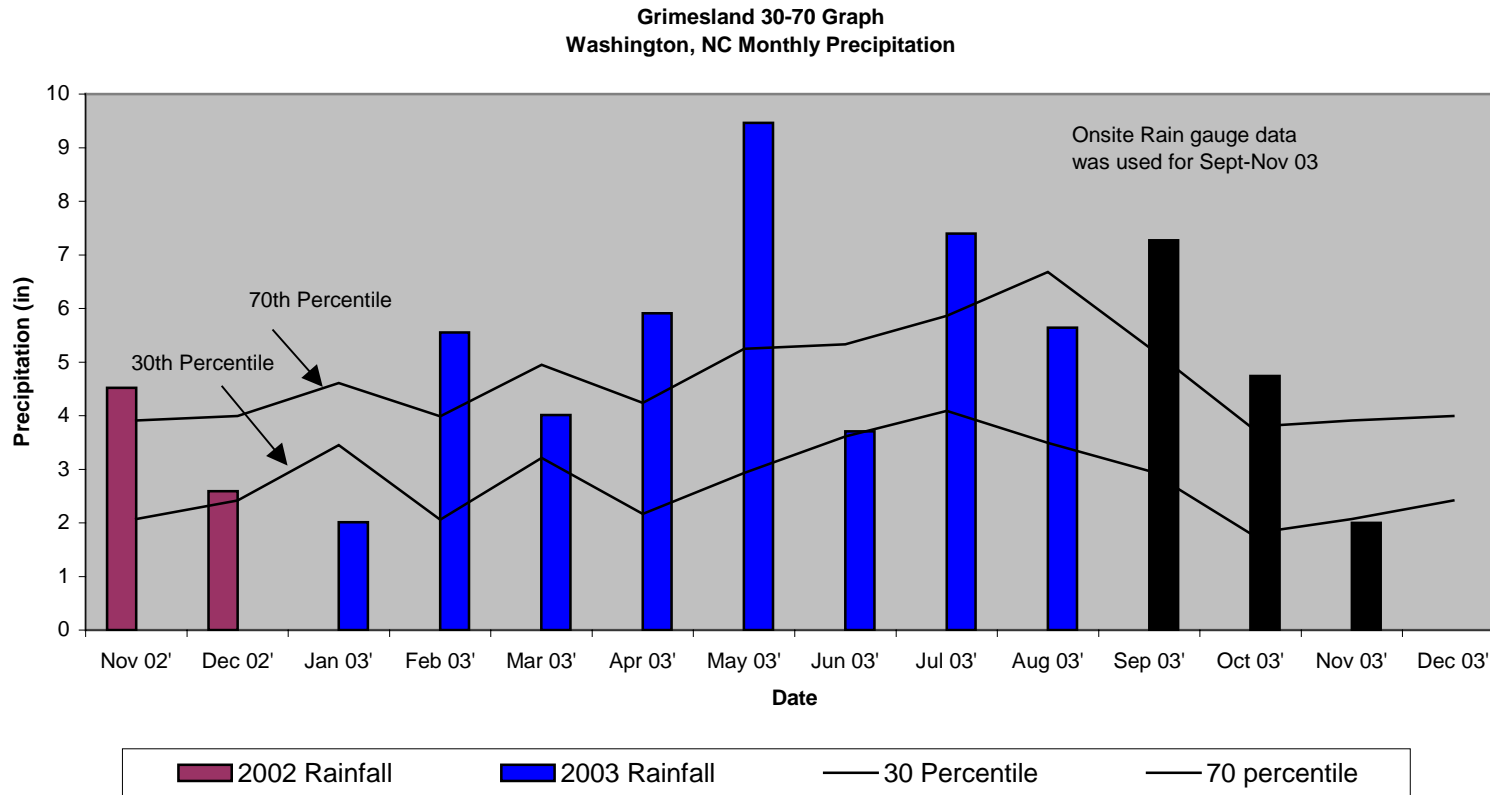
**Figure 4.** Grimesland Phase I 30-70 Percentile Graph, Washington, NC

Figure 4 is a graph of monthly rainfall for the period of November 2002 through October 2003 compared to historical precipitation data (collected between 1972 and 2003) for Washington, North Carolina. Rainfall data from the onsite rain gauge was used for the months of (September 03' - November 03'). The NC State Climate Office provided the rainfall data. The comparison of 2003 rainfall versus historical values gives an indication of how 2003 compares to historical climate conditions.

For the 2003-year, November (02'), February, April, May, July, September, and October experienced above average rainfall. The months of January and November recorded below average rainfall for the site. December (02'), March, June, and August experienced average rainfall. Overall, 2003 experienced an average to above average rainfall year.
