# ANNUAL REPORT FOR 2003

**Mashoes Road Mitigation Site**  
**Dare County**  
**Project No. 8.T051402**  
**TIP No. R-2551WM**

Prepared By:  
Office of Natural Environment & Roadside Environmental Unit  
North Carolina Department of Transportation  
December 2003

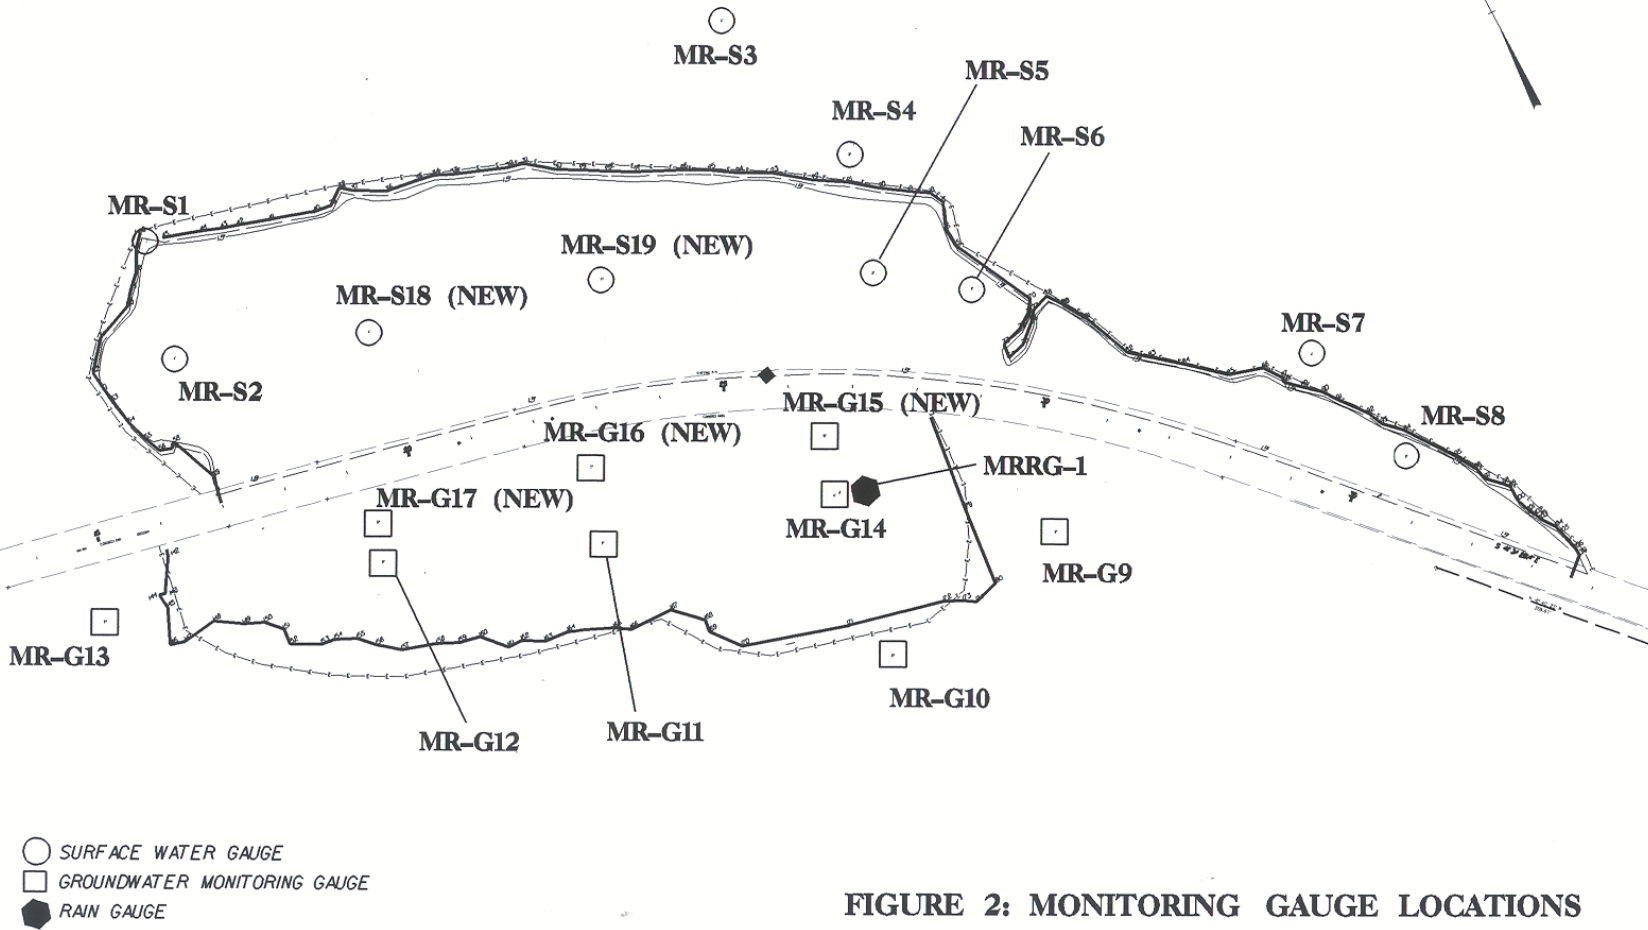
**FIGURE 2: MONITORING GAUGE LOCATIONS**

Six groundwater-monitoring gauges, eight surface gauges, and one rain gauge were installed in 1999 (Figure 2). Three more groundwater-monitoring gauges were installed during 2001 to evaluate potential drainage by the side canal. Also, two additional surface gauges were added to the coastal marsh wetland area. The rain gauge and monitoring gauges recorded daily readings of rainfall and depth to groundwater, respectively. The surface gauges record tidal conditions eight times daily; however, only one representative reading was used for graphing and statistical purposes in this report.

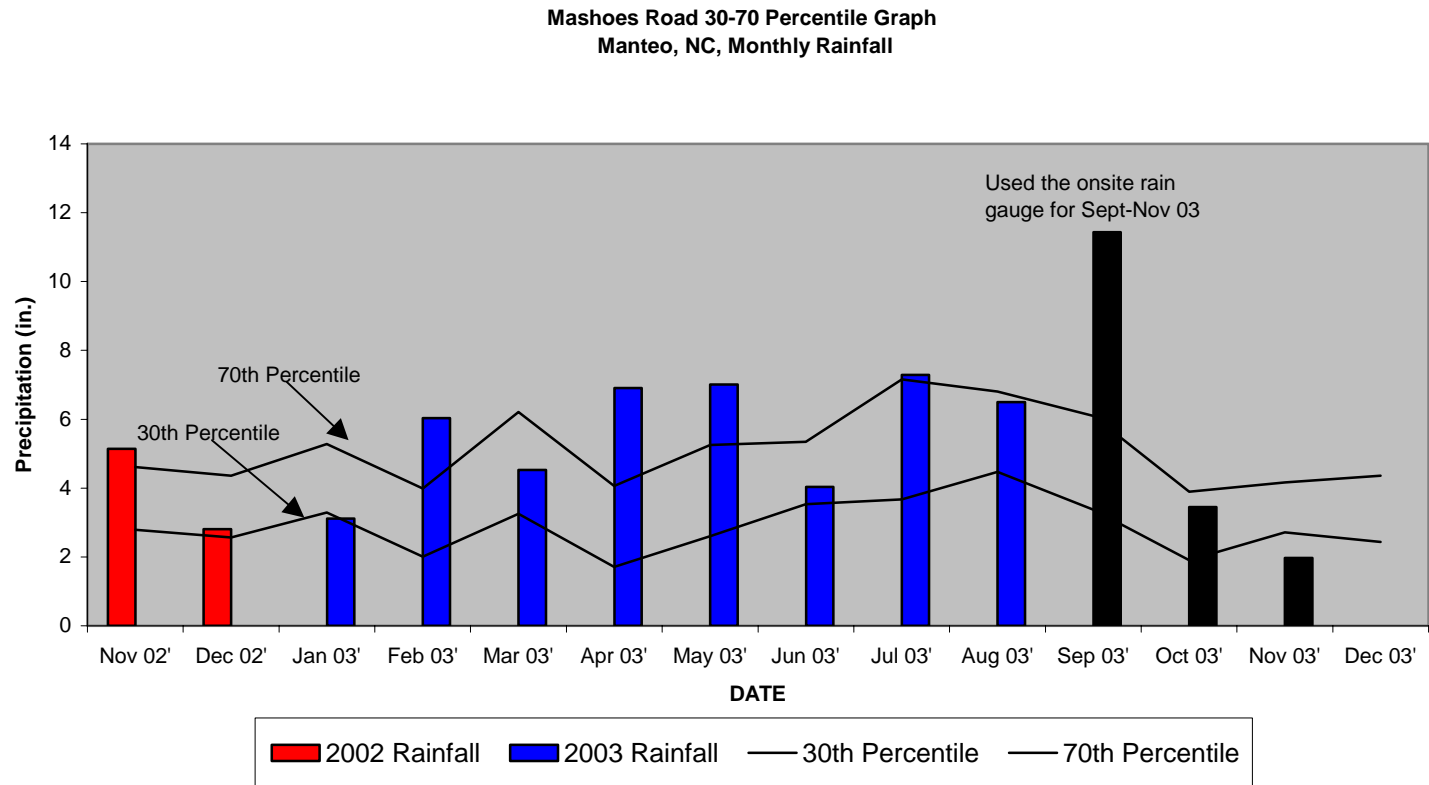
**FIGURE 4. 30-70 Percentile Graph**

Figure 4 represents an examination of the local climate in comparison with historical data in order to determine whether 2003 was “average” in terms of climate conditions. The two lines represent the 30<sup>th</sup> and 70<sup>th</sup> percentiles of monthly precipitation for Manteo, NC. The bars are monthly rainfall totals for 2002 and 2003. The historical data was collected from the State Climate Office of North Carolina.

For the 2003-year, January and November experienced below average rainfall. The months of December (02'), March, June, August, and October all recorded average rainfall for the site. November (02'), February, April, May, July, and September experienced above average rainfall. The rainfall data from the onsite rain gauge was used for the months of (September-November). Overall, 2003 experienced an average rainfall year.

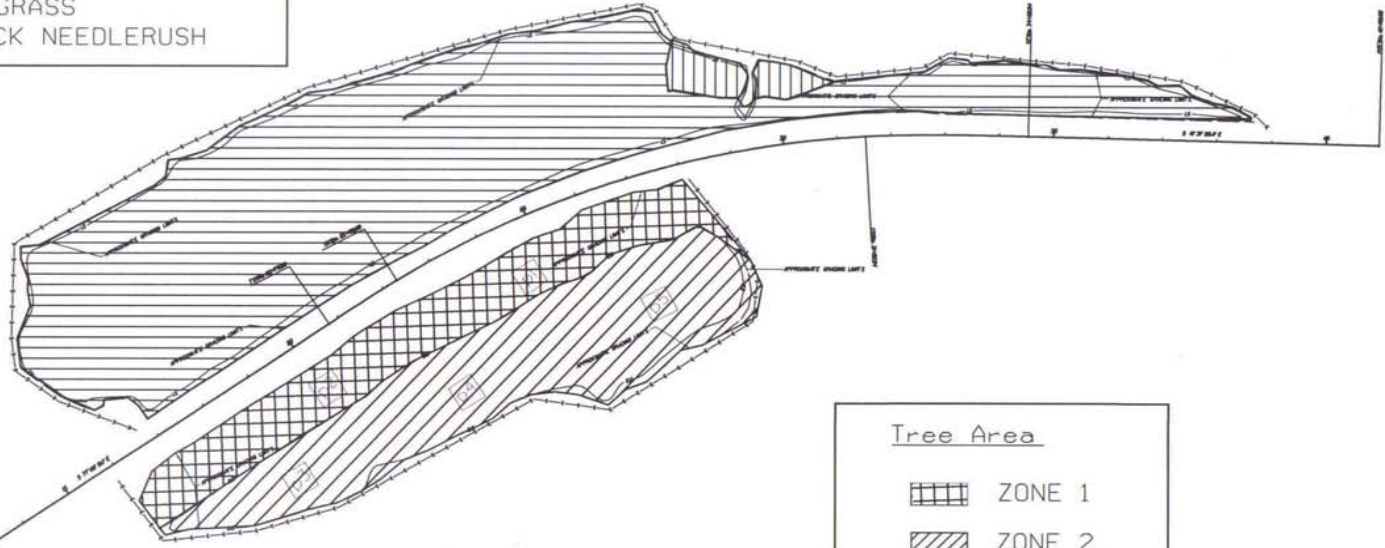
# Dare County, North Carolina Mashoes Road Mitigation Site Planting Plan

Marsh Area

SAWGRASS

BLACK NEEDLERUSH

Tree Area

ZONE 1

ZONE 2

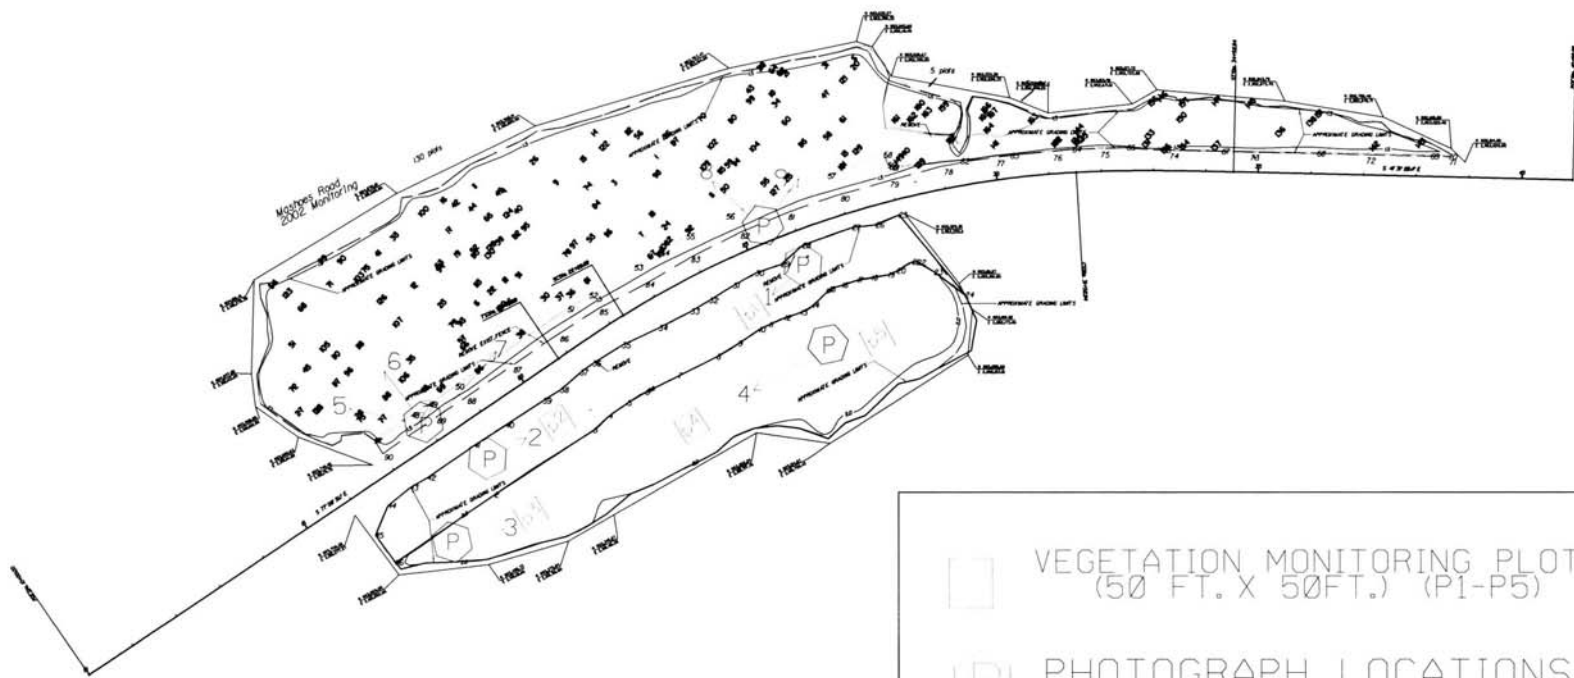
Photo and Vegetation Plot Locations

VEGETATION MONITORING PLOTS  
 (50 FT. X 50FT.) (P1-P5)

PHOTOGRAPH LOCATIONS
