# ANNUAL REPORT FOR 2003

**South Buffalo Creek Mitigation Site  
Guilford County  
Project No. 8.U493501  
TIP No. I-2402 WM**

Prepared By:  
Office of Natural Environment & Roadside Environmental Unit  
North Carolina Department of Transportation  
December 2003

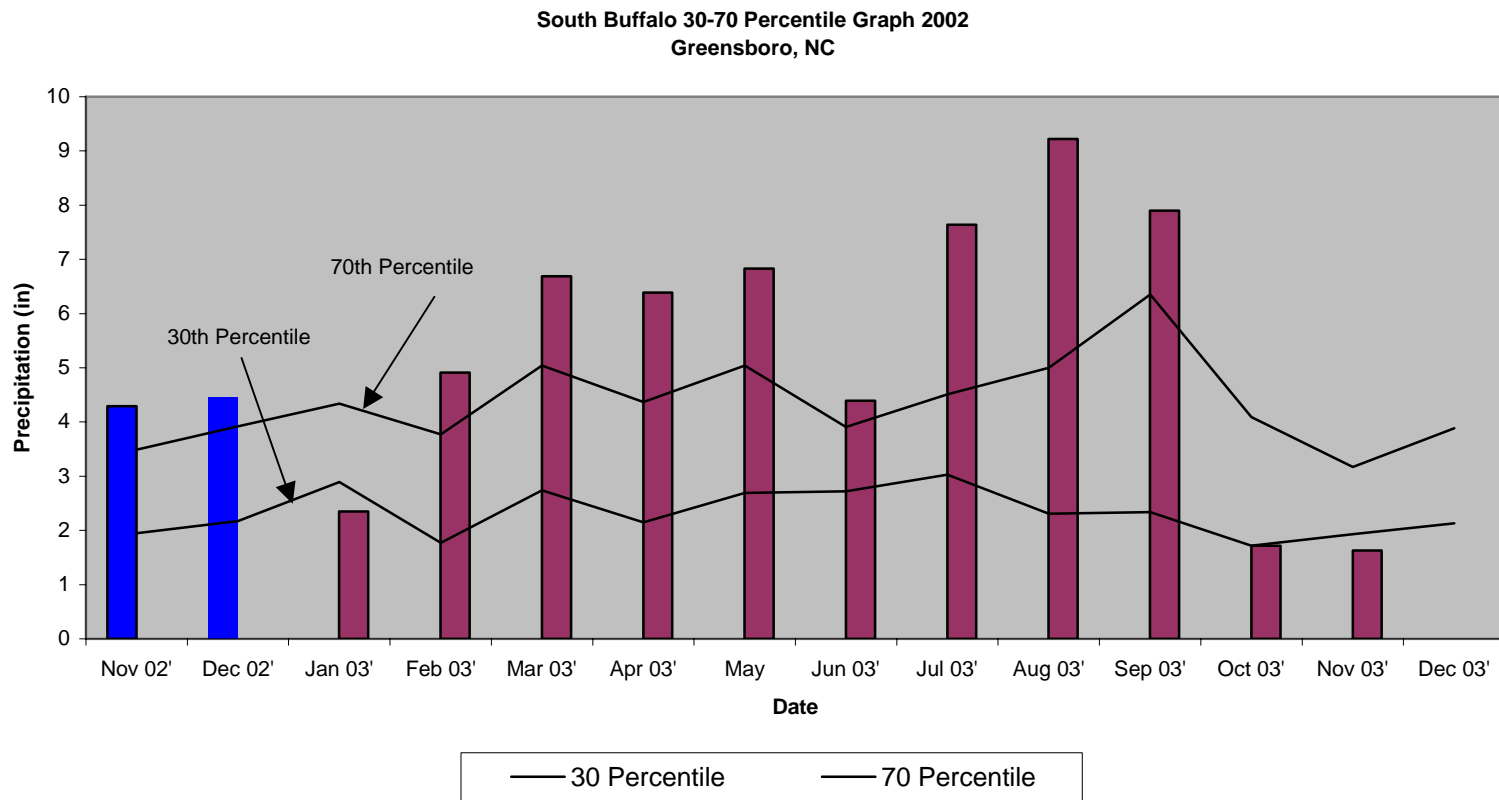
**FIGURE 4. 30-70 Percentile Graph**

Figure 4 represents an evaluation of 2003 rainfall in comparison with historical rainfall data in order to determine whether 2003 was “average” in terms of precipitation. The historical rainfall data was collected from 1972 through 2003 (30 years). All rainfall data was collected from the NC State Climate Office, Greensboro weather station.

The monthly rainfall totals for the period of November 2002 through November 2003 are shown in Figure 4. The data for this period shows above average rainfall for November (02'), December (02'), February, March, April, May, June, July, August, and September. January, October, and November experienced below average rainfall. Overall, 2003 experienced an above average rainfall year.

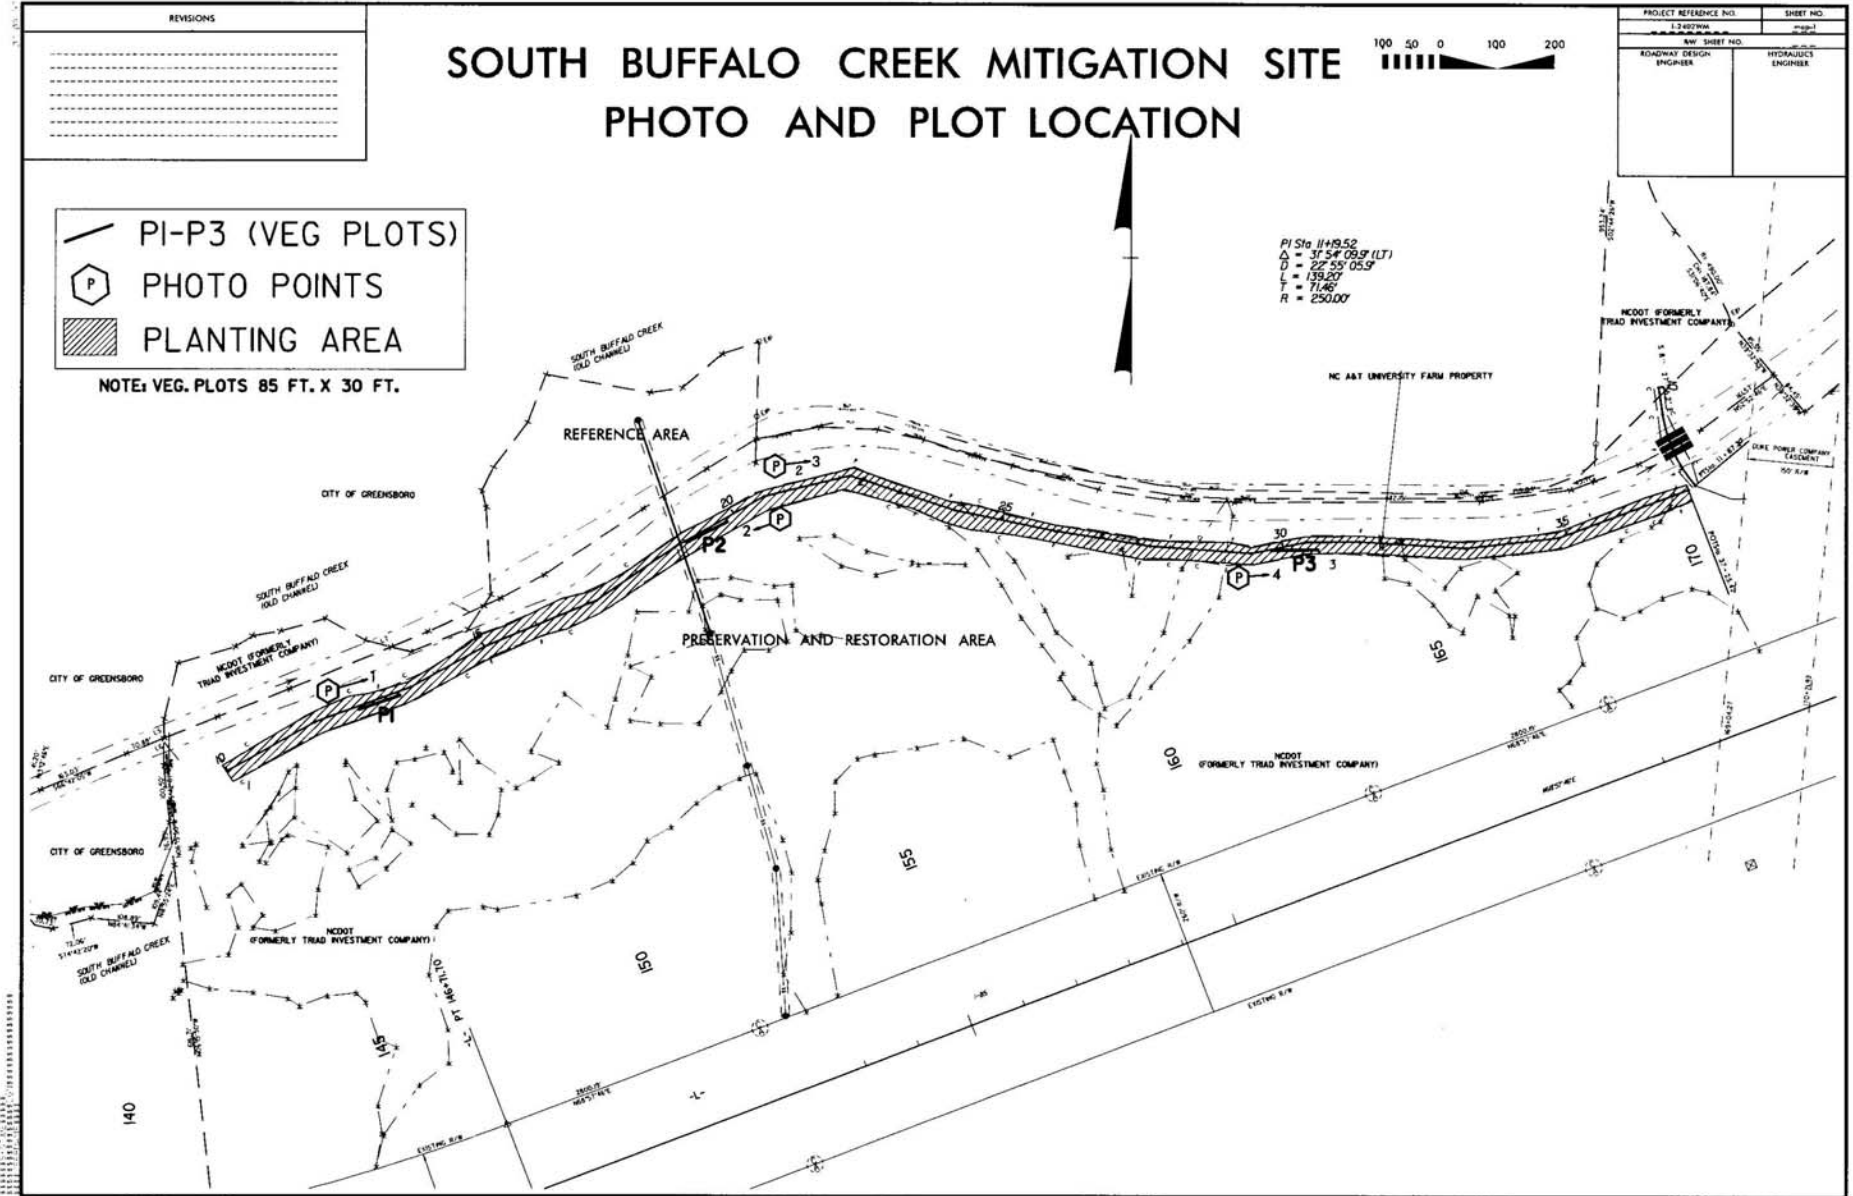
# SOUTH BUFFALO CREEK MITIGATION SITE PHOTO AND PLOT LOCATION

NOTE: VEG. PLOTS 85 FT. X 30 FT.
