ANNUAL REPORT FOR 2004

**Haws Run Mitigation Site
Pender and Onslow Counties
Project No. 6.259002T
TIP No. R-2405WM**

Prepared By:
Office of Natural Environment & Roadside Environmental Unit
North Carolina Department of Transportation
December 2004

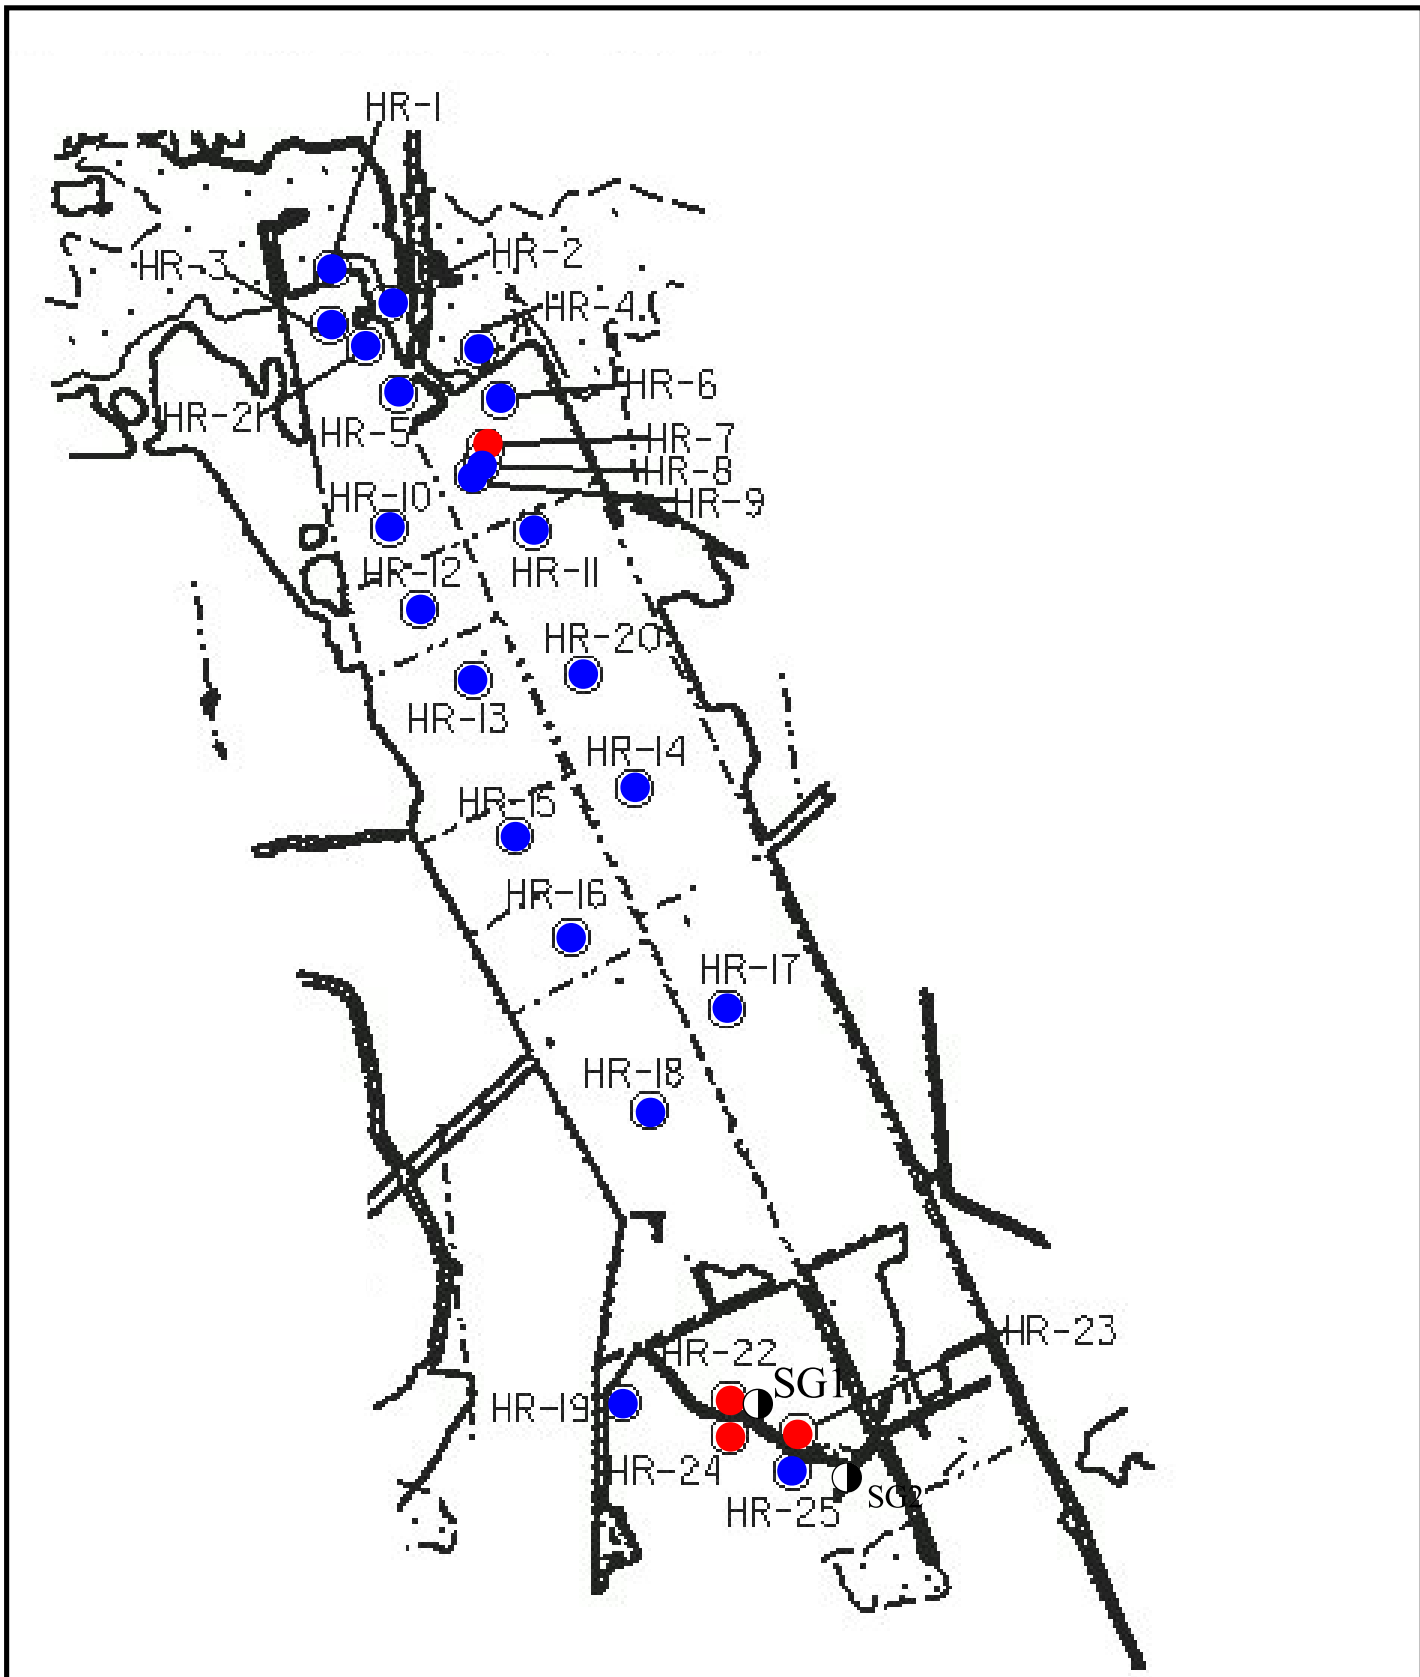
Figure 3. 2004 Hydrologic Monitoring Gauge Results

The maximum number of consecutive days that the groundwater was within twelve inches of the surface was determined at each gauge. This number was converted into a percentage of the 238-day growing season. Because of the variability between wetland systems and within wetland types, the monitoring gauge results are segmented into percentage ranges (Figure 3). Table 1 presents the monitoring results for the 2004 growing season as a range of percentages, actual percentages, and success dates of the longest hydroperiod for each gauge on the site. The reference gauges are also provided in Table 1.

- < 5%
- 5 - 8%
- 8 - 12.5%
- > 12.5%

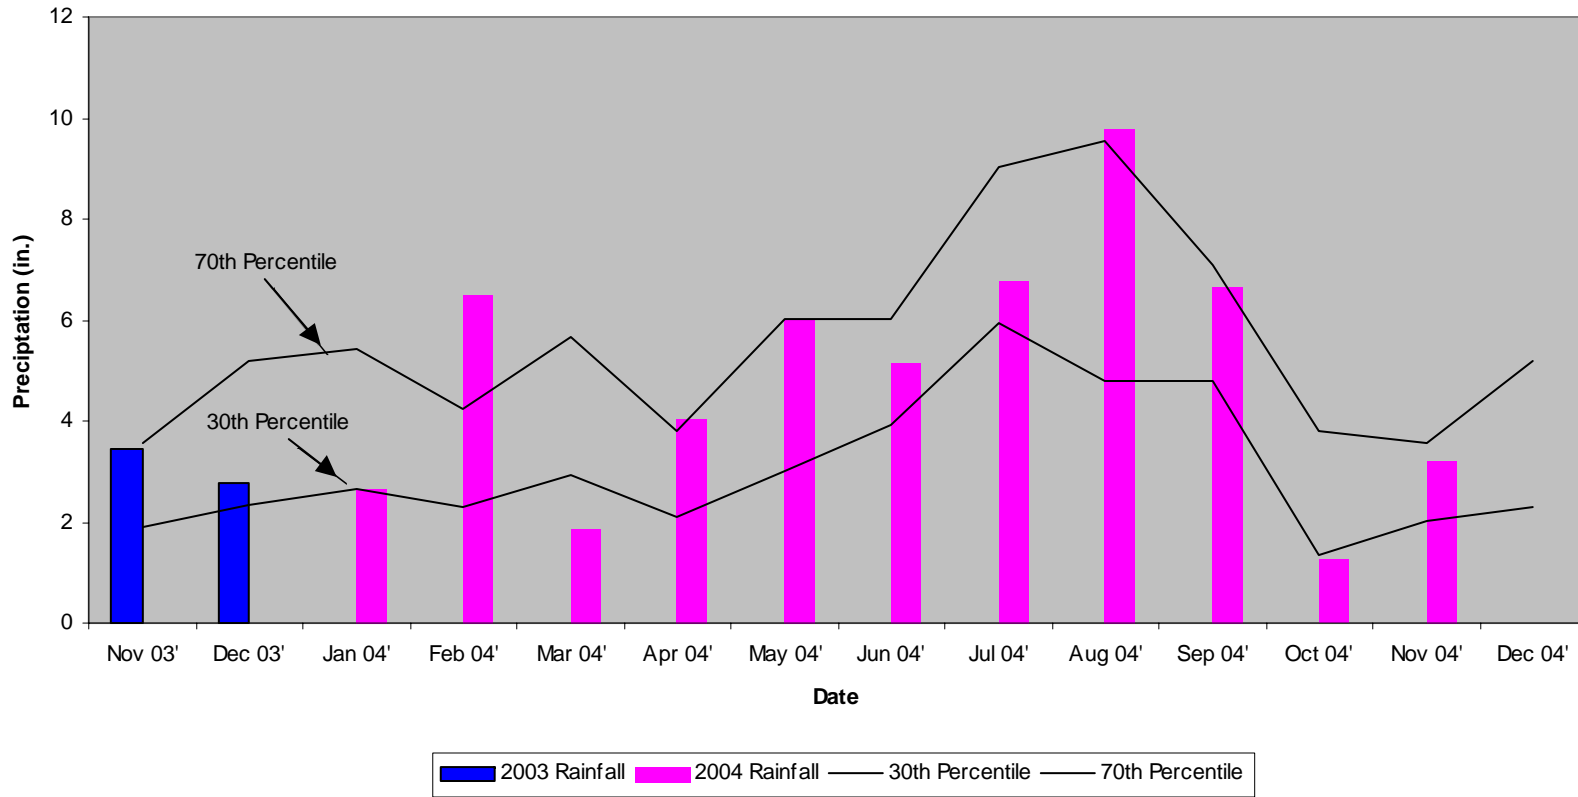
Figure 4. 30-70 Percentile Graph

Figure 4 is a comparison of monthly rainfall for the period of November 2003 through October 2004 to historical precipitation (collected between 1973 and 2004) for Wilmington, North Carolina. This comparison gives an indication of how 2004 relates to historical data in terms of climate conditions. The NC State Climate Office provided all offsite data.

For the 2004-year, February and August experienced above average rainfall. The months of March and October recorded below average rainfall for the site and November (03'), December (03'), January, April, May, June, July, September, and November experienced average rainfall. Overall, 2004 experienced an average rainfall year.

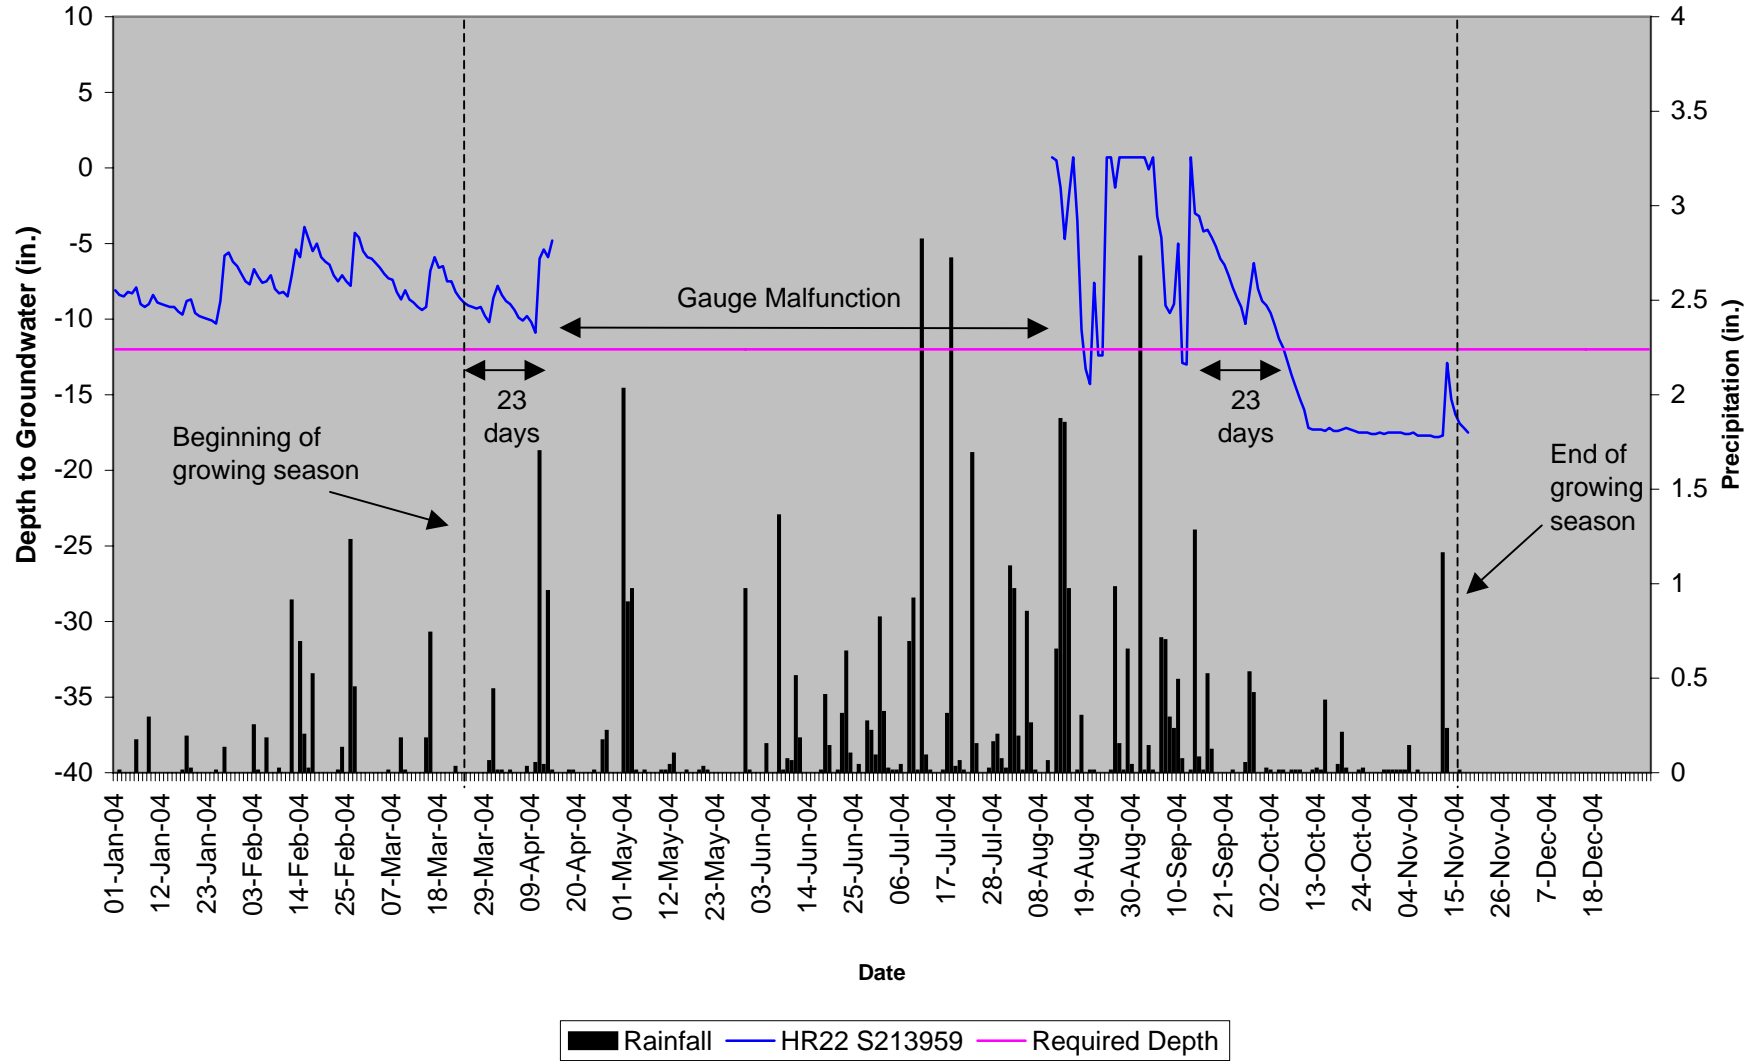
Haws Run HR-22 20" Groundwater

- Gauge HR-22 malfunctioned during the growing season (April 15-August 10).

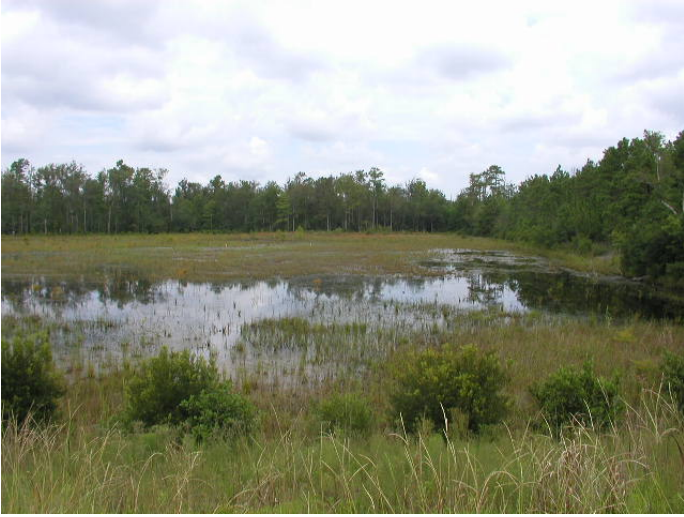
Photo 1

The area around plot one has been inundated with water at every site visit (See photos 1 and 2). The planted tree seedlings did not survive in this area. NCDOT supplemental planted this area in March 2002 with bald cypress, swamp blackgum, overcup oak, and green ash. These more wet tolerant trees have survived well in that area.
