# ANNUAL REPORT FOR 2004

**Long Creek Mitigation Site  
Mecklenburg County  
Project No. 8.U672204  
TIP No. R-2248**

Office of Natural Environment & Roadside Environmental Unit  
North Carolina Department of Transportation  
December 2004

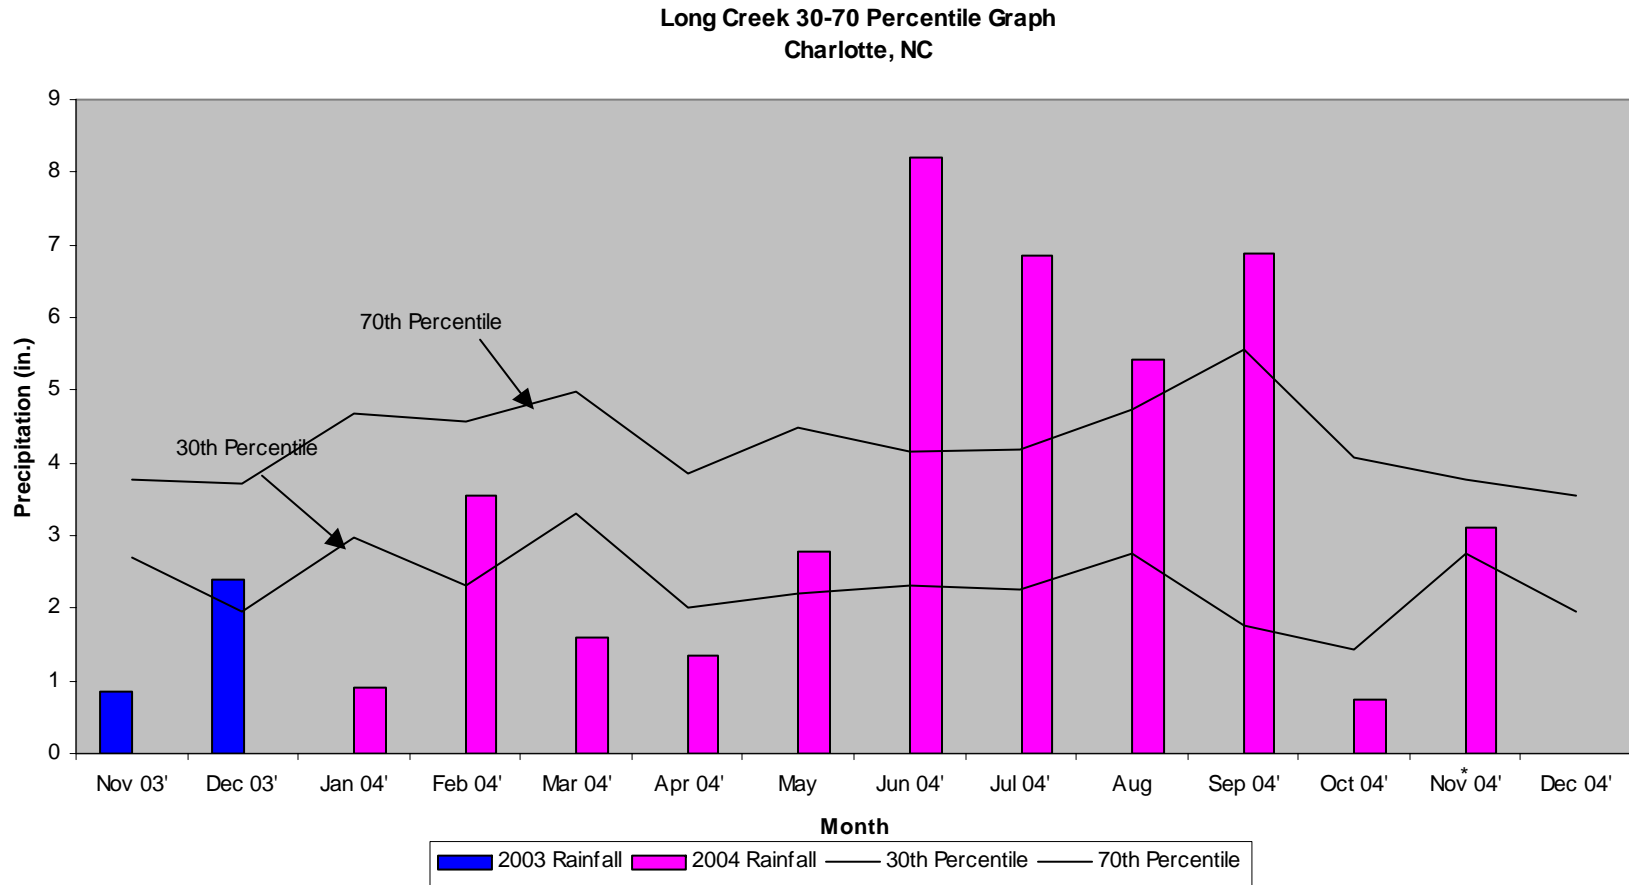
**Figure 4. 30-70 Percentile Graph**

Figure 4 is a comparison of 2003 and 2004 monthly rainfall to historical precipitation for the area. This comparison indicates if 2004 was “average” in terms of climate conditions by comparing the rainfall to that of historical rainfall (data collected between 1973 and 2004). The NC State Climate Office provided all historical data.

For the 2004-year June, July, August and September experienced above average rainfall. The months of November (03’), January, March, April, and October recorded below average rainfall for the site. December (03’), February, May, and November experienced average rainfall. Overall, 2004 experienced an average to above average rainfall year.

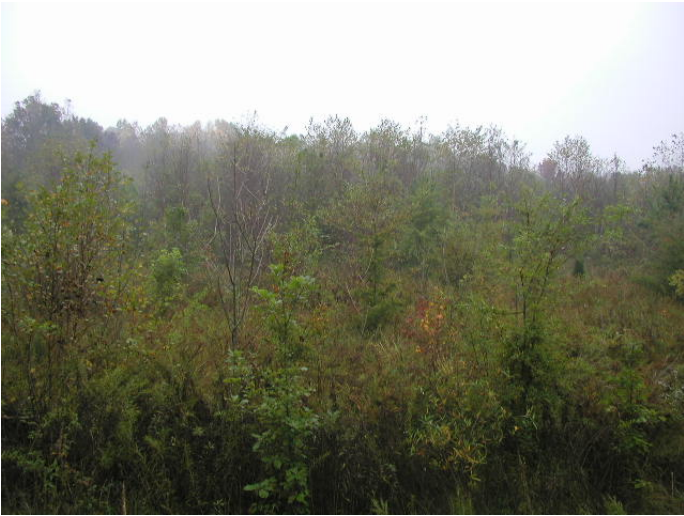
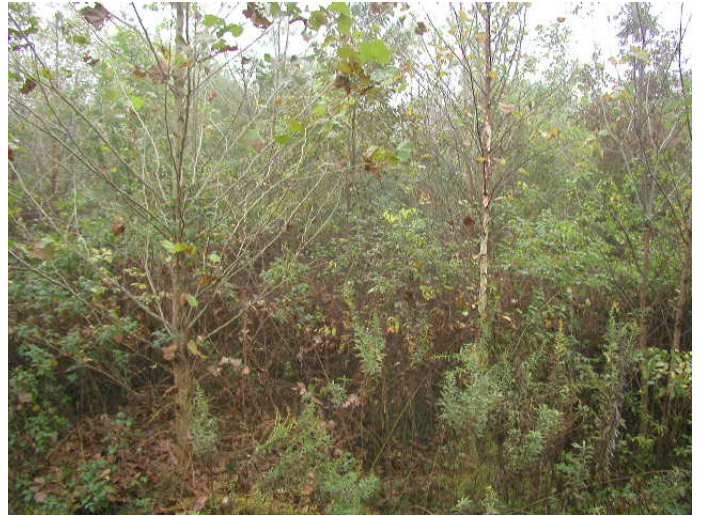
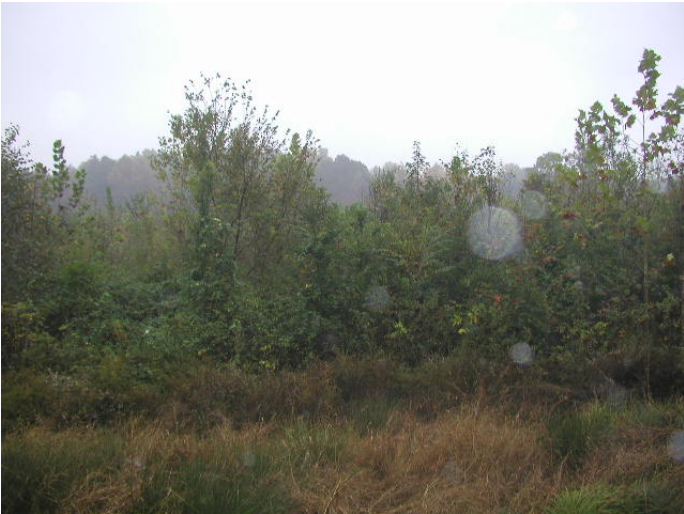
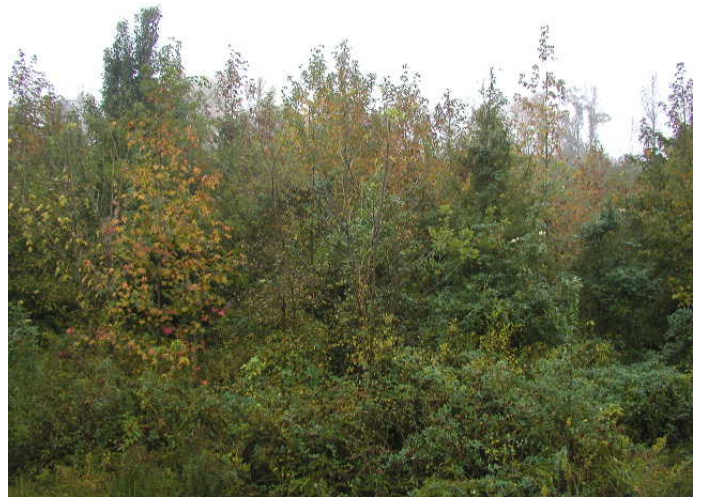
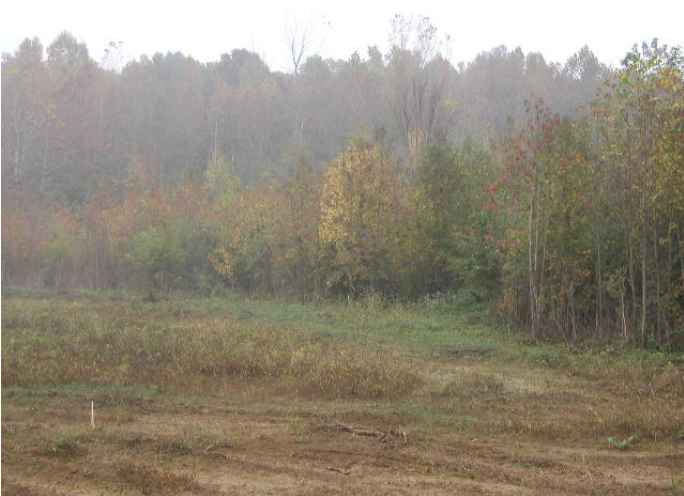
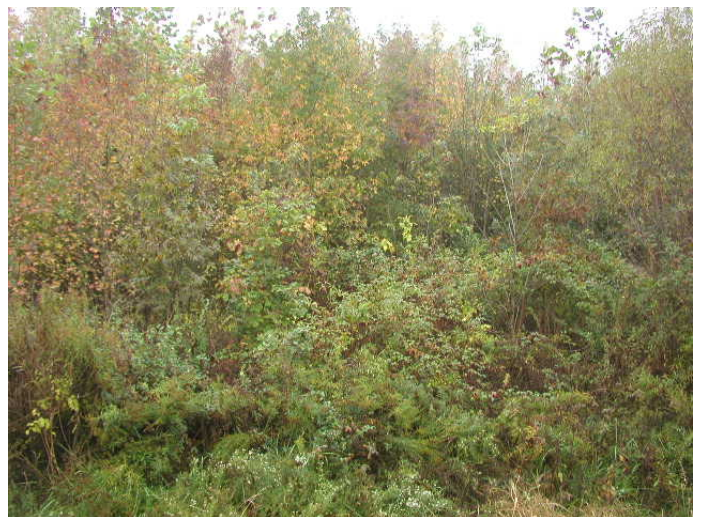
# Long Creek (Before Cutting)

The nuisance tree species were cut down on the Long Creek Site in October 2004, as requested by the resource agencies. The photographs illustrate before and after the cutting project.
