ANNUAL REPORT FOR 2004

**Roanoke Island Mitigation Site
Dare County
Project No. 8.1052501
TIP No. K-4003**

Prepared By:
Office of Natural Environment & Roadside Environmental Unit
North Carolina Department of Transportation
December 2004

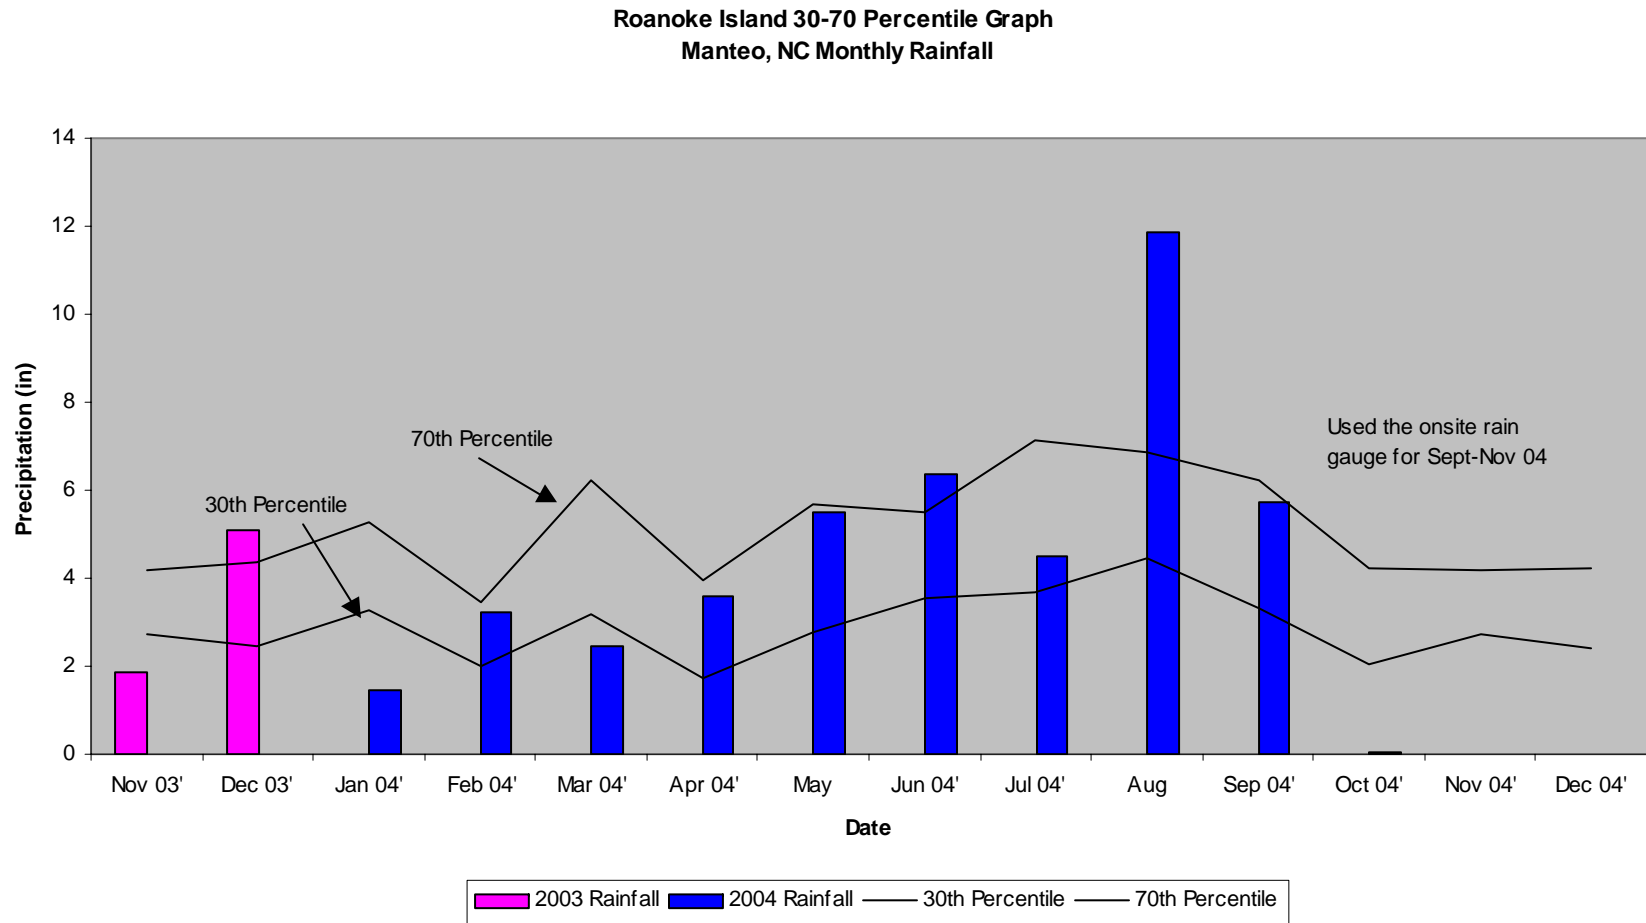
Figure 6. 30-70 Percentile Graph: Manteo, NC

Figure 6 provides an evaluation of the local climate in comparison with historical data in order to determine whether 2004 was “average” in terms of climate conditions. The two lines represent the 30th and 70th percentiles of monthly precipitation for Manteo, NC. The bars are monthly rainfall totals for 2003 and 2004. The onsite rain gauge at Roanoke Island was used for the 30-70 percentile graph for the months of September-November. The historical data was collected from the State Climate Office of North Carolina.

For the 2004-year, November (03’), January, and March experienced below average rainfall. The months of February, April, May, July, and September all recorded average rainfall for the site. December (03’), June, and August experienced above average rainfall. The rainfall data from the onsite rain gauge was used for the months of September-November. Overall, 2004 experienced an average rainfall year.
