ANNUAL REPORT FOR 2004

**Sawmill Mitigation Site
Craven County
Project No. 8.1170801
TIP No. B-2531WM**

Office of Natural Environment & Roadside Environmental Unit
North Carolina Department of Transportation
December 2004

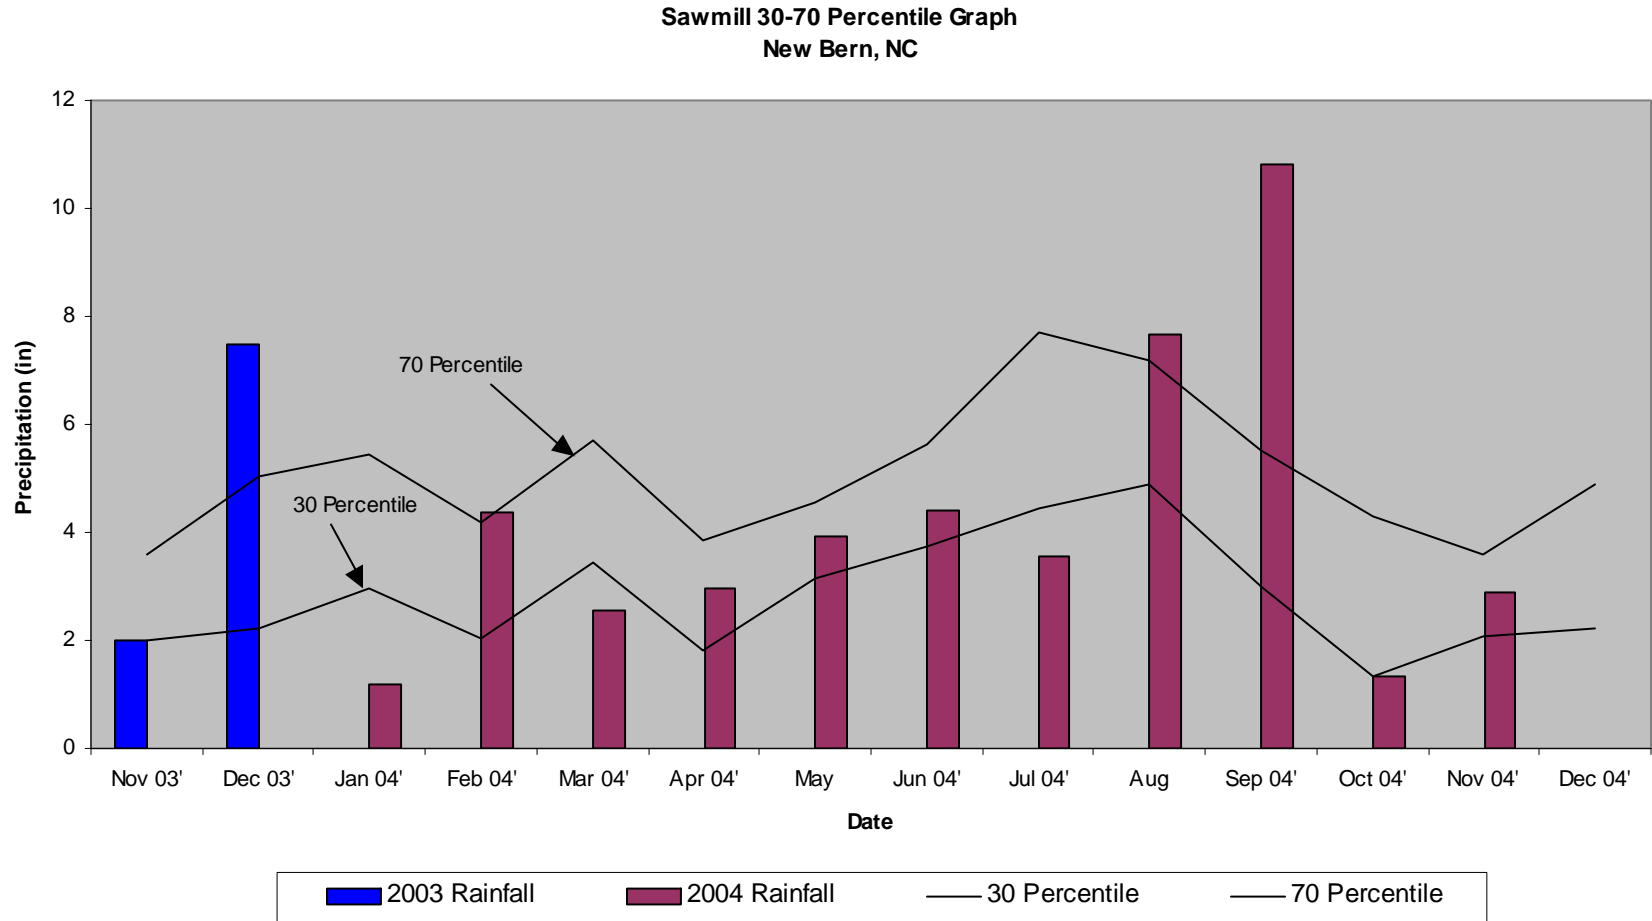
Figure 4. 30-70 Percentile Graph, New Bern, NC

Figure 4 is a comparison of the 2004 monthly rainfall to the historical precipitation (collected between 1973 and 2004) for New Bern, North Carolina. This comparison gives an indication of how 2004 relates to historical data in terms of climate conditions. The NC State Climate Office provided all local rainfall information.

This graph is used to indicate the general precipitation conditions for the surrounding area. The data obtained for the 2004-year indicates above average precipitation for December (03'), August and September. Below average precipitation was reported for November (03'), January, March, July, and October. The months of February, April, May, June, and November experienced average precipitation. Overall, the 2004-year exhibited an average rainfall year.
