ANNUAL REPORT FOR 2004

**U. S. Marine Corps Mitigation Site
Onslow County
Project No. 6.269010T
TIP No. U-2107 WM**

Prepared By:
Office of Natural Environment & Roadside Environmental Unit
North Carolina Department of Transportation
December 2004

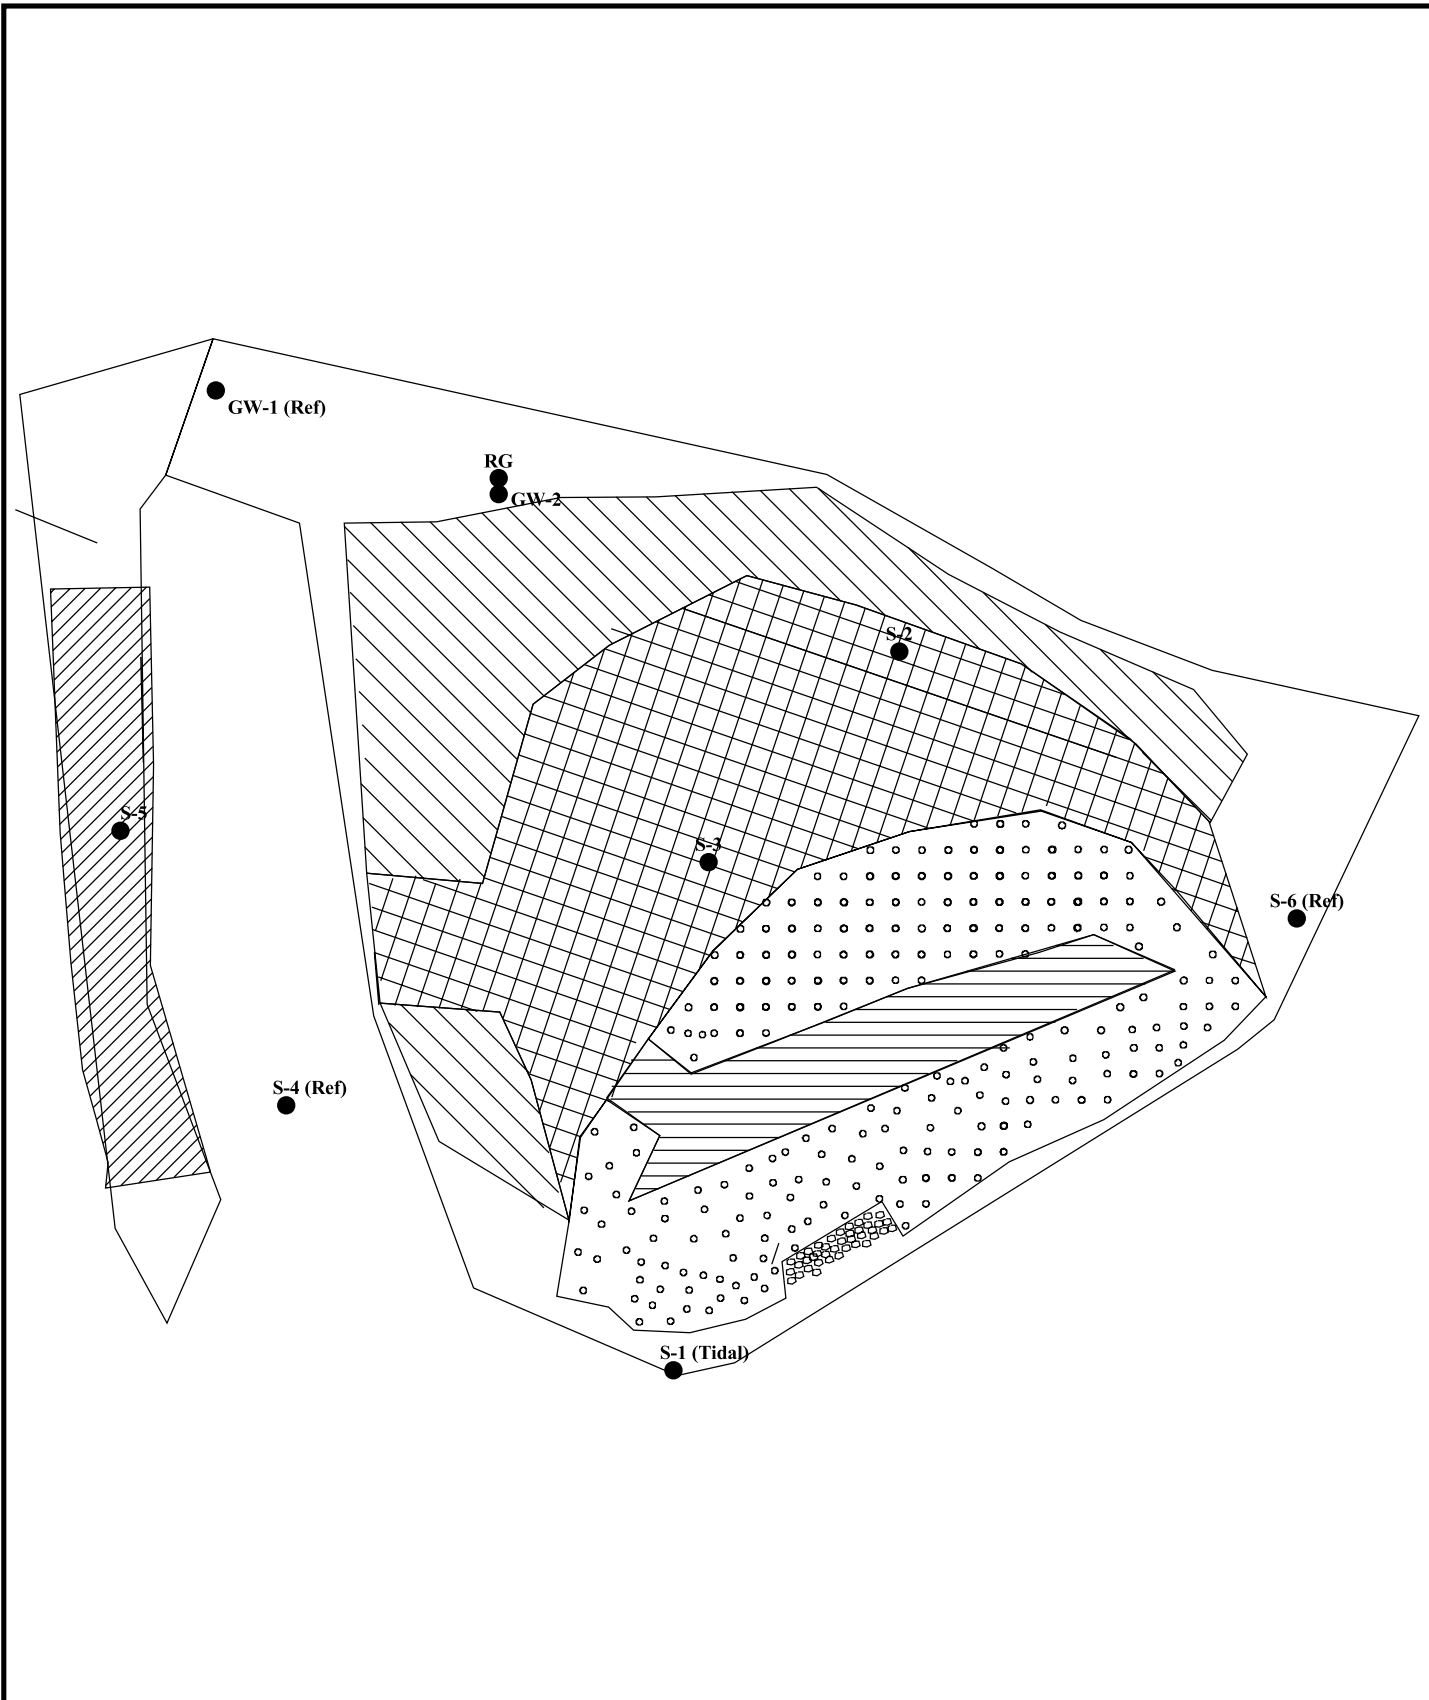
Figure 2. Gauge Location Map

There is one tidal gauge, five surface water-monitoring gauges, two groundwater gauges, and one rain gauge installed onsite (Figure 2). The tidal gauge measures water elevation every three hours, while the surface water gauges record every hour. The automatic monitoring gauges record daily readings of groundwater depth. This is the third year of hydrologic monitoring for the site, following the regrading activities.

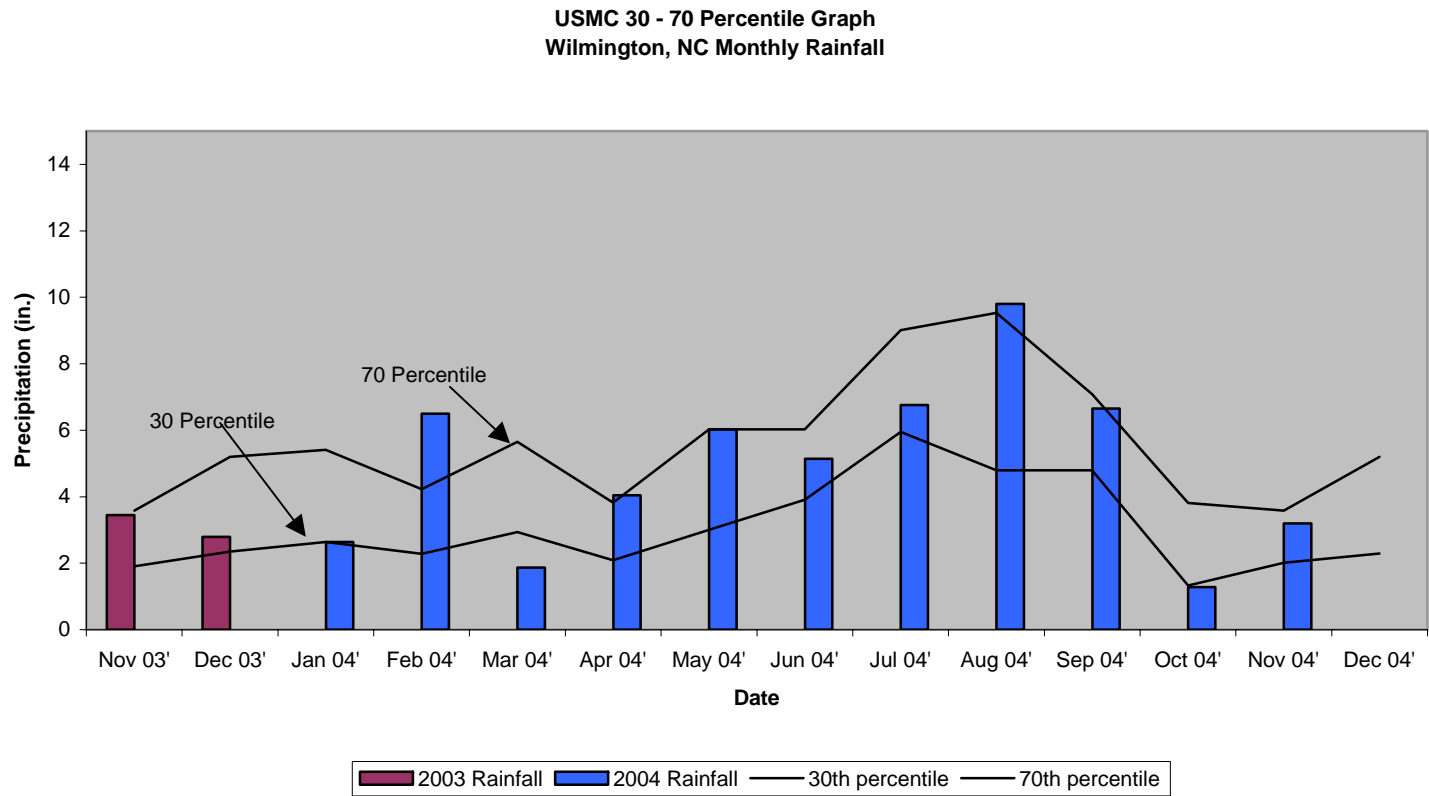
FIGURE 4. 30-70 Percentile Graph

Figure 3 is a comparison of monthly rainfall for the period of November 2003 through October 2004 to historical precipitation (collected between 1973 and 2004) for Wilmington, North Carolina. This comparison gives an indication of how 2004 relates to historical data in terms of climate conditions. The NC State Climate Office provided all offsite data.

For the 2004-year, February and August experienced above average rainfall. The months of March and October recorded below average rainfall for the site. November (03'), December (03'), January, April, May, June, July, September, and November experienced average rainfall. Overall, 2004 experienced an average rainfall year.

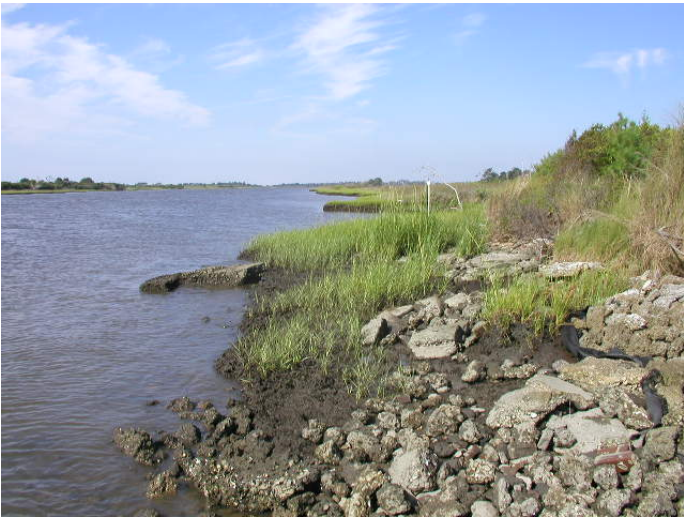
Photo 9 (Shoreline)

NCDOT regraded portions of the site in 2002. The marsh portion of the site was replanted in April 2002 and supplemental planted in May 2003. The site was treated for phragmites in June 2004. Photographs 9 through 12 show that the rock structure on the shoreline has stabilized and *Spartina alterniflora* is coming in naturally.

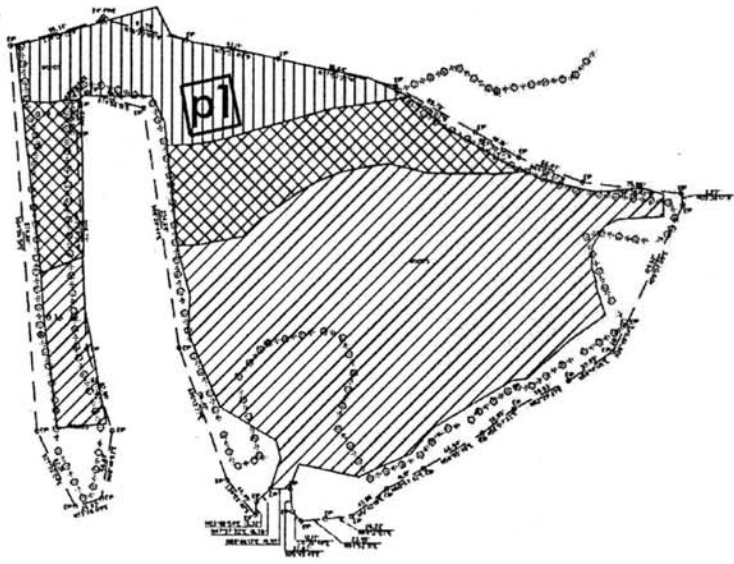
USMC Marsh/Shrub Site Onslow County, U-2107 WM PLANTING PLAN

The following plant communities were planted in the Shrub Area:

The following plant communities were planted in the Marsh Grass Area:

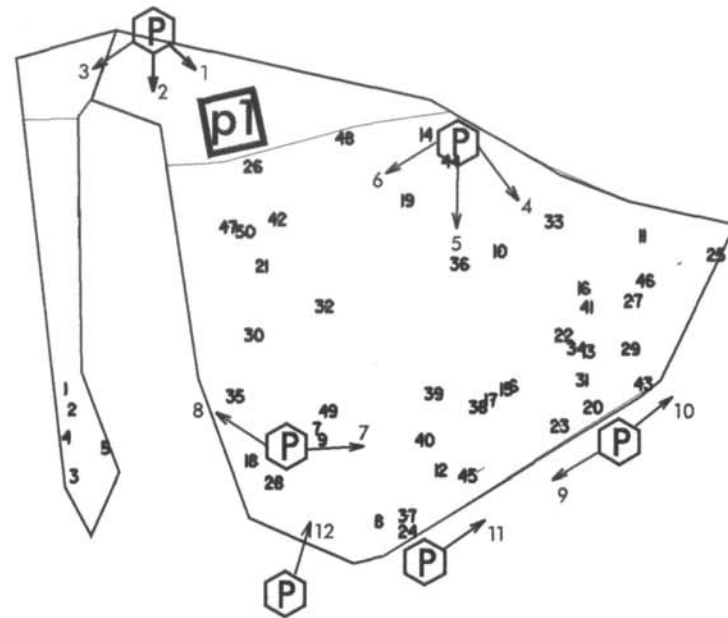
PHOTO AND VEGETATION PLOT LOCATIONS

Approximately 2.93 acres (of the 3.5 acres) involved marsh grass planting. There were 50 random plots established throughout the planting area that were located using GPS. Five of the sample plots were located as outside of the planted area. This is due to variances involved with the GPS system and the random point-generating program used to establish sample plot locations. These plots are labeled out of bounds and are not used in the calculations of the percent frequency and scale value. The vegetative coverage and frequency do not currently meet the success criteria. Based on the percent frequency and scale value, the marsh grass area is on track for year 3.
