ANNUAL REPORT FOR 2004

Waste Water Treatment Mitigation Site
New Hanover County
Project No. 8.2250109
TIP No. U-92 A/B

Prepared By:
Office of Natural Environment & Roadside Environmental Unit
North Carolina Department of Transportation
December 2004

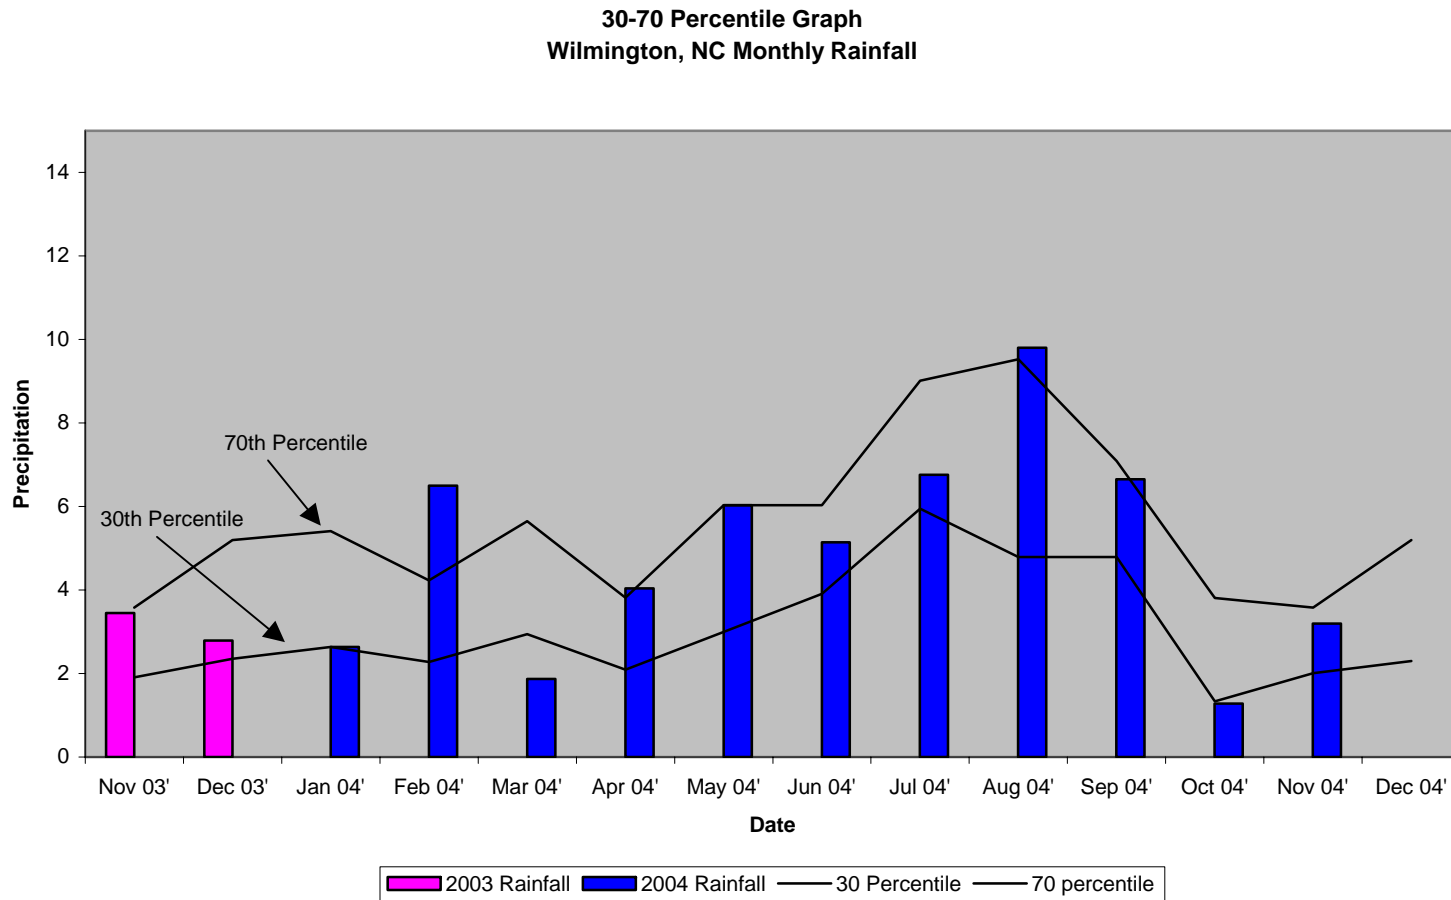
FIGURE 3: 2004 30-70 Percentile Graph

Figure 3 examines the local climate in comparison with historical data in order to determine whether 2004 was "average" in terms of climate conditions. The two lines represent the 30th and 70th percentiles of monthly precipitation for Wilmington, NC. The bars are monthly rainfall totals for 2003 and 2004. The historical data was collected from the State Climate Office of North Carolina.

For the 2004-year, February and August experienced above average rainfall. The months of March and October recorded below average rainfall for the site. November (03'), December (03'), January, April, May, June, July, September, and November experienced average rainfall. Overall, 2004 was an average rainfall year at the Waste Water Mitigation Site.
