ANNUAL REPORT FOR 2004

White's Store Mitigation Site
Dare County
Project No. 8.T051401
TIP No. R-2551WM

Prepared By:
Office of Natural Environment & Roadside Environmental Unit
North Carolina Department of Transportation
December 2004

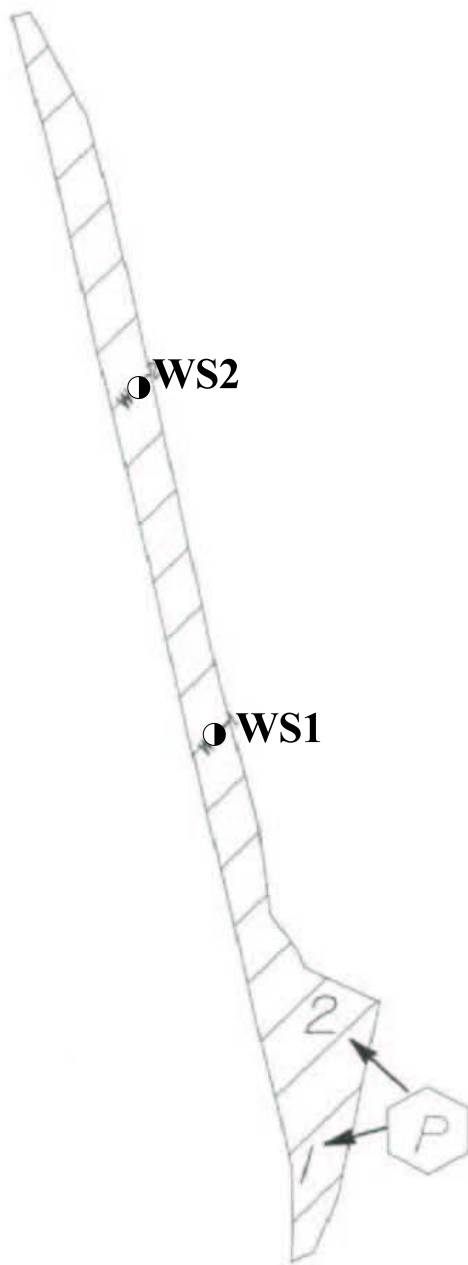
Figure 2. Gauge Location Map

The site was constructed by grading to a natural wetland elevation in order to replicate the hydrology of adjacent emergent communities that were also used as reference ecosystems. Two groundwater-monitoring gauges were installed on the site in March 2002. At the request of the resource agencies, these two gauges were reset in May 2003 as surface water gauges that record data in 3-hour intervals (Figure 2).

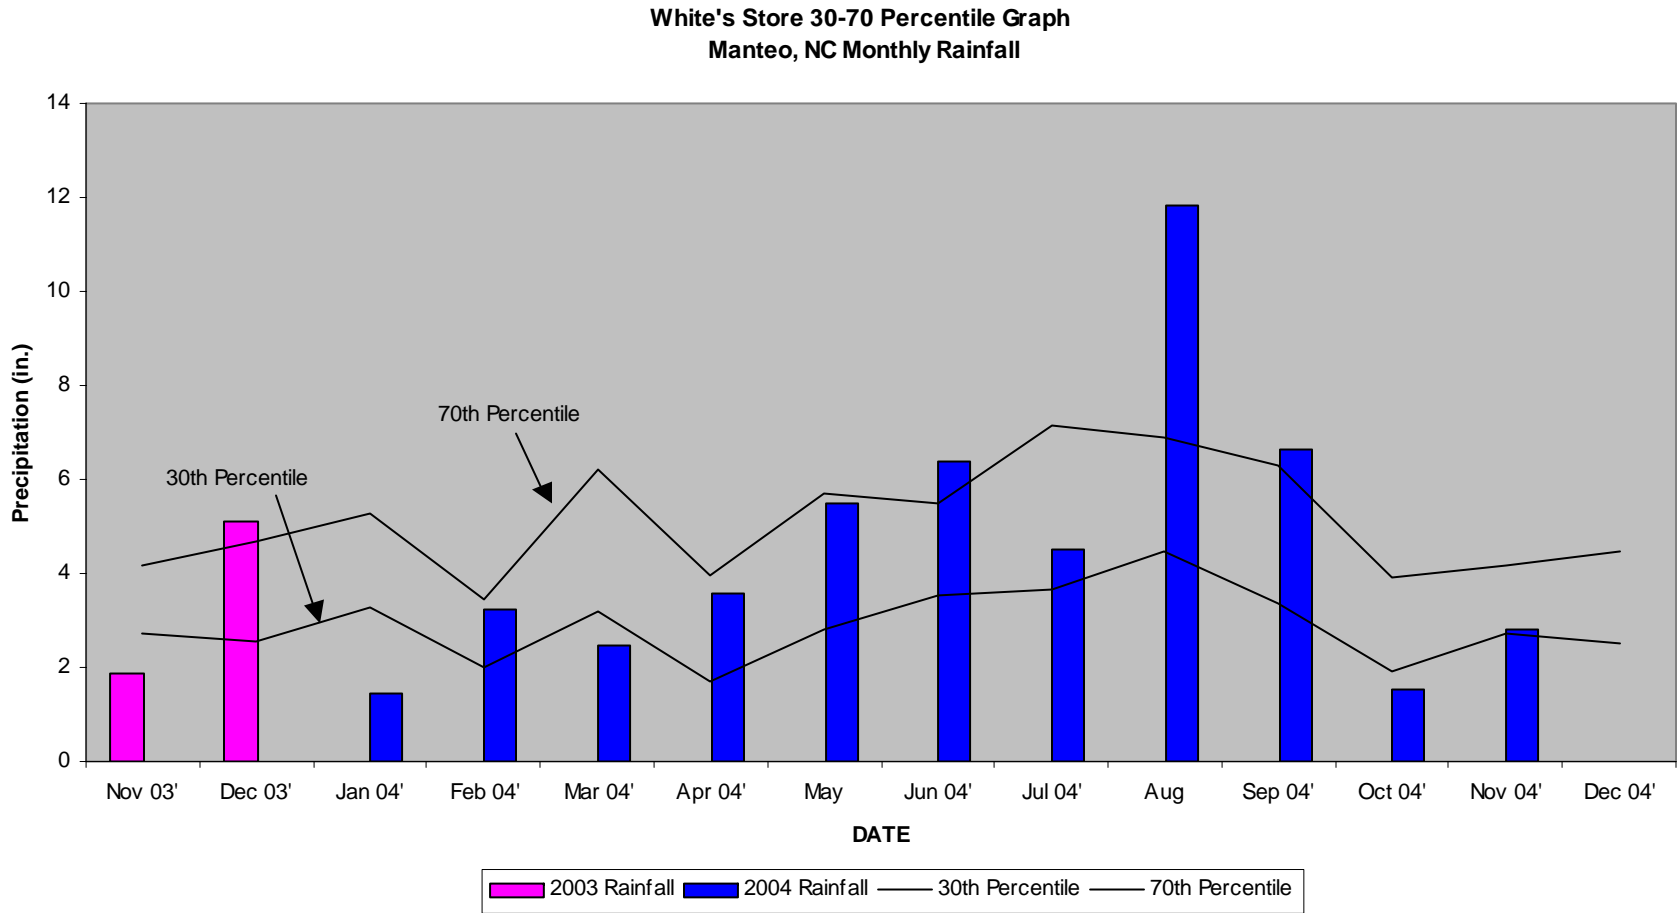
Figure 3. 30-70 Percentile Graph

Figure 3 represents an examination of the local climate in comparison with historical data in order to determine whether 2004 was "average" in terms of climate conditions. The two lines represent the 30th and 70th percentiles of monthly precipitation for Manteo, NC. The bars are monthly rainfall totals for 2003 and 2004. The historical data was collected from the State Climate Office of North Carolina.

For the 2004-year, November (03'), January, March, and October experienced below average rainfall. The months of February, April, May, July, and November all recorded average rainfall for the site. December (03'), June, August, and September experienced above average rainfall. The rainfall data from the onsite rain gauge was used for the months of September-November. Overall, 2004 experienced an average rainfall year.
