ANNUAL REPORT FOR 2006

**Deer Creek Mitigation Site
Carteret County
TIP No. R-2105 WM**

Prepared By:
Natural Environment Unit & Roadside Environmental Unit
North Carolina Department of Transportation
January 2007

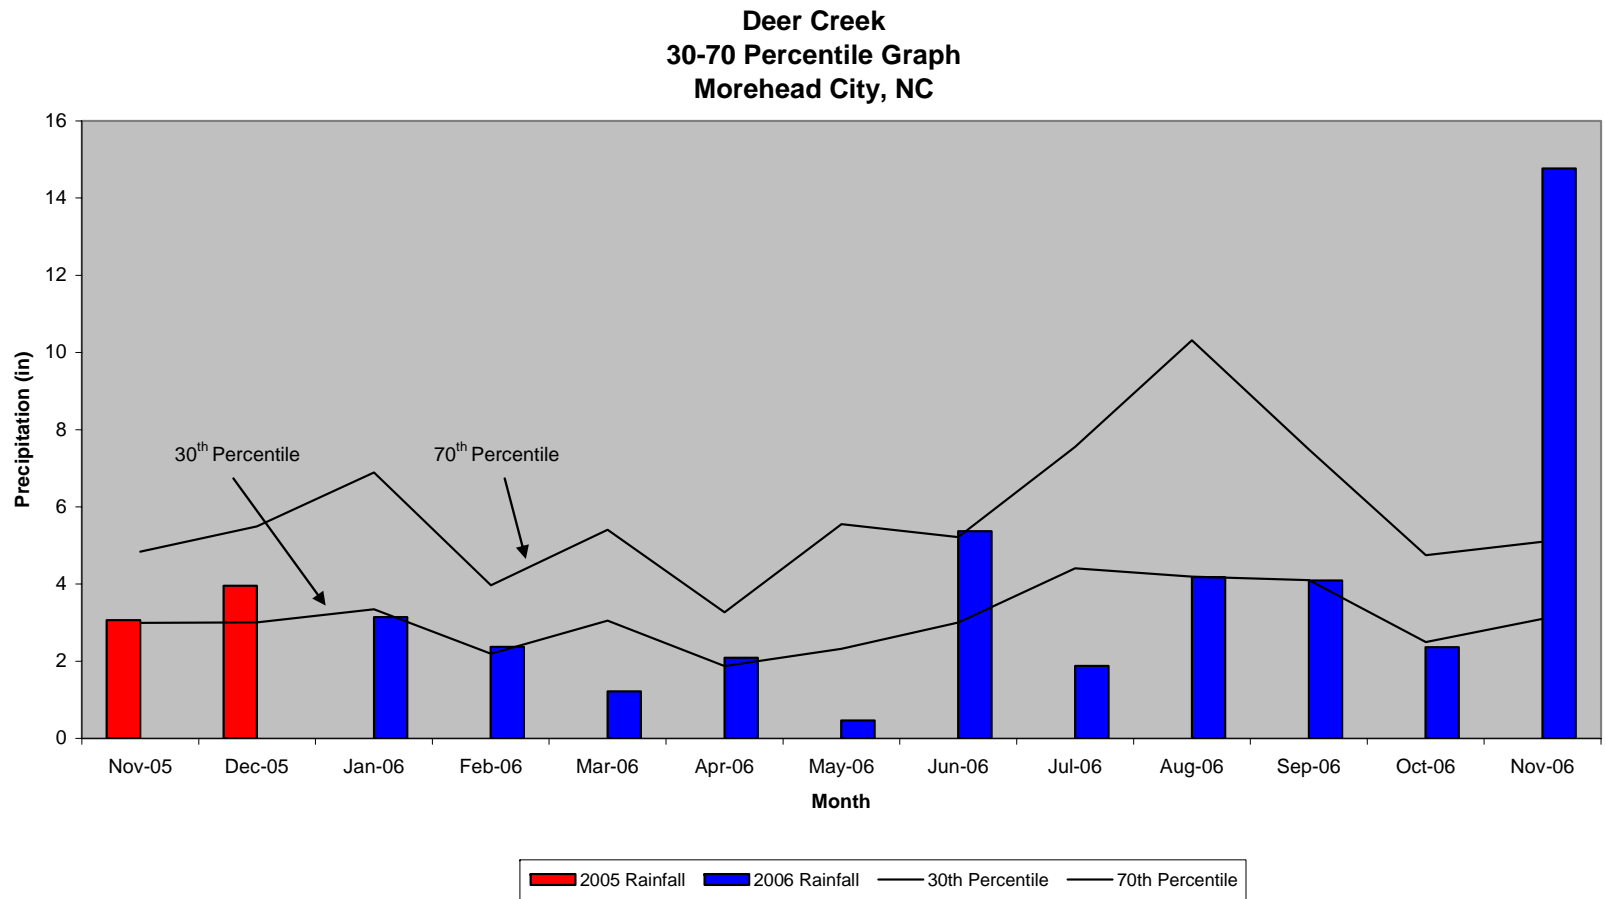
Figure 4: 30-70 Percentile Graph

Figure 4 is a comparison of monthly rainfall for the period of January through November 2006 to historical precipitation (collected between 1975 and 2006) for Morehead City, North Carolina. This comparison gives an indication of how 2006 relates to historical data in terms of climate conditions. The NC State Climate Office provided all of the local rainfall information.

Precipitation is not the primary hydrologic input for the site; therefore, it is expected that the site would show the required flooding regardless of area rainfall totals.
