# ANNUAL REPORT FOR 2000

***Mud Creek Mitigation Site  
Henderson County  
Project No. 8.T842404  
TIP No. R-2713***

Prepared By:  
Natural Systems Unit & Roadside Environmental Unit  
North Carolina Department of Transportation  
December 2000

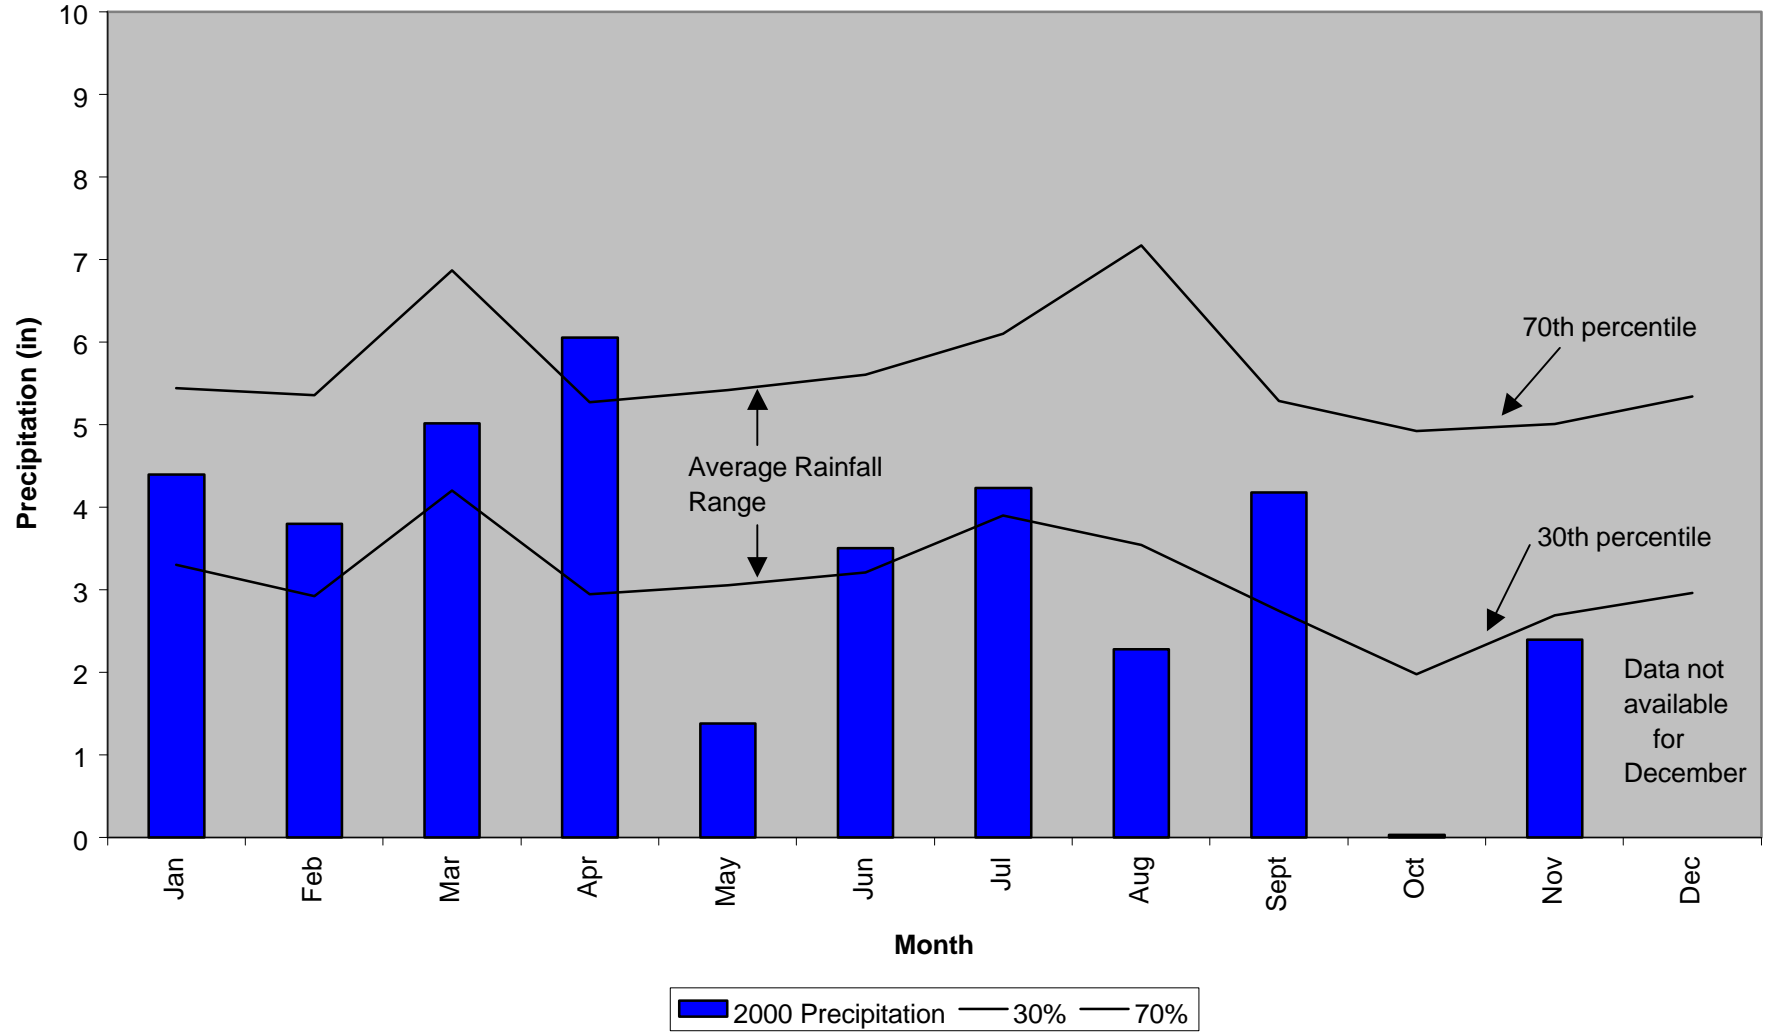
### Mud Creek 30 - 70 Percentile Graph Hendersonville, NC

Figure 4 is a comparison of the 2000 monthly rainfall with the historical rainfall for the area. The lines represent the 30<sup>th</sup> and 70<sup>th</sup> percentiles of monthly precipitation for Hendersonville, North Carolina. These percentiles are based on rainfall data collected between 1966 and 1996 from a National Climatic Data Center official gauge and serve as the historical data for the area. The percentiles create the “normal range” for rainfall for the vicinity.

The bars on the graph represent the total monthly rainfall from January through November of 2000. The 2000 rain data is from North Carolina State Climate Office gauge in Hendersonville, located in northern Henderson County.

Data for Henderson County shows that the area experienced normal rainfall during the months of January, February, March, June, July and September. Henderson County was drier than average during May, August, October and November. April was slightly above average. The December data was not available.

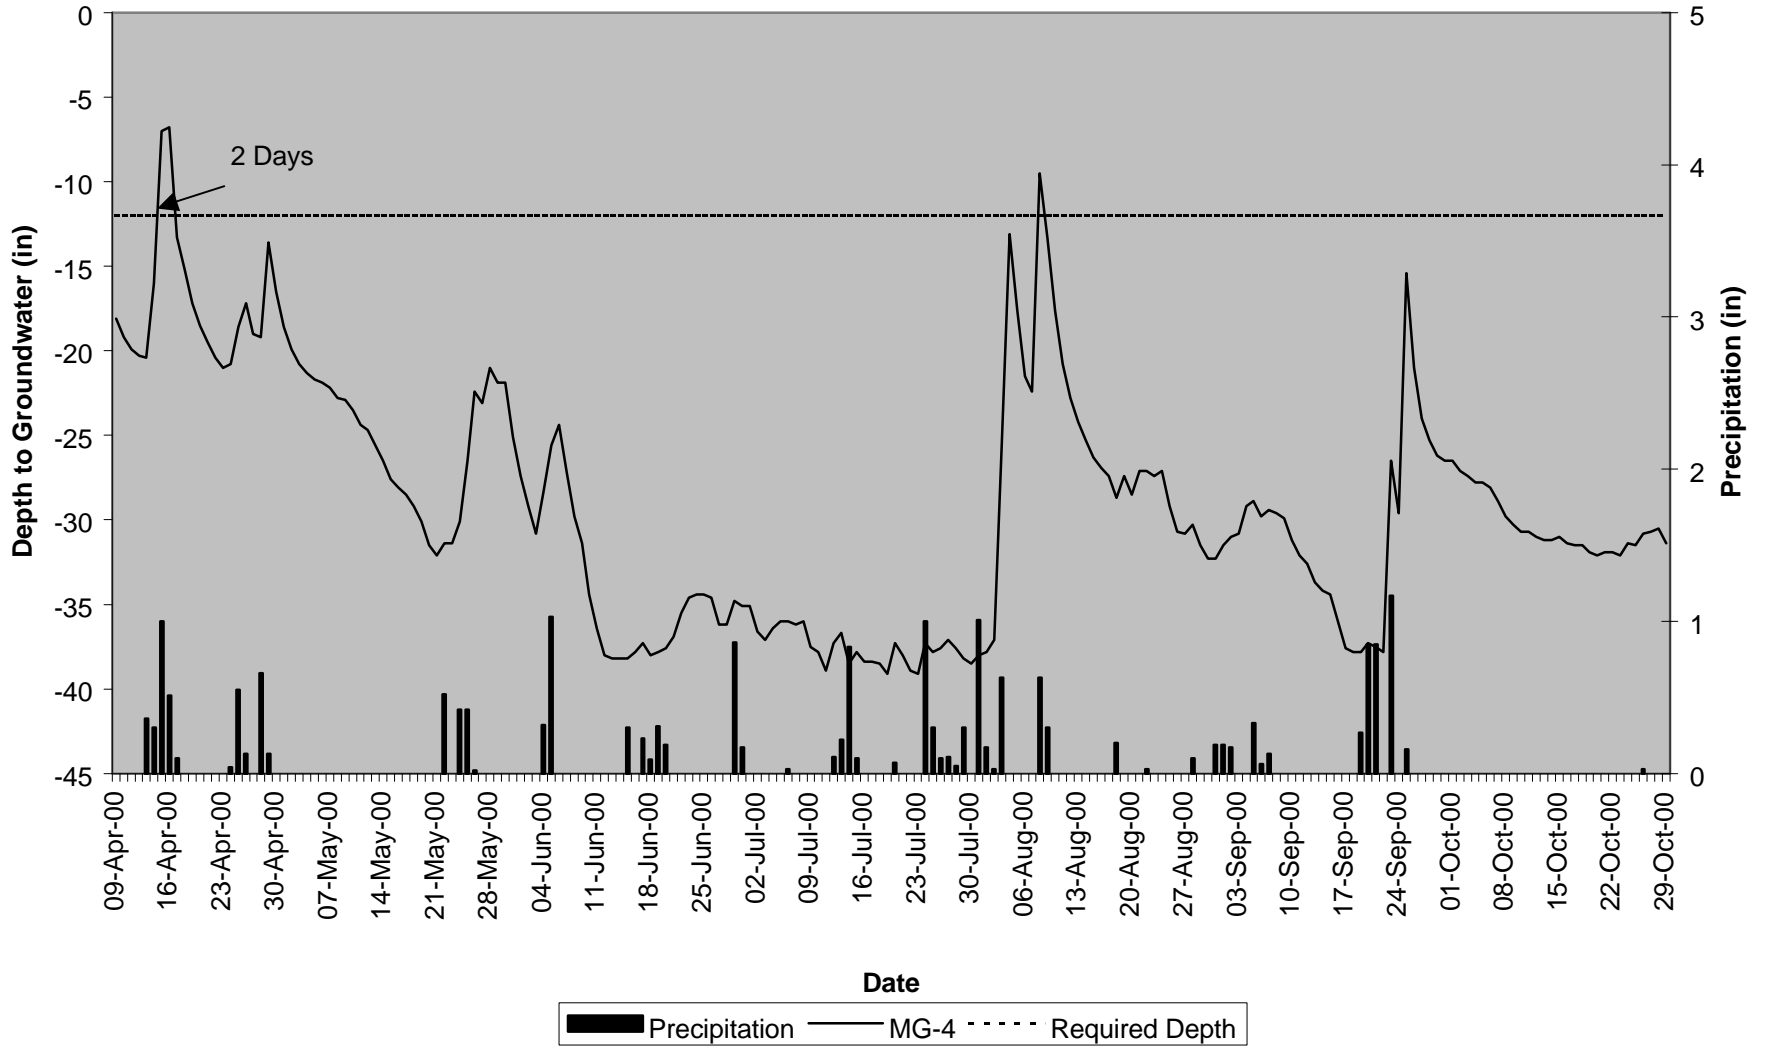
# Mud Creek MG-4

During the 2000 growing season, groundwater was never within twelve inches of the surface at MG-2, MG-8 and MG-9. Groundwater levels were within twelve inches of the surface less than 5% of the growing season at MG-1 (four days), MG-3 (six days) and MG-4 and MG-7 (two days). Groundwater levels were within twelve inches of the surface less than 8% of the growing season at MG-10 (14 days). Groundwater was present within twelve inches of the surface for 13.2% (27 days) at MG-5 and 17.7% (36 days) at MG-6.

Also of note is that MG-4, MG-5, and MG-6 are located in an area which was delineated as a wetland and confirmed by the USACE on December 6, 1995. In reference to Table 1, MG-4 appears to fall short of meeting “marginal” wetland status.

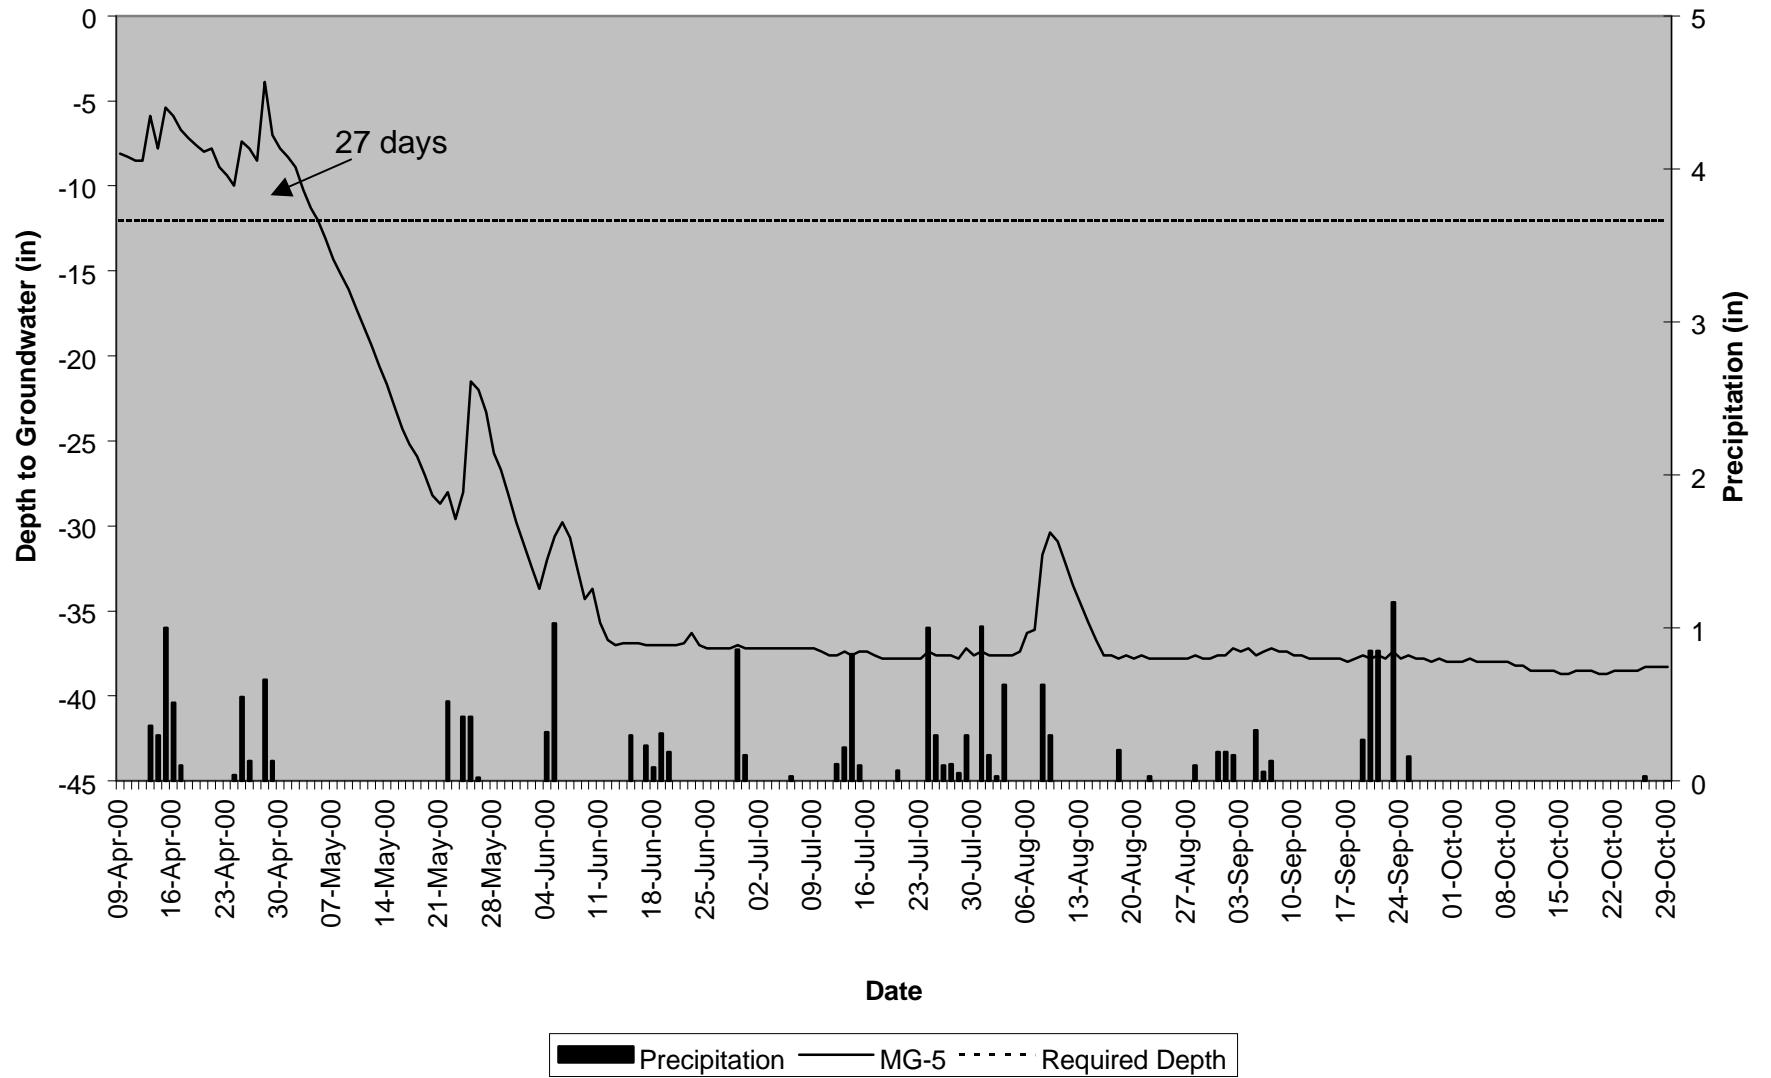
# Mud Creek MG-5

Two of the ten monitoring gauges indicated wetland hydrology. MG-5 and MG-6 achieved successful wetland hydrology for a consecutive 12.5% of the growing season. It should be pointed out that these gauges are reference gauges and located in an established wetland that has not been graded or excavated. MG-10 achieved successful hydrology for a consecutive 6.9% of the growing season. The remaining seven gauges did not achieve successful wetland hydrology. Of these wells, MG-1, MG-2, MG-3, MG-7 and MG-8 are located in areas of constructed wetland. MG-4 is located in an existing wetland that has been impacted. MG-9 is located in one of the typically wetter portions of the site.
