# ANNUAL REPORT FOR 2000

**Tucker Mitigation Site  
Currituck County  
Project No. 6.049009T  
TIP No. R-2228WM**

Prepared By:  
Natural Systems Unit & Roadside Environmental Unit  
North Carolina Department of Transportation  
December 2000

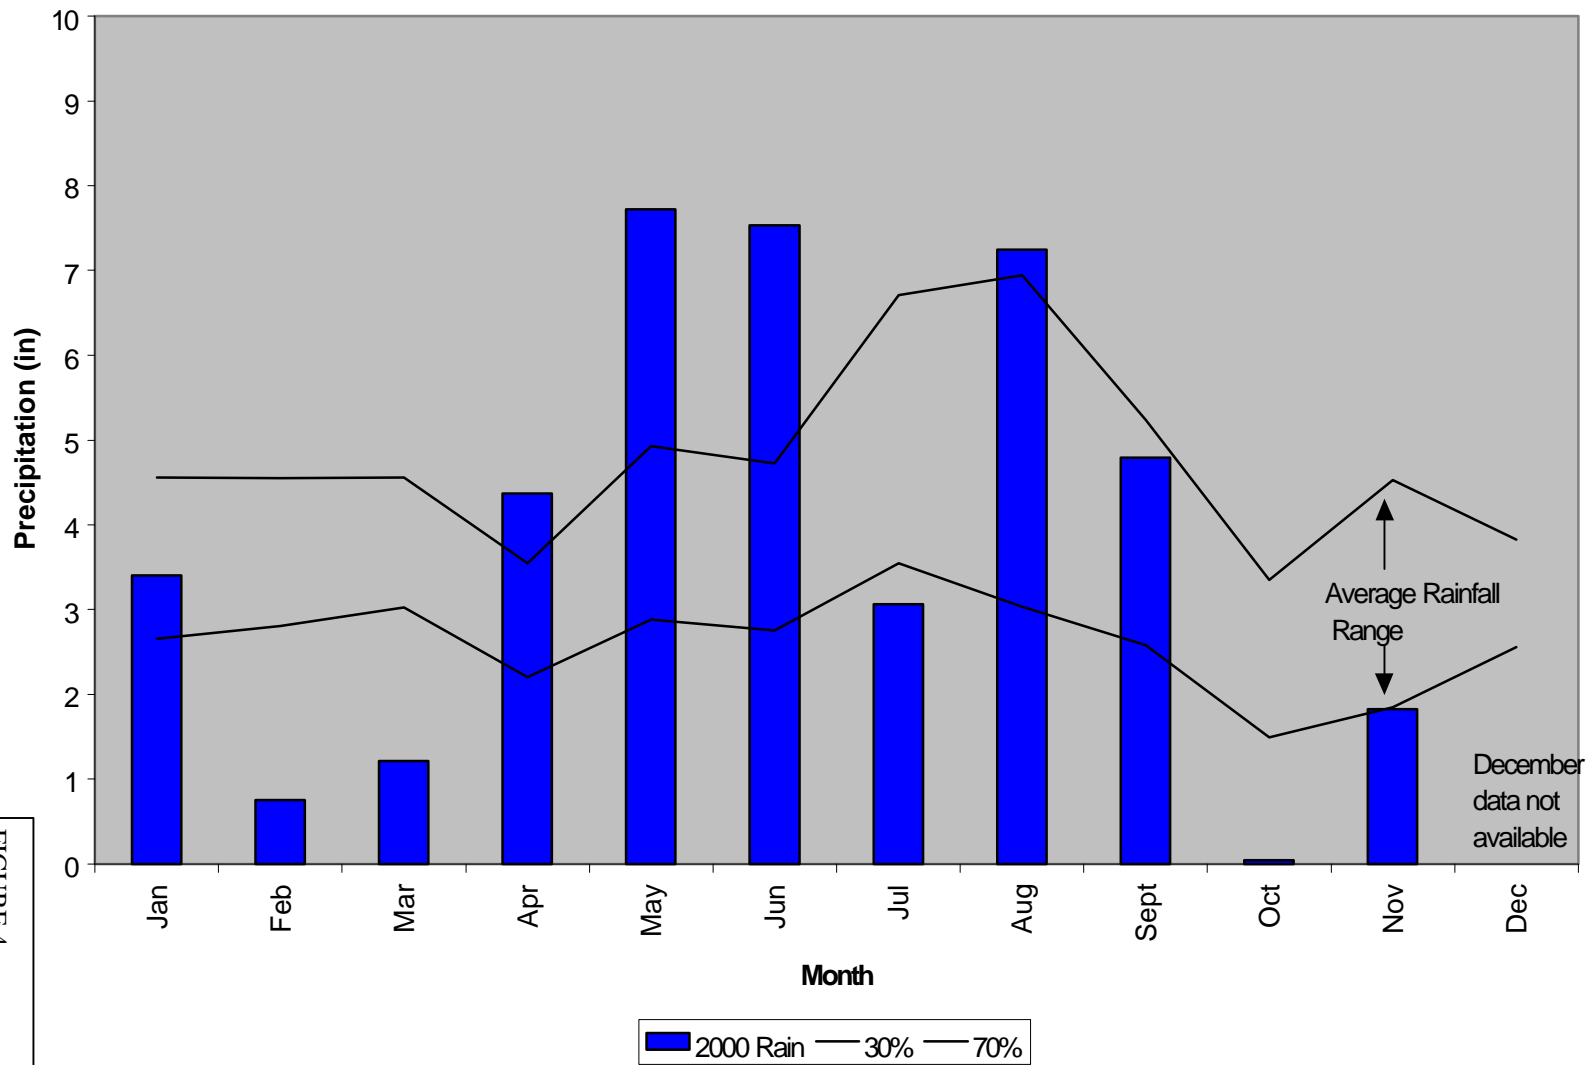
FIGURE 4  
30-70 Percentile Graph

Figure 4 represents an examination of the local climate in comparison with historical data to determine whether 2000 was “normal” in terms of climate conditions. The figure compares the rainfall from 2000 with that of historical rainfall (data collected between 1948 and 1996). All rainfall data was collected from the NC State Climate Office. The graph shows 2000 rainfall totals from January 2000 through the end of November 2000 which includes the growing season for this site. In the year 2000, February, March, and October had extremely below normal rainfall; July and November were below normal. May and June, showed significantly above average rainfall.

December data not available

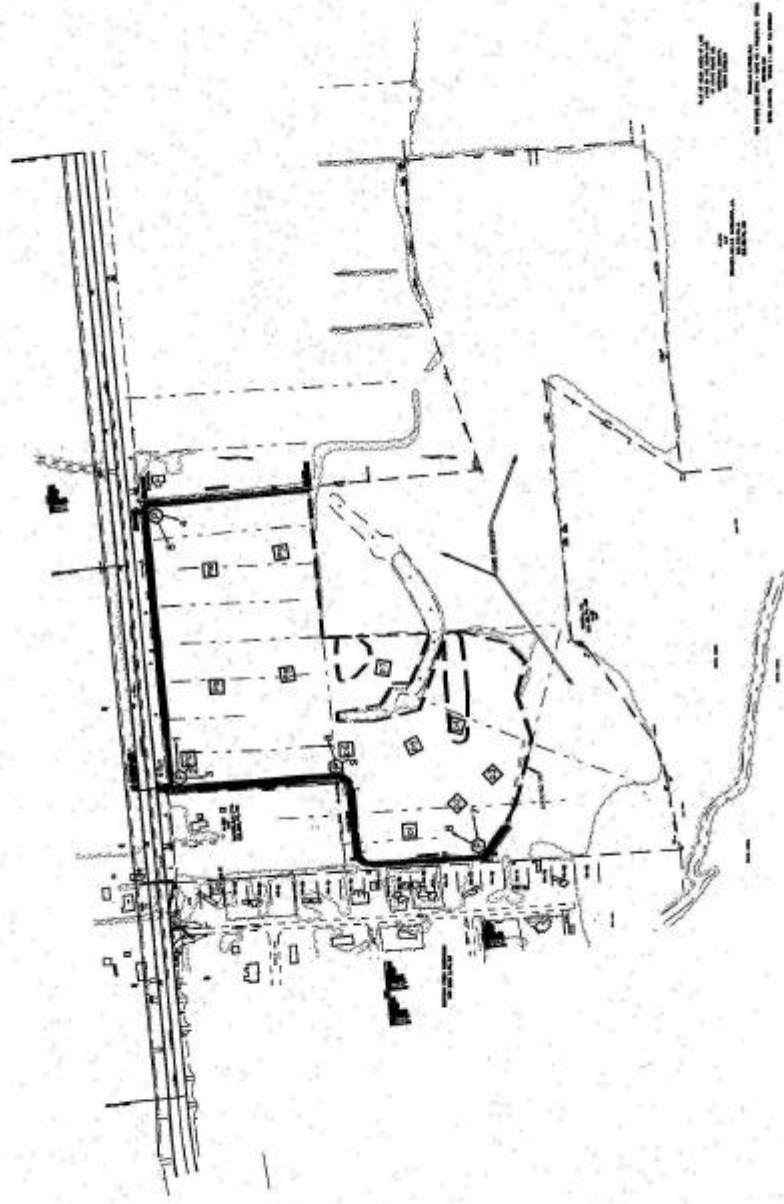
**Tucker Farm Mitigation Site  
Photo and Plot Locations  
2000 Monitoring**

To determine tree density, 50' x 50' plots are installed immediately following planting. The actual number of planted trees which occur within the plot are counted. This number is equated to the number within each plot, which represents 680 trees per acre (average). The survival monitoring number is compared to the planted number to obtain survival percentage. This percentage is applied to the 680 trees per acre to obtain an estimated tree per acre for the site. (Density = monitoring count / planted trees x 680)

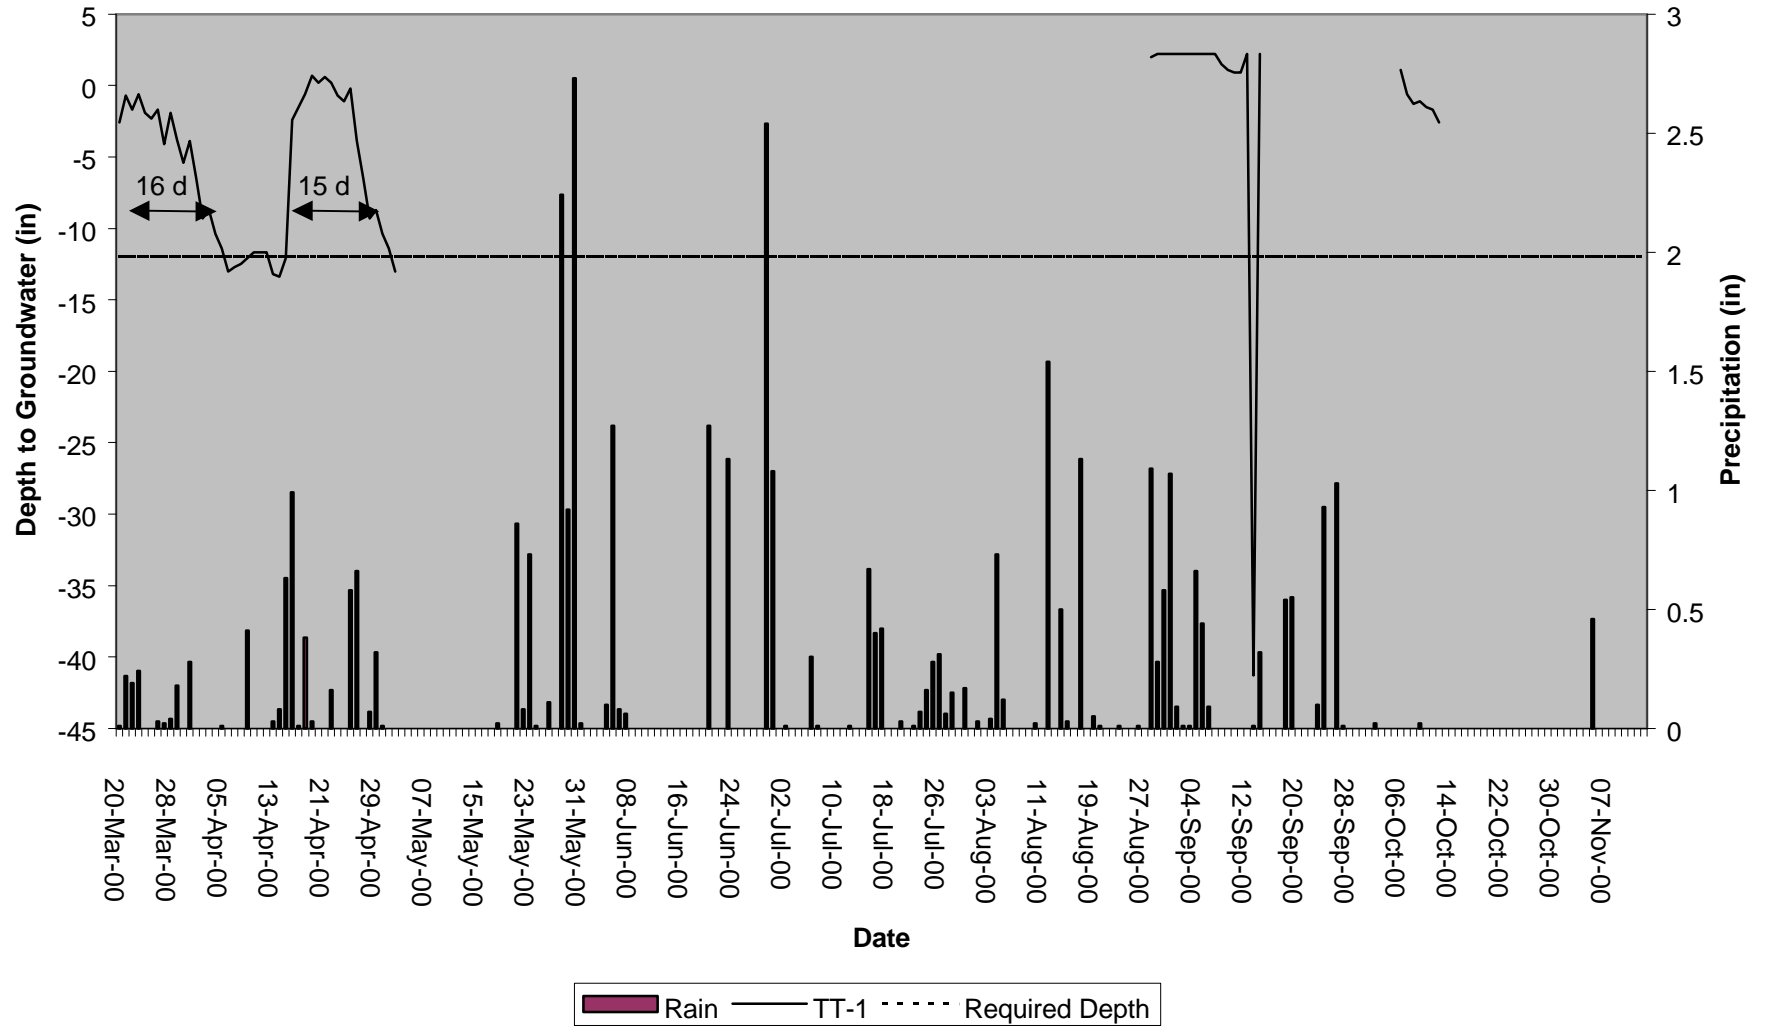
# TT-1

This year (2000) the majority of the monitoring gauges on site have shown saturation for long periods of time. Monitoring gauge TT-1 was eliminated from the analysis because battery failure resulted in no data for most of the growing season (see graph of TT-1 in Appendix A). Gage TT-1 was checked, maintained, and reset three times during the growing season to no avail. Of the remaining nine gauges, eight exhibited saturation within 12 inches of the surface for over 12.5% of the growing season. This is an improvement over the 1999 results by 20 percent. In 2000, TT-6 showed saturation for 8% of the growing season, which is similar to the 1999 results. Monitoring gauge TT-6 is situated in a locally elevated part of the site. May and June exhibited greater than normal rainfall and July lower than normal rainfall (Figure 4), thus TT-3 data would be closer to saturation for 12.5% of the growing season.

*Specific problems:* Dead batteries hampered the data acquisition process. Monitoring gauge TT-1 did not record groundwater elevations from May 1 to August 29, September 14 to October 6 and October 12 to November 15. Several attempts to repair and reset this gage proved unsuccessful. As previously mentioned this gauge was eliminated from the data analysis due to the data gaps. This gage will be replaced prior to the next growing season. Monitoring gauge TT-3 had dead batteries for the month of August.

The results of the second year of monitoring indicate this site was successful. The majority of the groundwater gauges met the hydrologic success criteria. Gauge TT-1 malfunctioned multiple times during the year despite numerous maintenance efforts and will be replaced. Based upon a previous field investigation, gage TT-6 is situated in a locally high hummock rising approximately 8 inches above the surrounding area. Vegetation data also met success criteria. The average plot density was above the required 320 stems/acre, as well as densities within each zone. Vegetation and hydrologic monitoring will continue for a third year in 2001 at the Tucker Tract Mitigation Site.

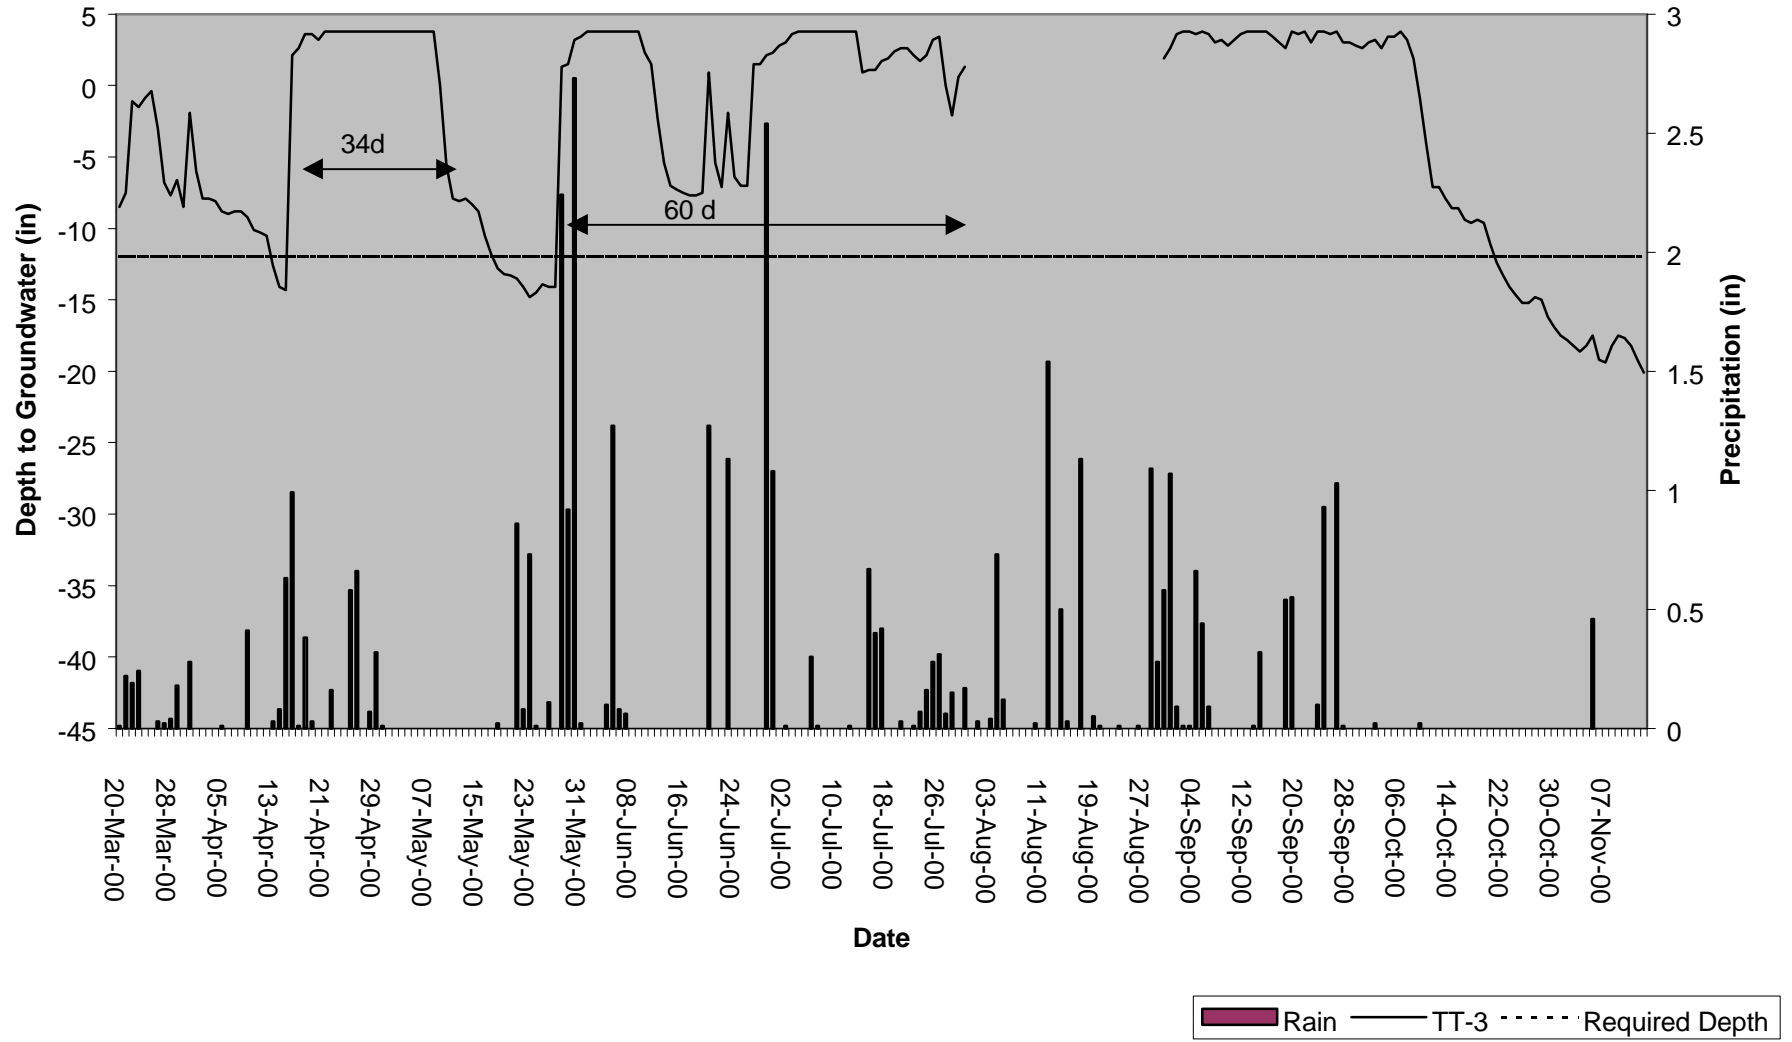
# TT-3

As previously mentioned, in 1999 monitoring gauges TT-3, TT-5, and TT-6 showed saturation for less than 10% of the growing season. By comparison in 2000, TT-3 showed saturation for 25% of the growing season from May 29 to July 27; TT-5 for 33% of the growing season from July 24 to October 11; and TT-6 for less than 10% of the growing season. The months of April, August and September exhibited rainfall at or slightly above the normal range. There were high rainfall amounts through April, May, and June with the May and June data being substantially above normal. These results contributed to the longer periods of saturation exhibited by the gauges. However, groundwater levels were maintained through the more normal rainfall periods of July, August and September and even into the low rainfall periods during October and November.

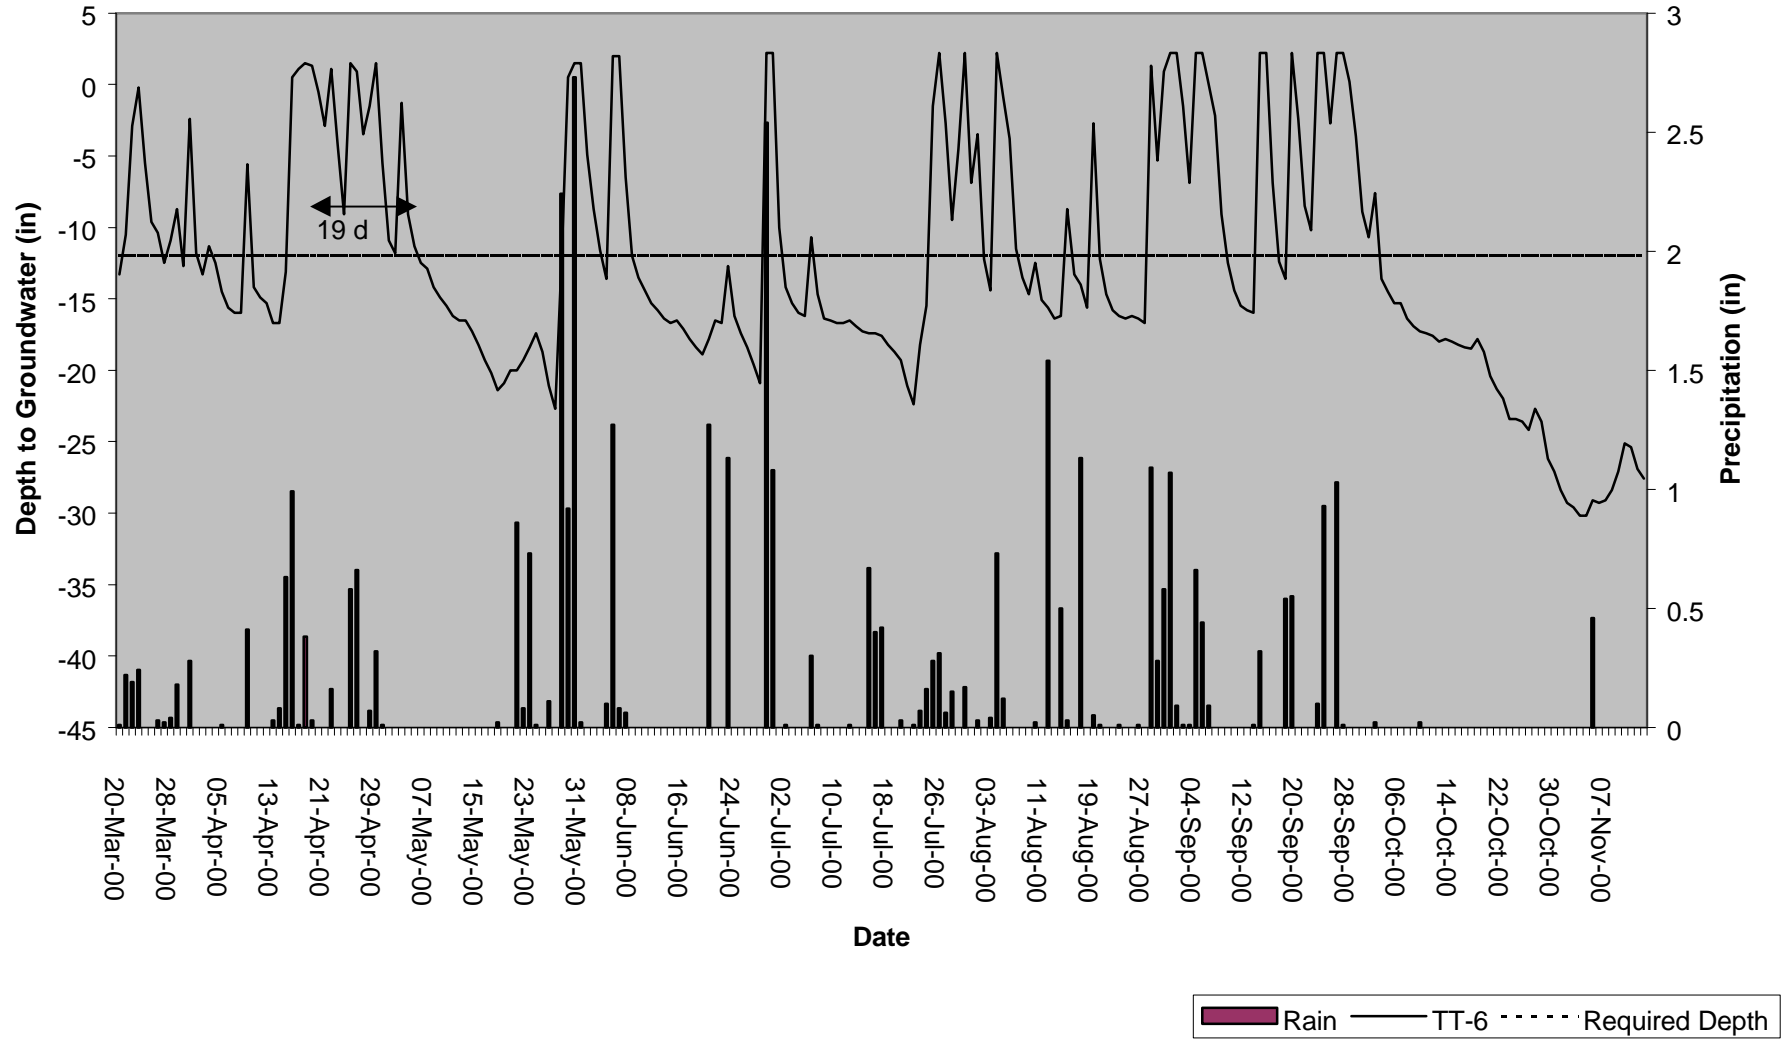
# TT-6

Hydrologic monitoring indicated that of the ten gauges on site, eight showed saturation for over 12.5% of the growing season, one gage (TT-6) showed saturation between 8 – 12.5% of the growing season (this gage, as noted last year, is situated in a local high area) and the remaining gage (TT-1) continually malfunctioned and will be replaced before the next growing season. Gage TT-1 is presented in the report for information purposes (it did show saturation between 5 – 8% of the growing season, and during vegetation monitoring this area was observed to be saturated). The second year vegetation monitoring of the planted areas revealed an average density to be 391 trees per acre, which is above the minimum requirement of 320 trees per acre.
