# ANNUAL REPORT FOR 2001

**Bethel Church Mitigation Site**

**Yadkin County**

**Project No. 6.779004T**

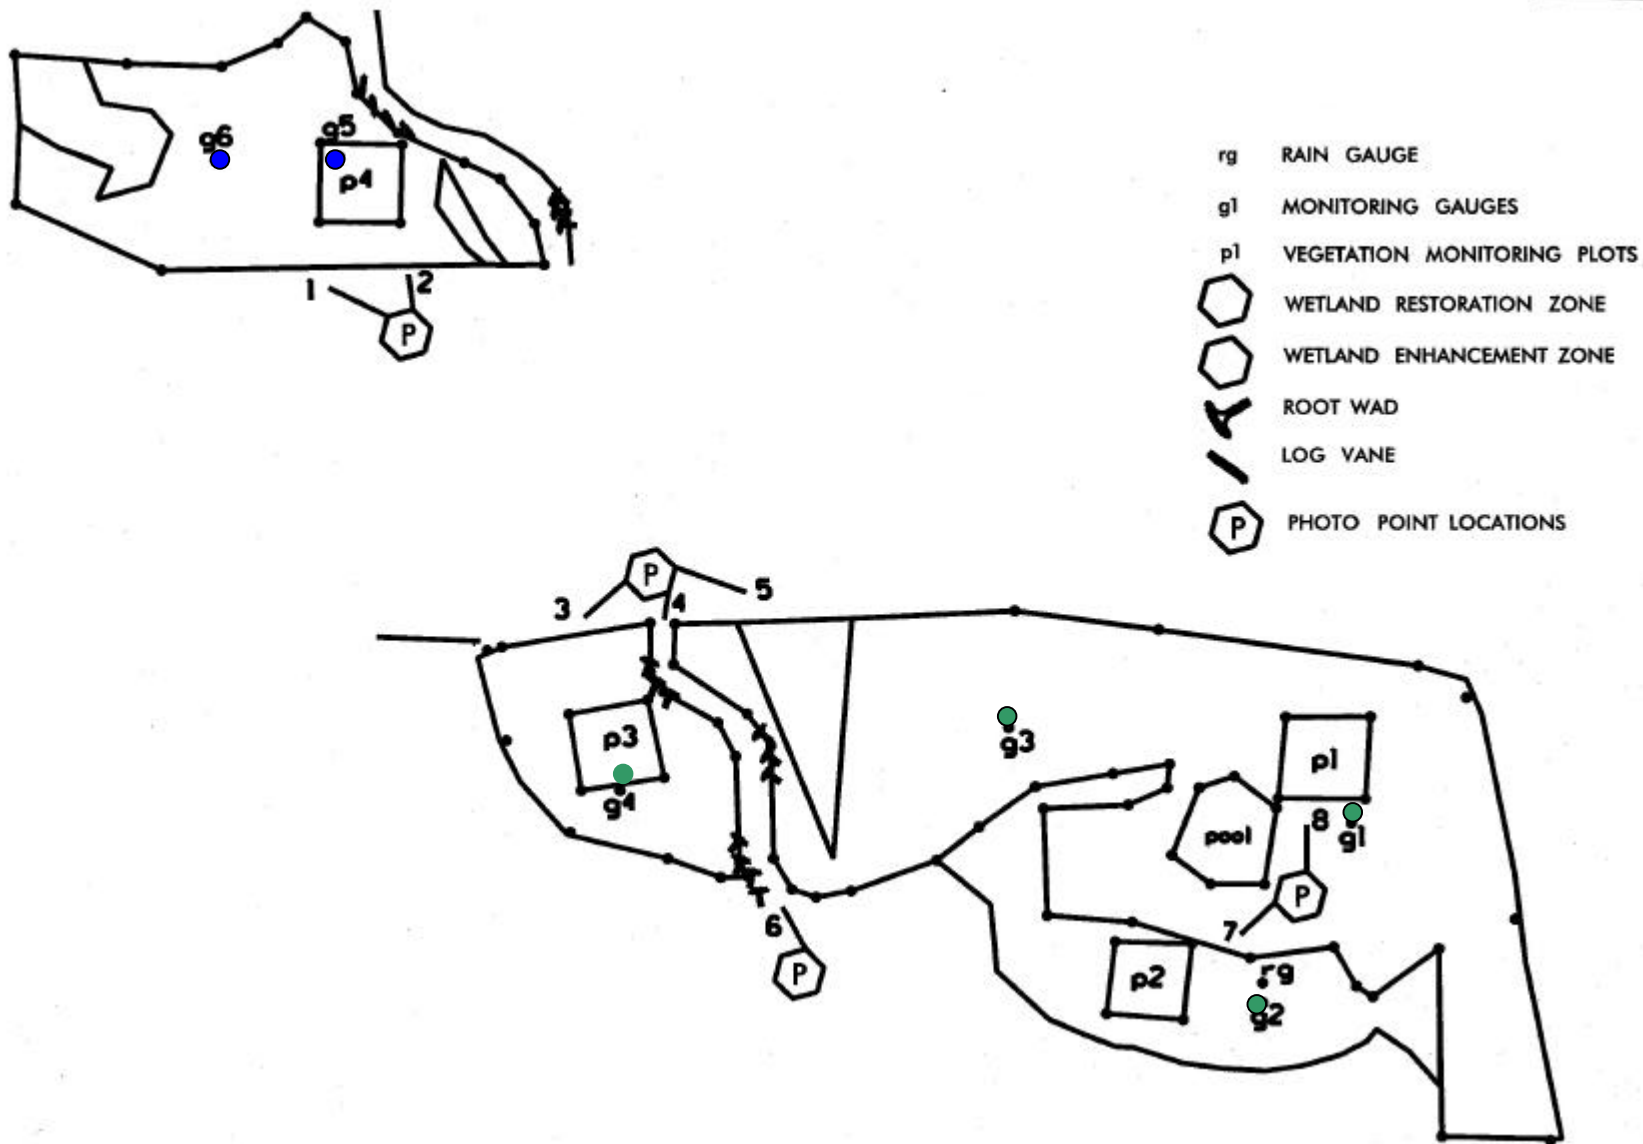
**FIGURE 2: BETHEL CHURCH MONITORING PLAN  
& 2001 GAUGE RESULTS**

In March 2001, six monitoring gauges were installed across the site (Figure 2). The automatic monitoring gauges record daily readings of groundwater depth. This represents the first growing season that the monitoring gauges have been in place since construction of the site.

Figure 2 represents a graphical representation of the hydrologic results. Gauges highlighted in blue indicate wetland hydrology for more than 12.5% of the growing season. Gauges highlighted in green show hydrology between 8% and 12.5% of the season.

Monitoring Gauge	< 5%	5% - 8%	8% - 12.5%	> 12.5%	Actual %*	Success Dates
GW-1			X		11.4	May 17-June 8
GW-2 (Existing Wetland)			X		11.9	Apr. 9-May 2
GW-3			X		11.4	May 17 –June 8
GW-4				X	65.4	Jun 19-Oct 28
GW-5				X	34.7	Apr. 9-Jun 17
GW-6				X	25.7	Apr. 26-Jun 16

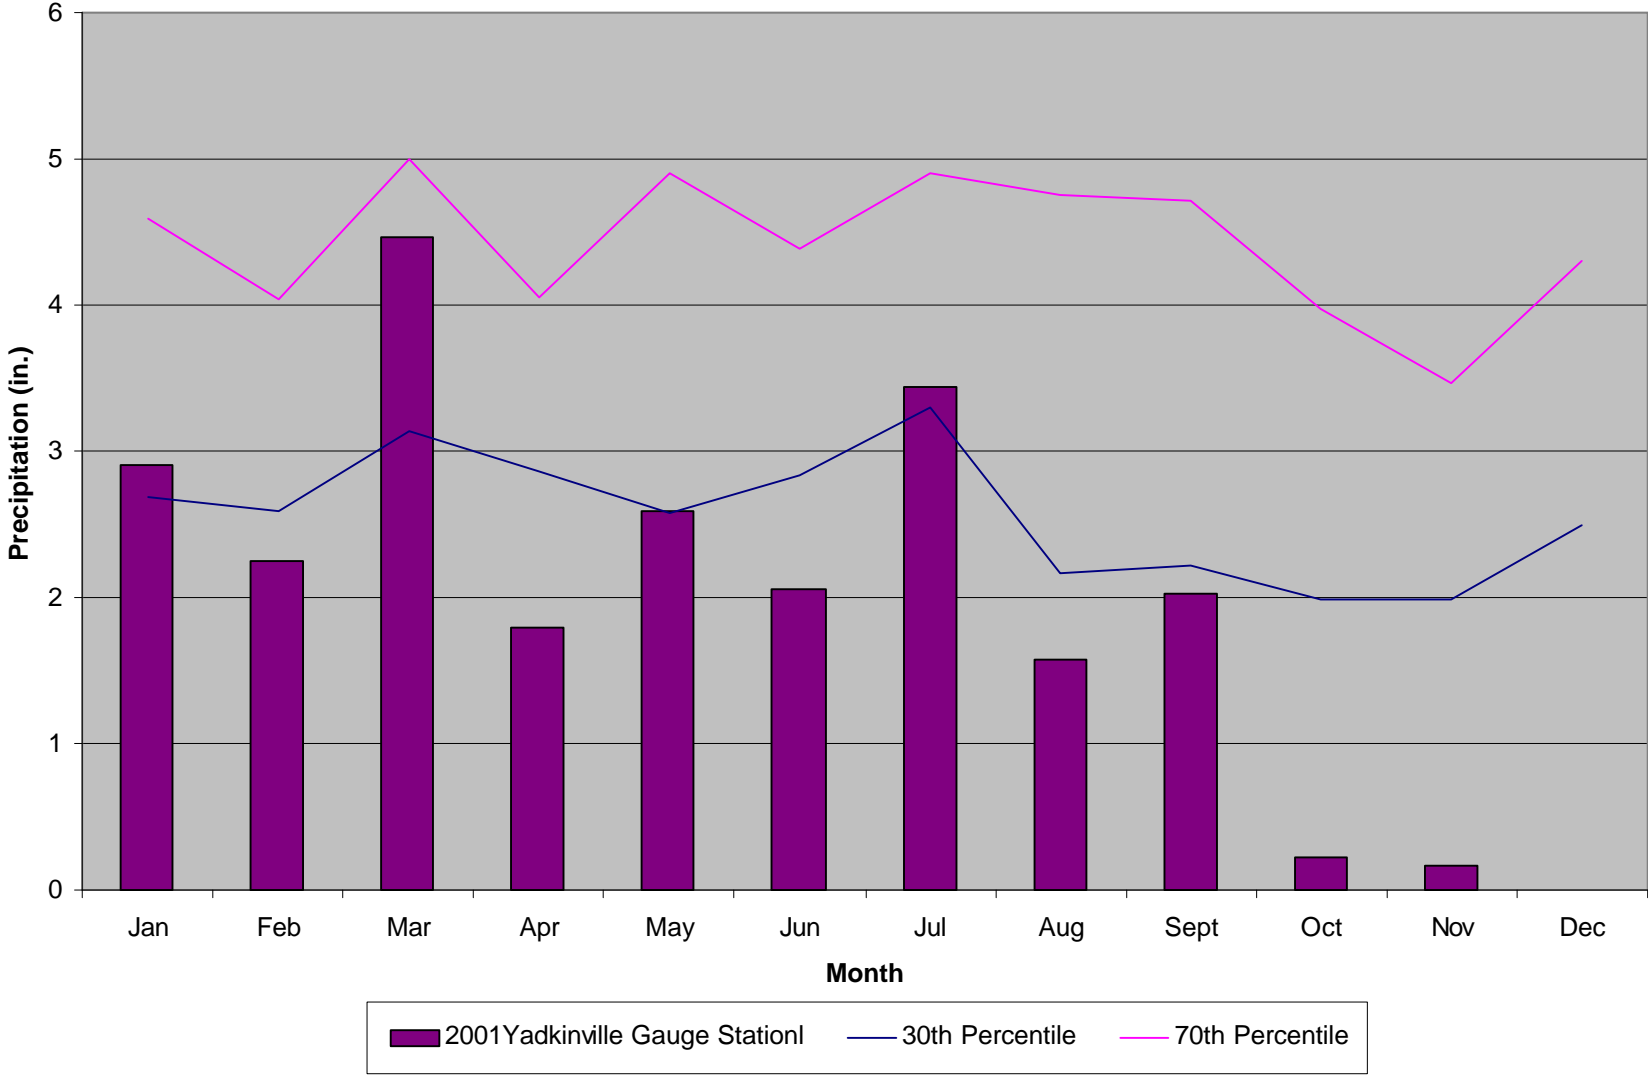
**FIGURE 4: Bethel Church 30-70 Percentile Graph  
Yadkin County**

Figure 4 represents an examination of the local climate in comparison with historical data in order to determine whether 2001 was “average” in terms of precipitation. The two lines represent the 30<sup>th</sup> and 70<sup>th</sup> percentiles of monthly historical precipitation at the Yadkinville Station. The bars represent the monthly rainfall totals for 2001. The historical data was also collected from the State Climatic Office for the Yadkinville weather station. With exception of January, March and July, monthly rainfall results for 2001 were below normal.

The 2001 growing season represents the first monitoring assessment period for the Bethel Church mitigation site since construction. It is concluded that the overall rainfall for 2001 was below.
