Supplement: 2001 Bethel Church Mitigation Annual Monitoring Report

Stream Monitoring Update – 2001

Bethel Church - Stream

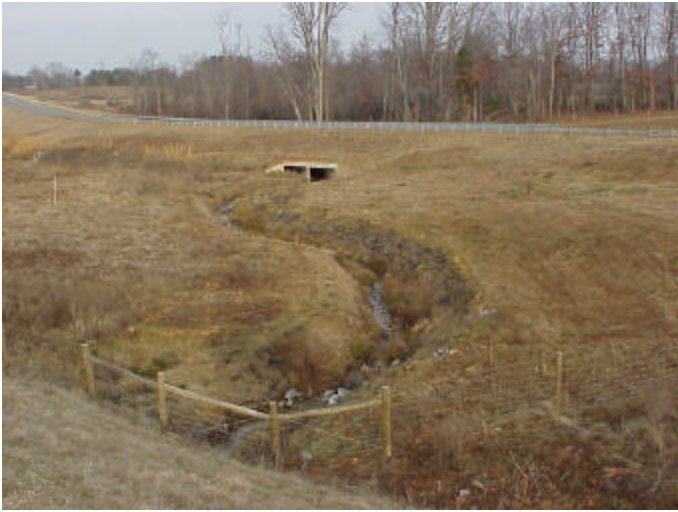
Photo 1

The following photographs show the conditions of the stream as of February 2002. As shown in these photographs, the stream banks have been stabilized with vegetation. In addition naturally re-generating herbaceous vegetation has been established throughout the length of the channel. (Photos 1-3 show portion of stream channel located on northern side of site; Photos 4-6 show portion of stream channel located on southern side of site.)
