# ANNUAL REPORT FOR 2001

**Casey Tract Mitigation Site  
Currituck County  
Project No. 6.049001T  
TIP No. R-2228**

Prepared By:  
Natural Systems Unit & Roadside Environmental Unit  
North Carolina Department of Transportation  
December 2001

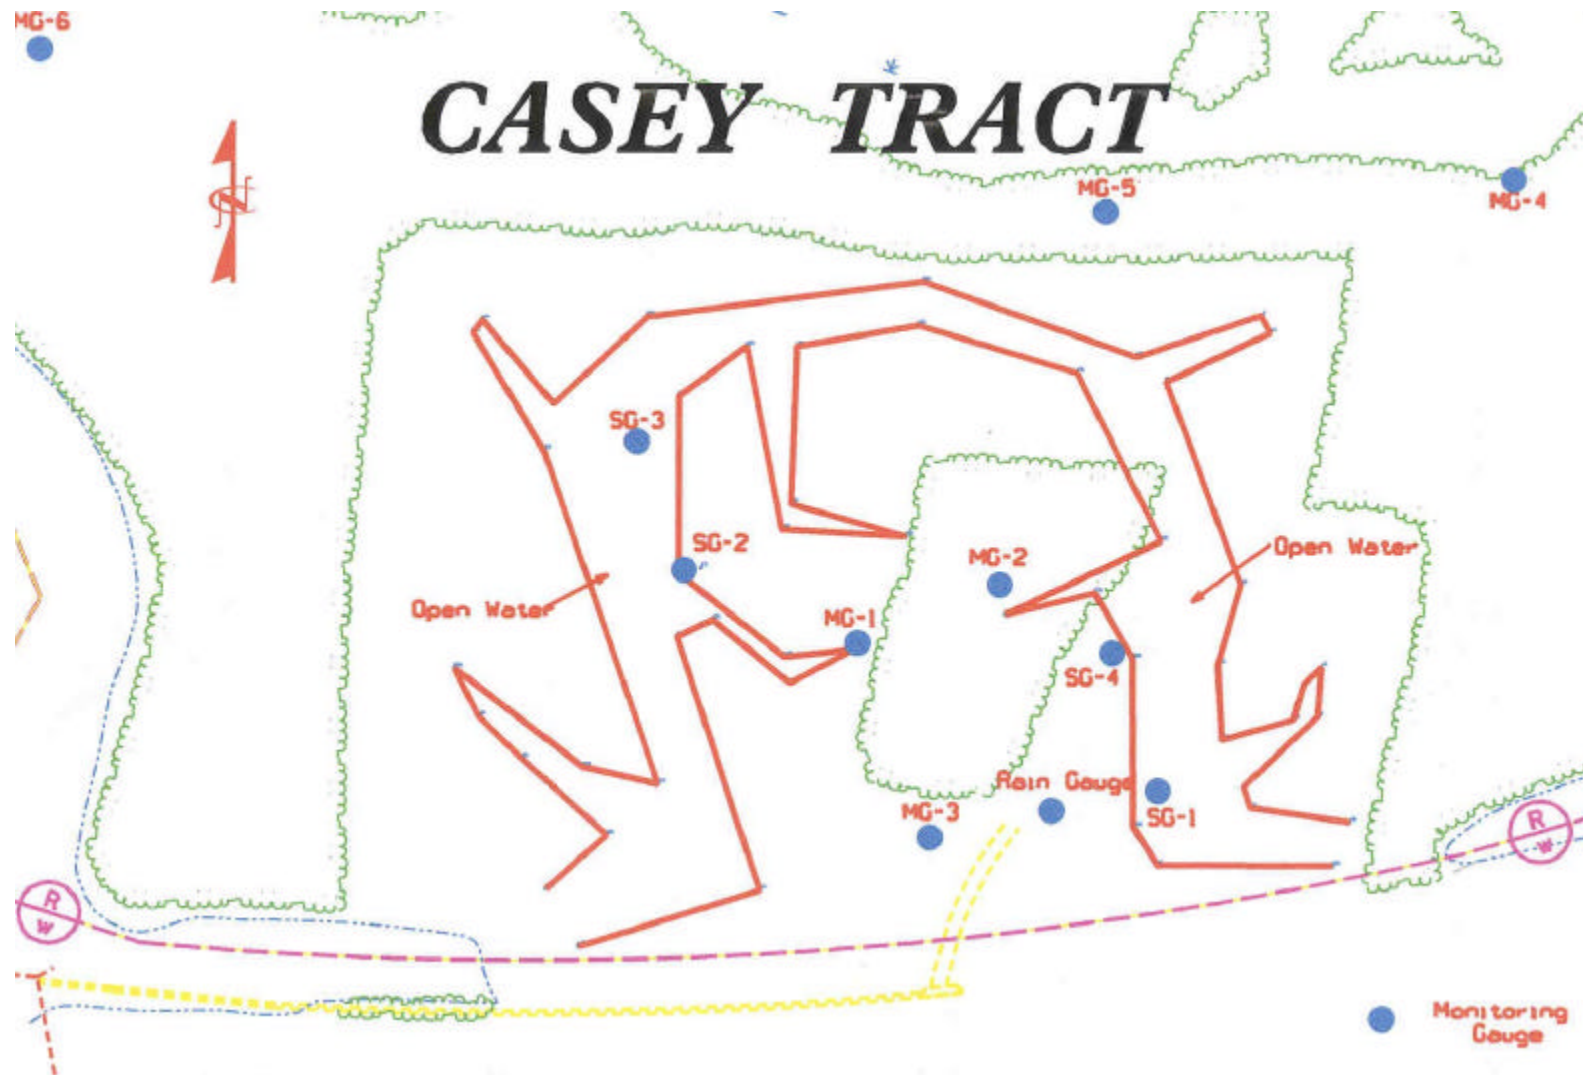
Figure 2  
Monitoring Gauge Location Map

Six groundwater-monitoring gauges, one rain gauge and four surface water gauges are installed at the Casey Tract (Figure 2). In August 2000, the original rain gauge was replaced with an Infinity rain gauge. The automatic monitoring gauges record daily readings of groundwater depth. Three of these groundwater-monitoring gauges are located within the reference wetland on site.

- SG-2 stopped recording data on September 27, 2001. The gauge was replaced and programmed to begin recording data on October 3.
- SG-4 was found to contain bad data in March 2001. The gauge was replaced and programmed to record data starting on March 9, 2001.
- MG-5 stopped recording data on February 9, 2001. The gauge was reset to record data starting on March 9, 2001.

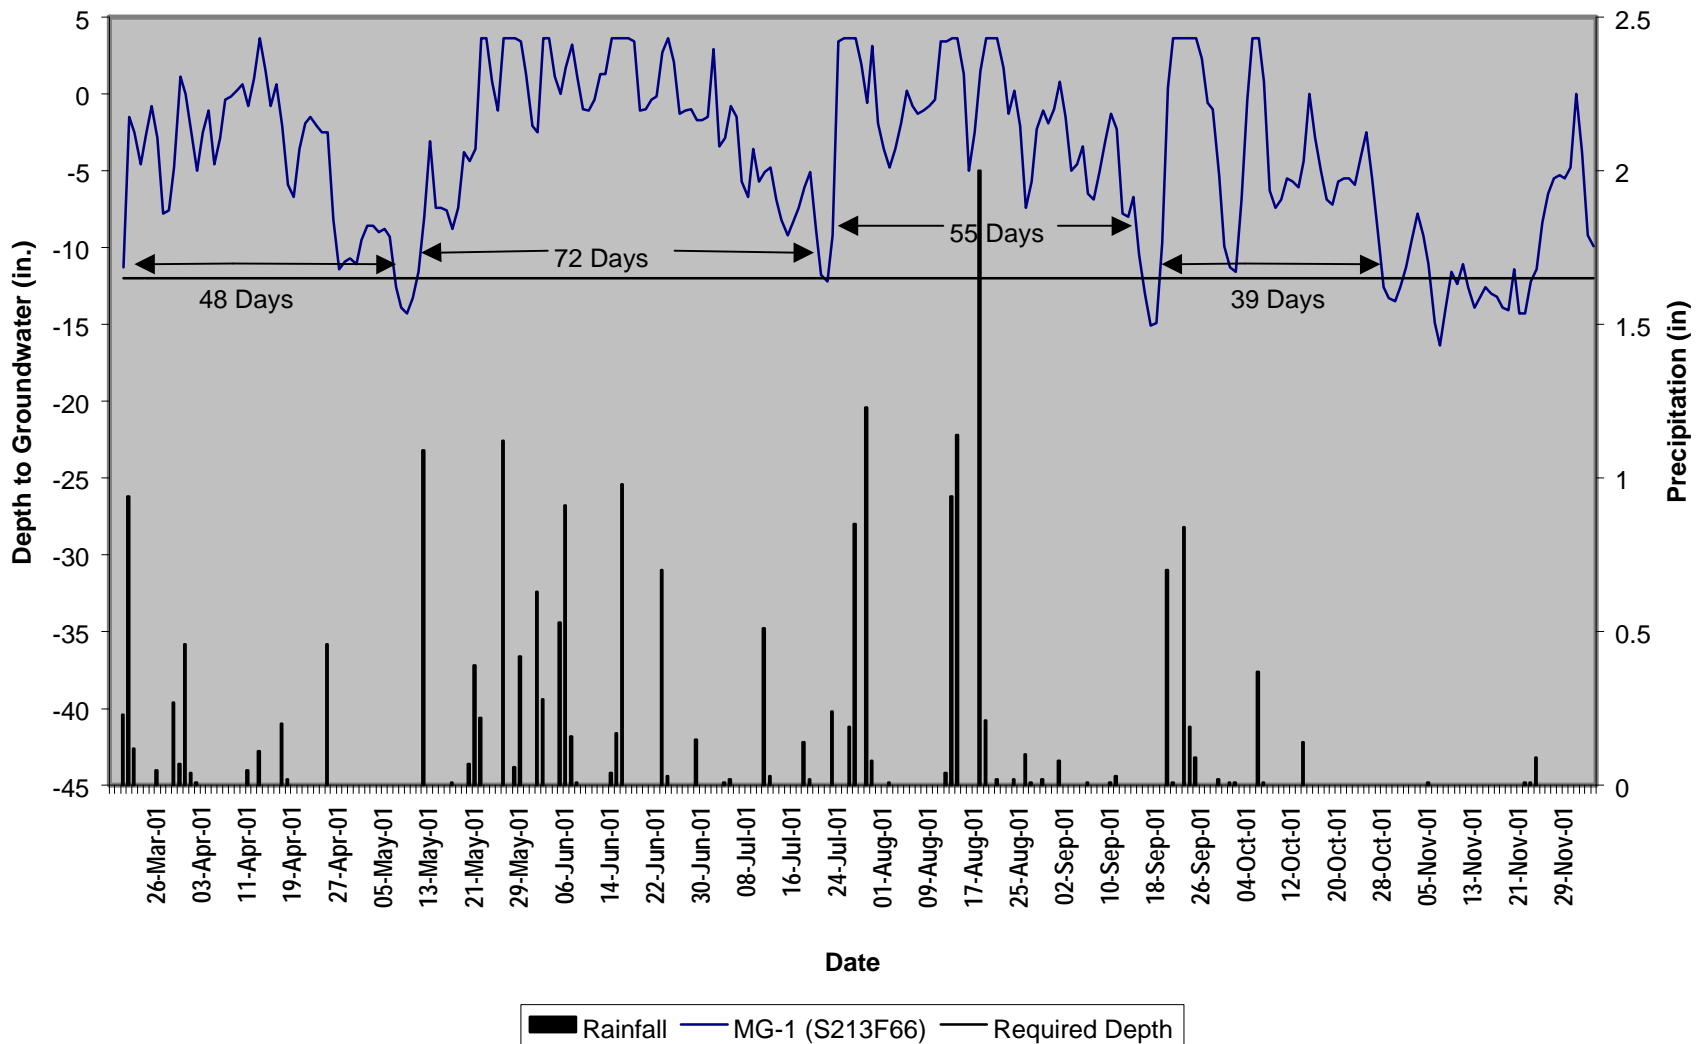
### Casey Tract Monitoring Gauge MG-1

Monitoring Gauge	< 5%	5% - 8%	8% - 12.5%	12.5%	Actual %	Success Dates
MG-1				✓	30.1	May 11-July 21
MG-2				✓	53.6	May 12-Sept 16
MG-3	✓				0	None
MG-4 (RG)				✓	27.2	May 12-July 15
MG-5 (RG)	✓				2.5	Sept 21-Sept 26th
MG-6 (RG)				✓	27.6	May 12-July 16

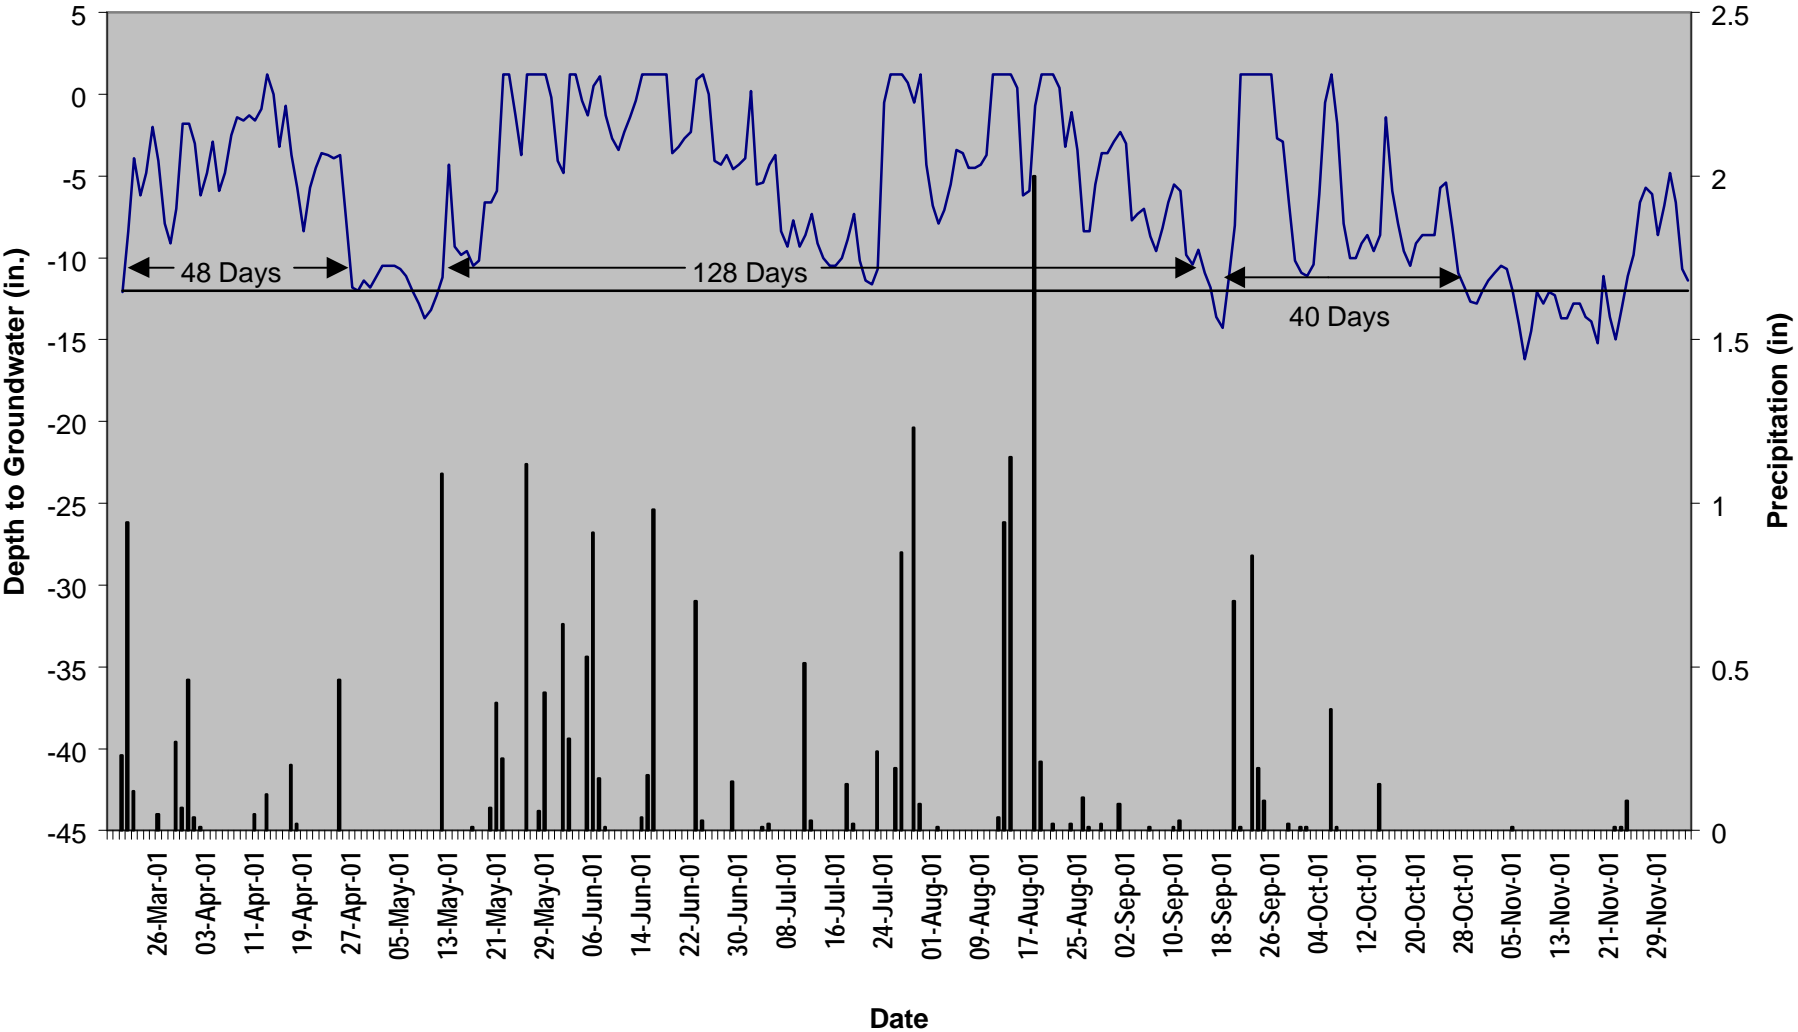
### Casey Tract Monitoring Gauge MG-2

■ Rainfall — MG-2 (S2B224D) — Required Depth
