ANNUAL REPORT FOR 2001

Deer Creek Mitigation Site
Carteret County
Project No. 6.16901T
TIP No. R-2105 WM

Prepared By:
Natural Systems Unit & Roadside Environmental Unit
North Carolina Department of Transportation
December 2001

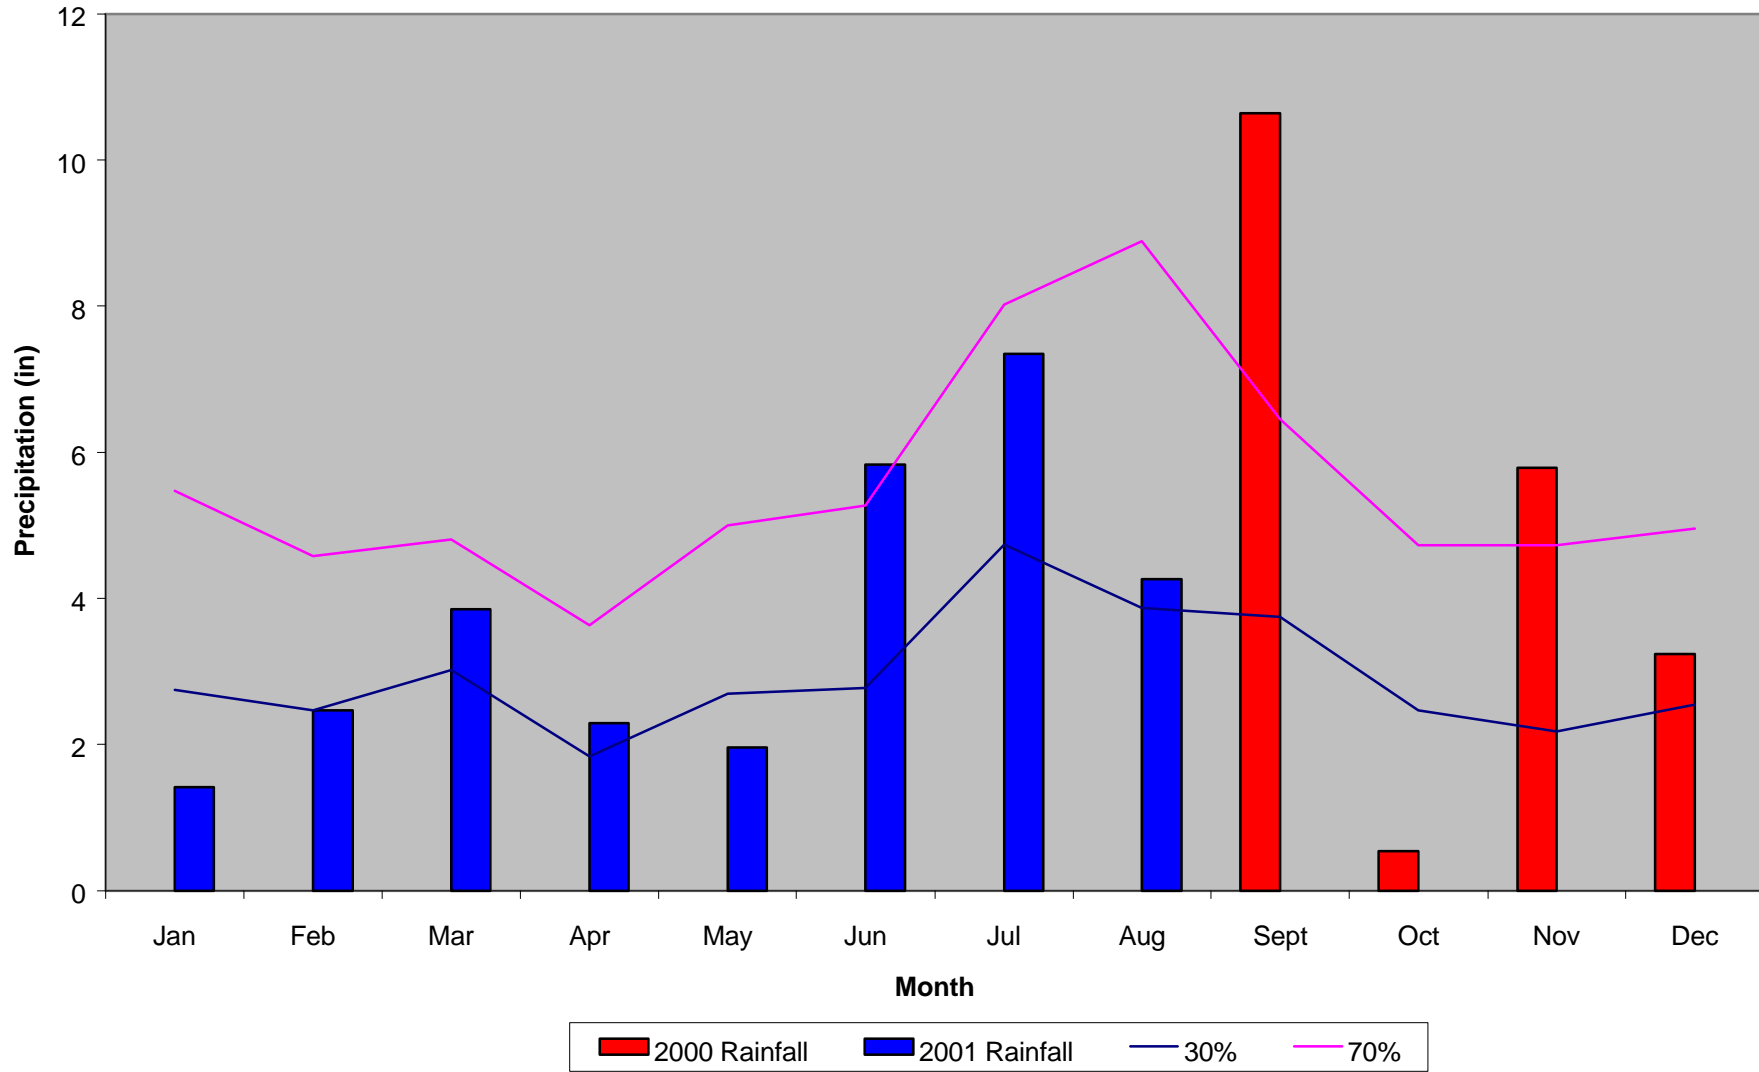
Figure 3. Deer Creek 30-70 Percentile Graph

Figure 4 is a comparison of 2000 and 2001 monthly rainfall to historical precipitation for the area. The two lines represent the 30th and 70th percentiles of monthly precipitation for Morehead City, NC. These percentiles represent monthly rainfall data collected between 1948 and 2001 that was provided by the State Climate Office of North Carolina at NC State University. Because of data availability, the 2001 rainfall encompasses precipitation through August 2001. The 2002 annual report will include a 30-70 percentile graph with the monthly rainfall from September through December of 2001.

Rainfall for the Morehead City vicinity in the past two years ranges from below average to above average.

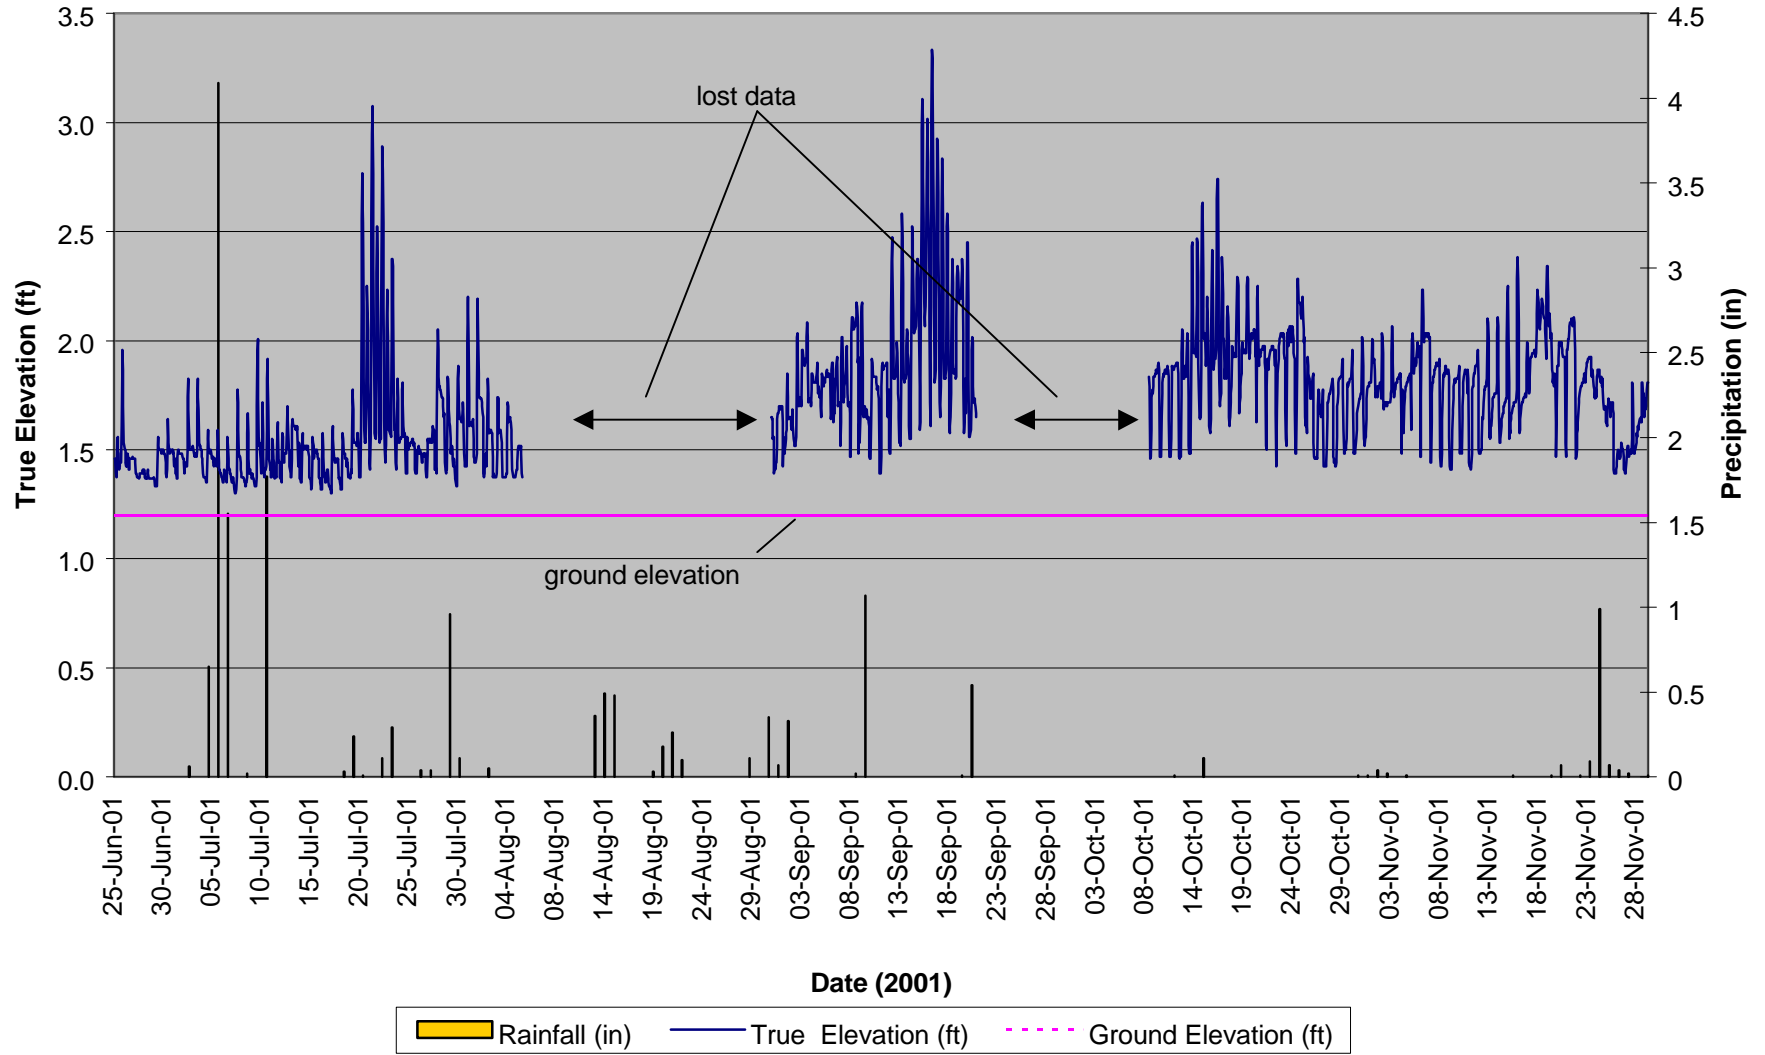
Deer Creek - SG1 Based on Elevation

Gauge 1 data shows that area to be inundated all the time with sporadic fluctuations. The water level never dropped below the ground elevation of 1.2 ft. During field visits, the site was observed flooded most of the time, however, in contrast to the gauge data, the site was observed with no surface water on at least one occasion.

Based on the data obtained from the surface water gauges, the inconsistencies between the gauges and between data and field observations show that some of the data is inaccurate. Therefore, conclusions concerning the success of the hydrology of the site can not be drawn for the 2001 growing season.

Due to the gauge malfunctions shown at this site and other NCDOT mitigation sites, all surface water gauges will be replaced with more reliable Infinity brand gauges for the 2002 growing season.

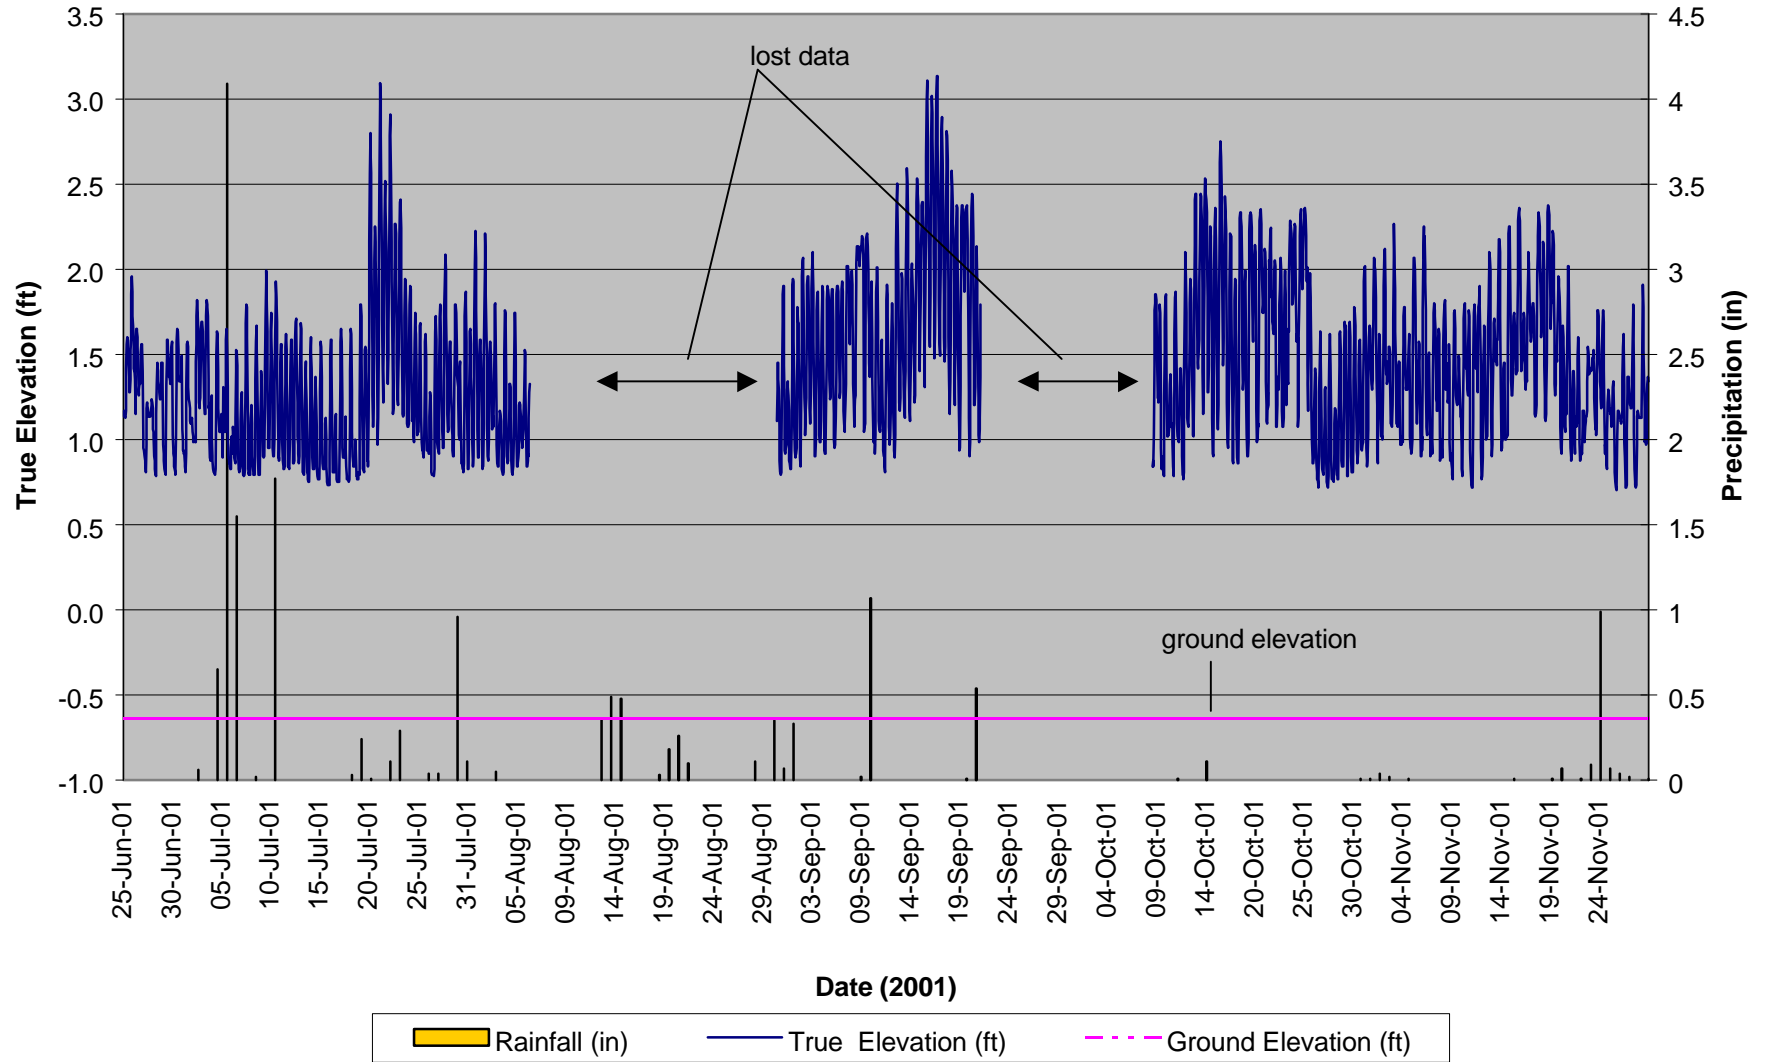
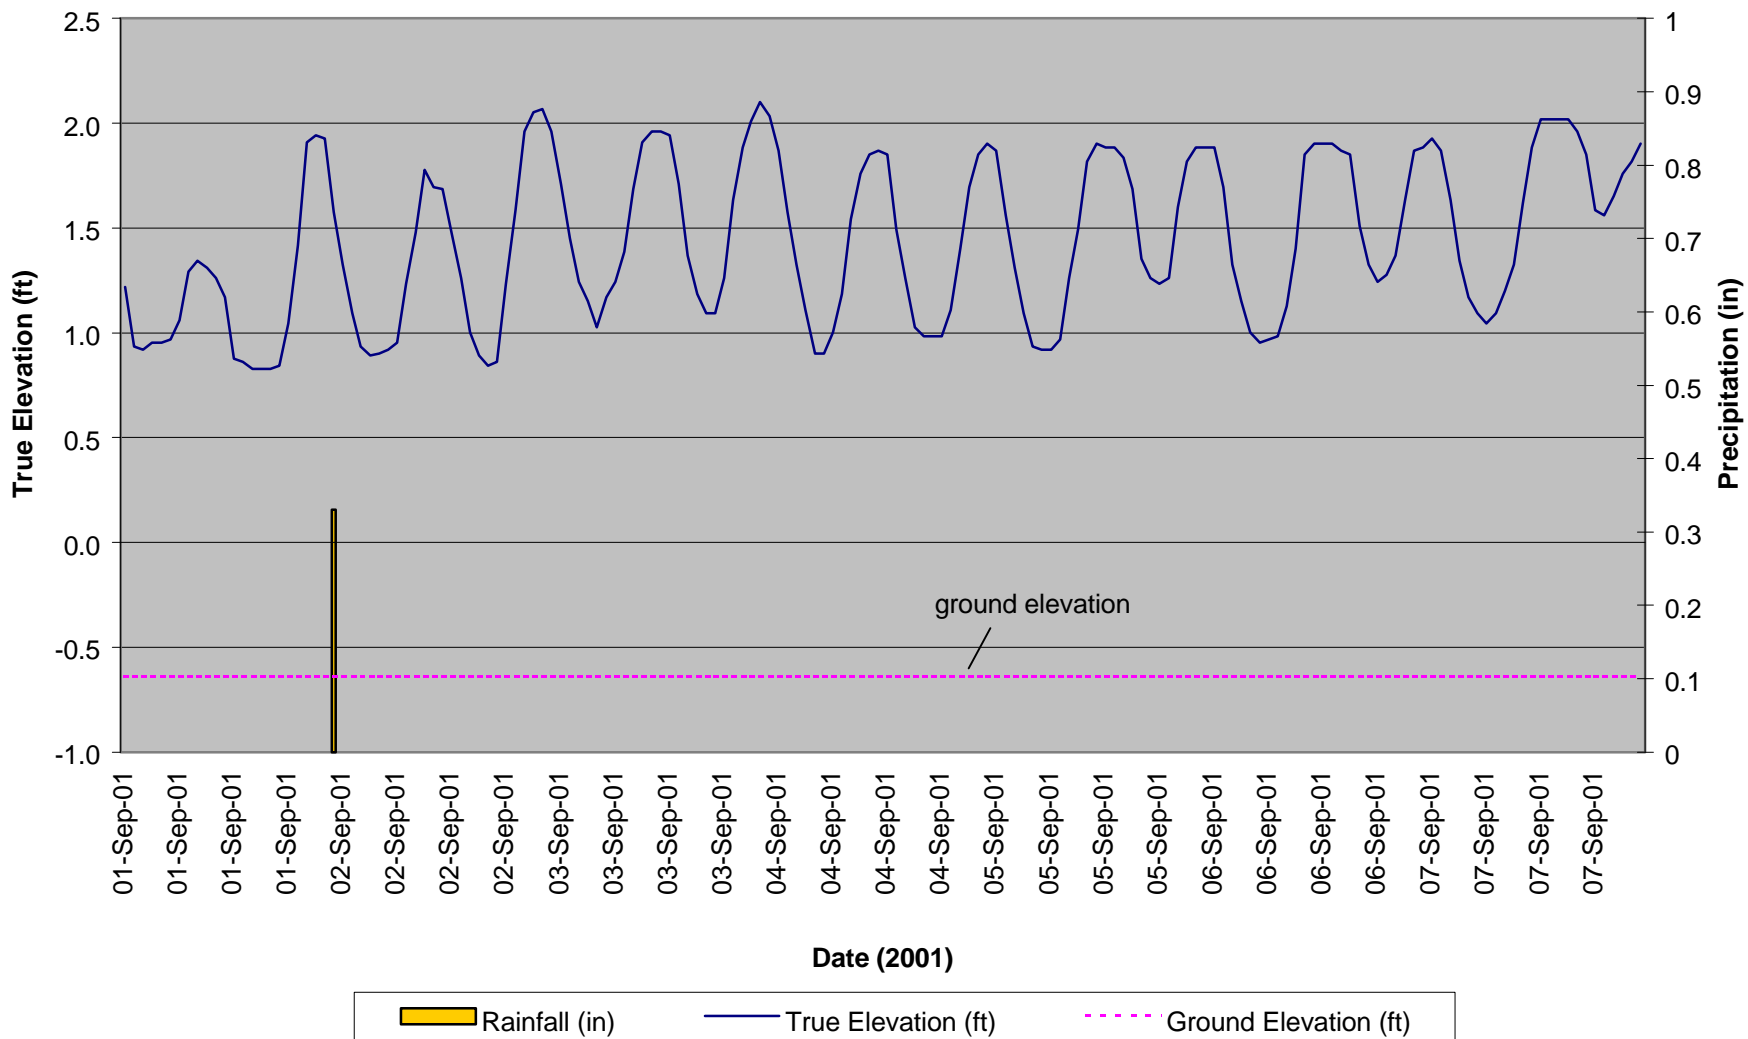
Deer Creek SG-2 Based on Elevation

Because the site is so small, low tide and high tide elevations should be consistent between the three gauges. Gauge 2 shows that the water was fluctuating between elevations of 1.3 ft and 2.5 ft (extremes excluded). Gauge 2 shows that the water was fluctuating between elevations of 0.8 ft and 2.4 ft (extremes excluded). Gauge 3 shows that the water was fluctuating between elevations of 0.2 ft and 2.6 ft (extremes excluded). All three gauges are producing data that is inconsistent with one another. Refer to the graphs in Appendix A that contain individual sample weeks of data for gauge comparison.
