ANNUAL REPORT FOR 2001

Dismal Swamp Mitigation Site
Gates / Perquimans County
Project No. 6.129003T
TIP No. R-2208 WM

Prepared By:
Natural Systems Unit & Roadside Environmental Unit
North Carolina Department of Transportation
December 2001

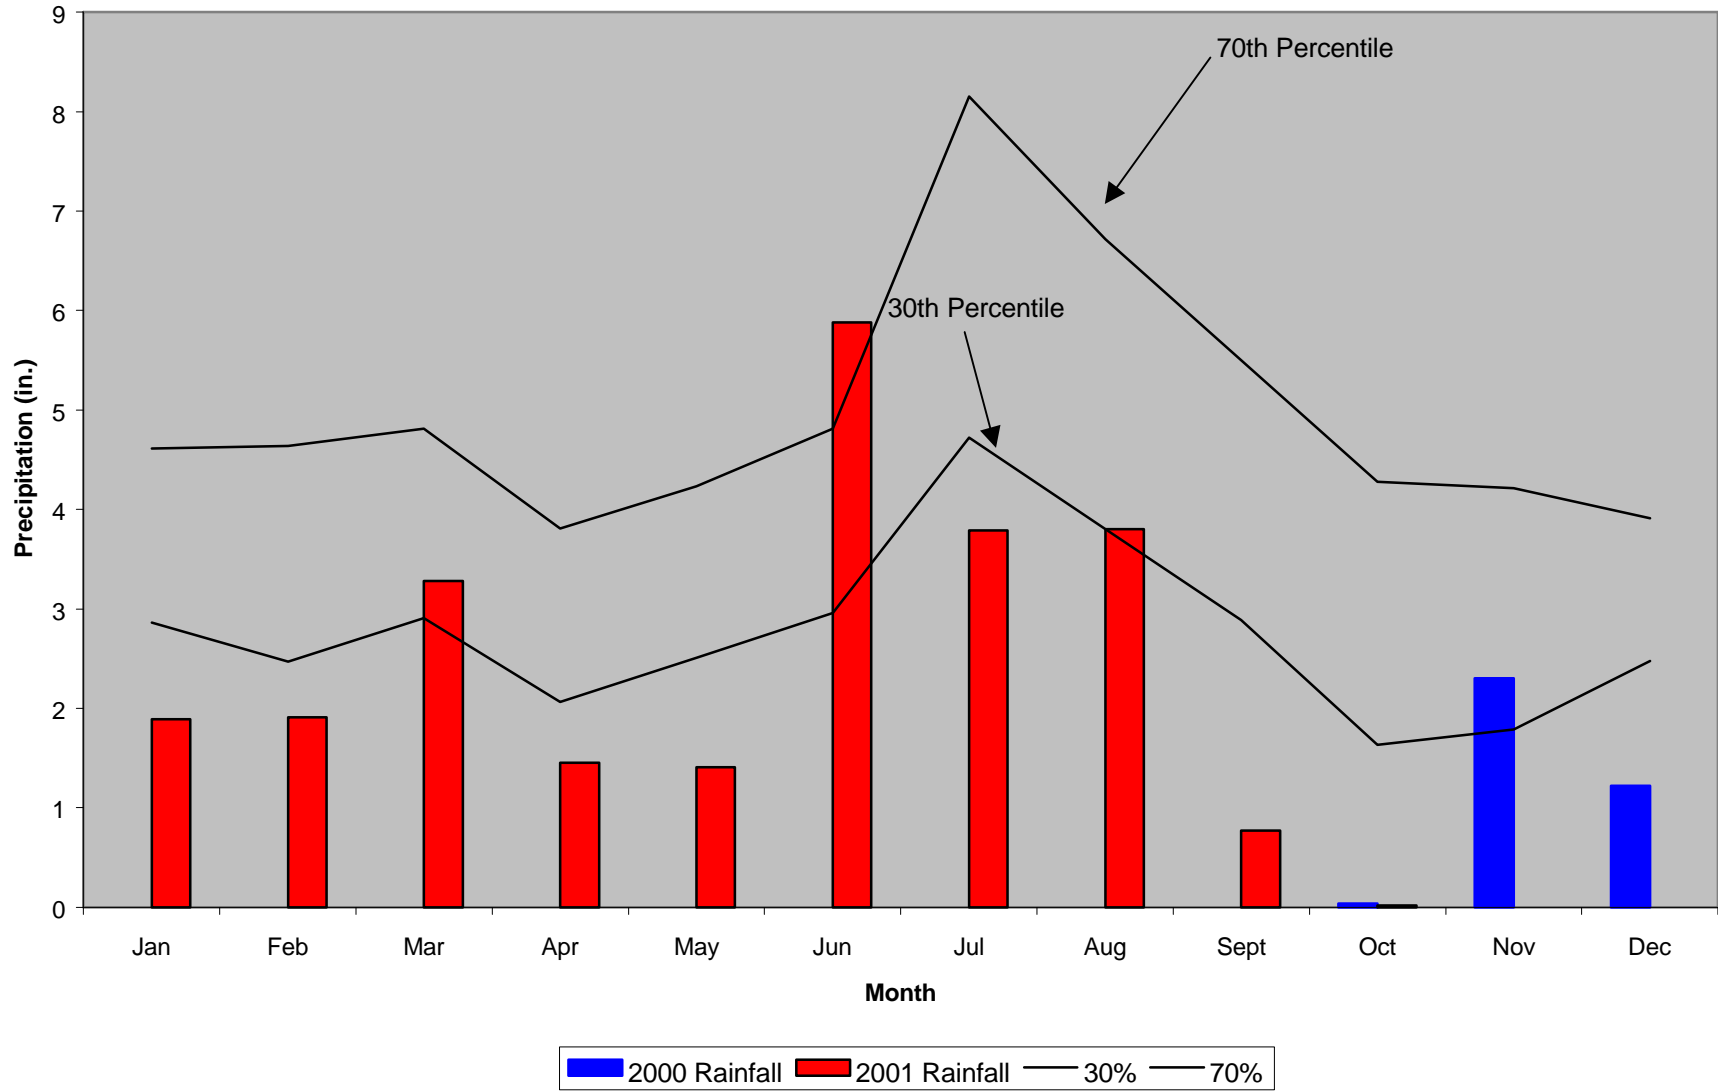
Figure 4. DISMAL SWAMP 30-70 PERCENTILE GRAPH

Figure 4 is a comparison of 2000 and 2001 monthly rainfall to historical precipitation for the area. The two lines represent the 30th and 70th percentiles of monthly precipitation for Elizabeth City, NC. These percentiles represent monthly rainfall data collected between 1931 and 1998 from a National Climatic Data Center rain gauge. The 1998 through 2001 monthly rainfall data was provided by the State Climate Office of North Carolina at NC State University. Because of data availability, the 2001 rainfall encompasses precipitation through November 26, 2001. The 2002 annual report will include a 30-70 percentile graph with the monthly rainfall for December of 2001.

Rainfall for the Elizabeth City vicinity in the past two years ranges from below average to above average. In 2001, 8 of the 11 months of data fell below the 30 - 70 percentile range with only 1 month, June, being above the range. The gauges that met the success criteria did not meet only during an above average period of rainfall. Overall, rainfall was below average for 2001.

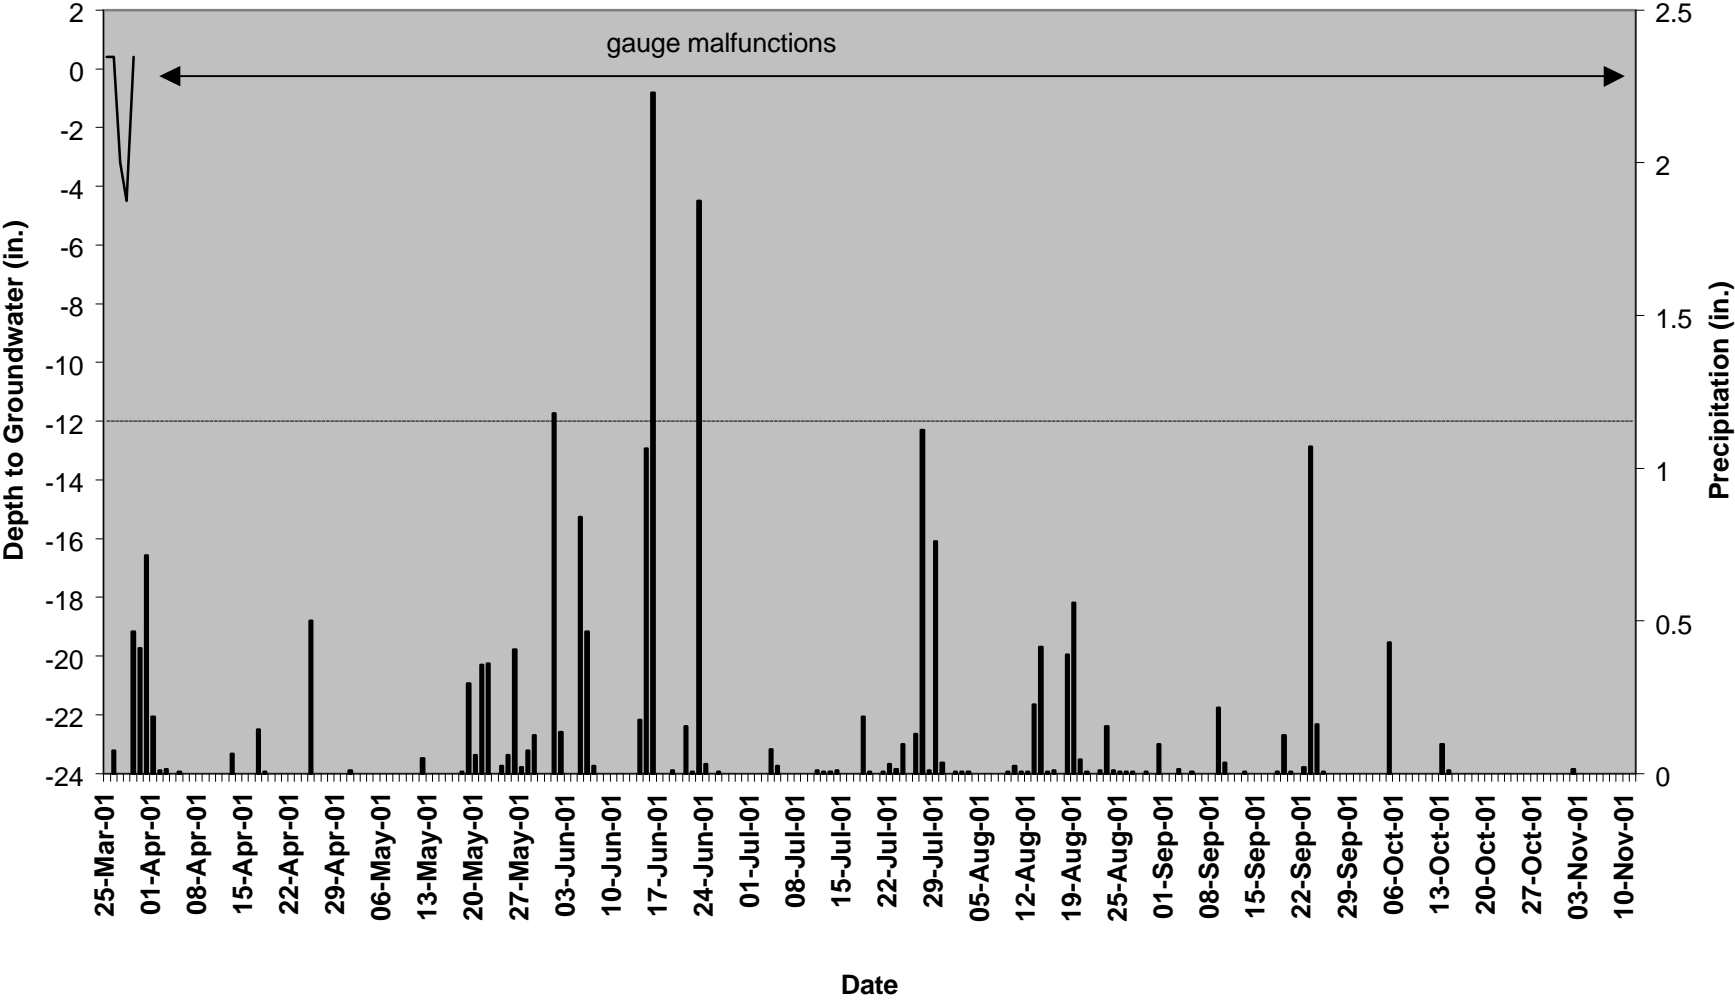
Dismal Swamp-G10

*Gauge DS-10 only had 6 days of data collected due to continuous gauge problems. The percentage does not reflect data from the entire growing season.

Rainfall
 S158B14
 DS-10
 Required Depth

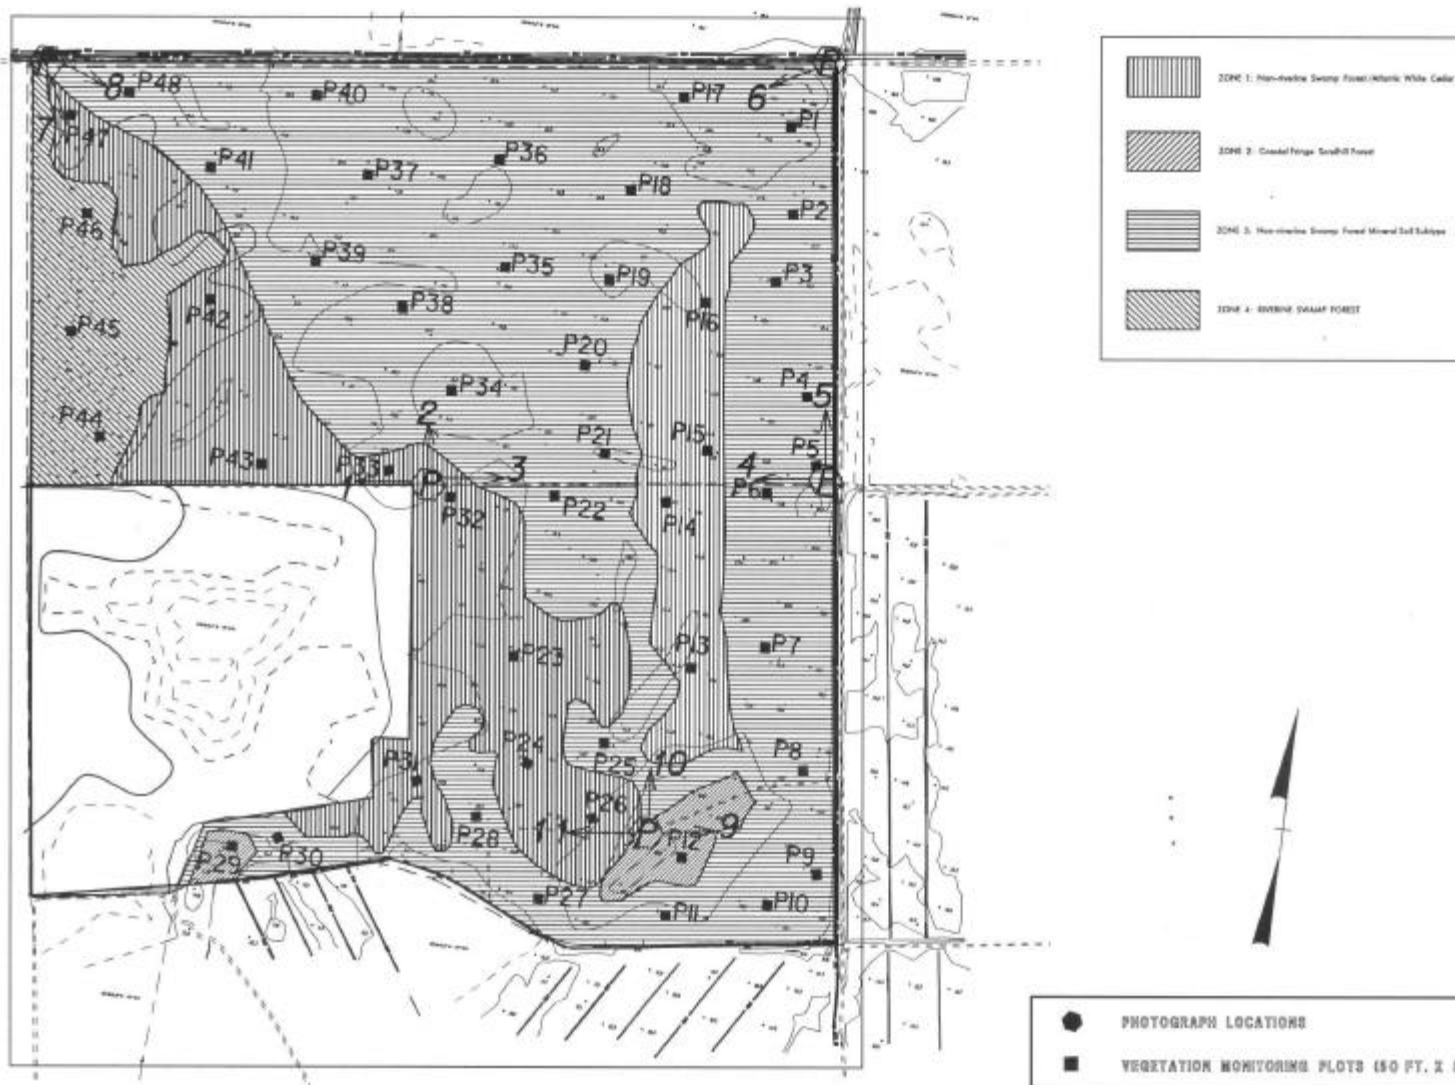
DISMAL SWAMP MITIGATION SITE PHOTO AND PLOT LOCATIONS

2001 MONITORING
