# ANNUAL REPORT FOR 2001

**Long Creek Mitigation Site  
Mecklenburg County  
Project No. 8.U672204  
TIP No. R-2248**

Natural Systems Unit & Roadside Environmental Unit  
North Carolina Department of Transportation  
December 2001

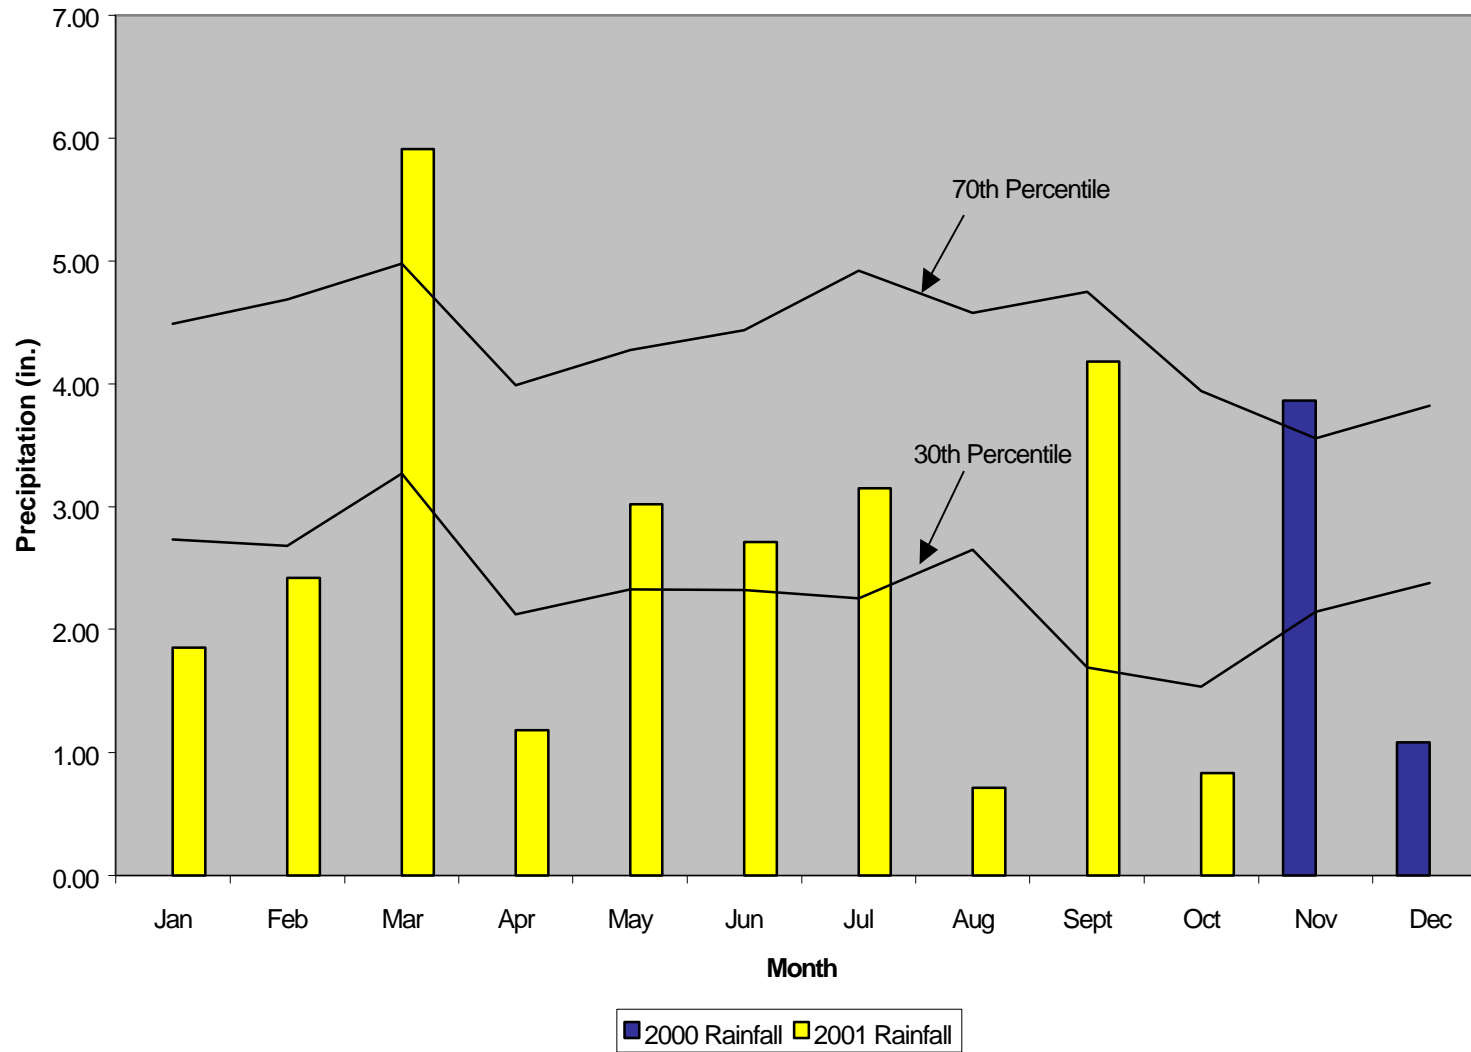
**Figure 4.** Long Creek 30-70 Percentile Graph, Charlotte, NC

Figure 4 is a comparison of the 2001 monthly rainfall to historical precipitation (collected between 1948 and 2000) for the Charlotte area. Rainfall data presented in the figure represents an average of the onsite gauges. It is assumed that, if the 2001 rainfall totals represented by bars fall between the average precipitation lines for each month, then the local climate was experiencing average conditions for that particular region. This comparison gives an indication of how 2001 relates to historical data in terms of average rainfall.

Months below the normal rainfall include: January, February, April, August, and October. Months with normal rainfall include: May, June, July, and September. The only month with above normal rainfall conditions was March. November and December 2001 rainfall were not available for this report, so data from 2000 was used.

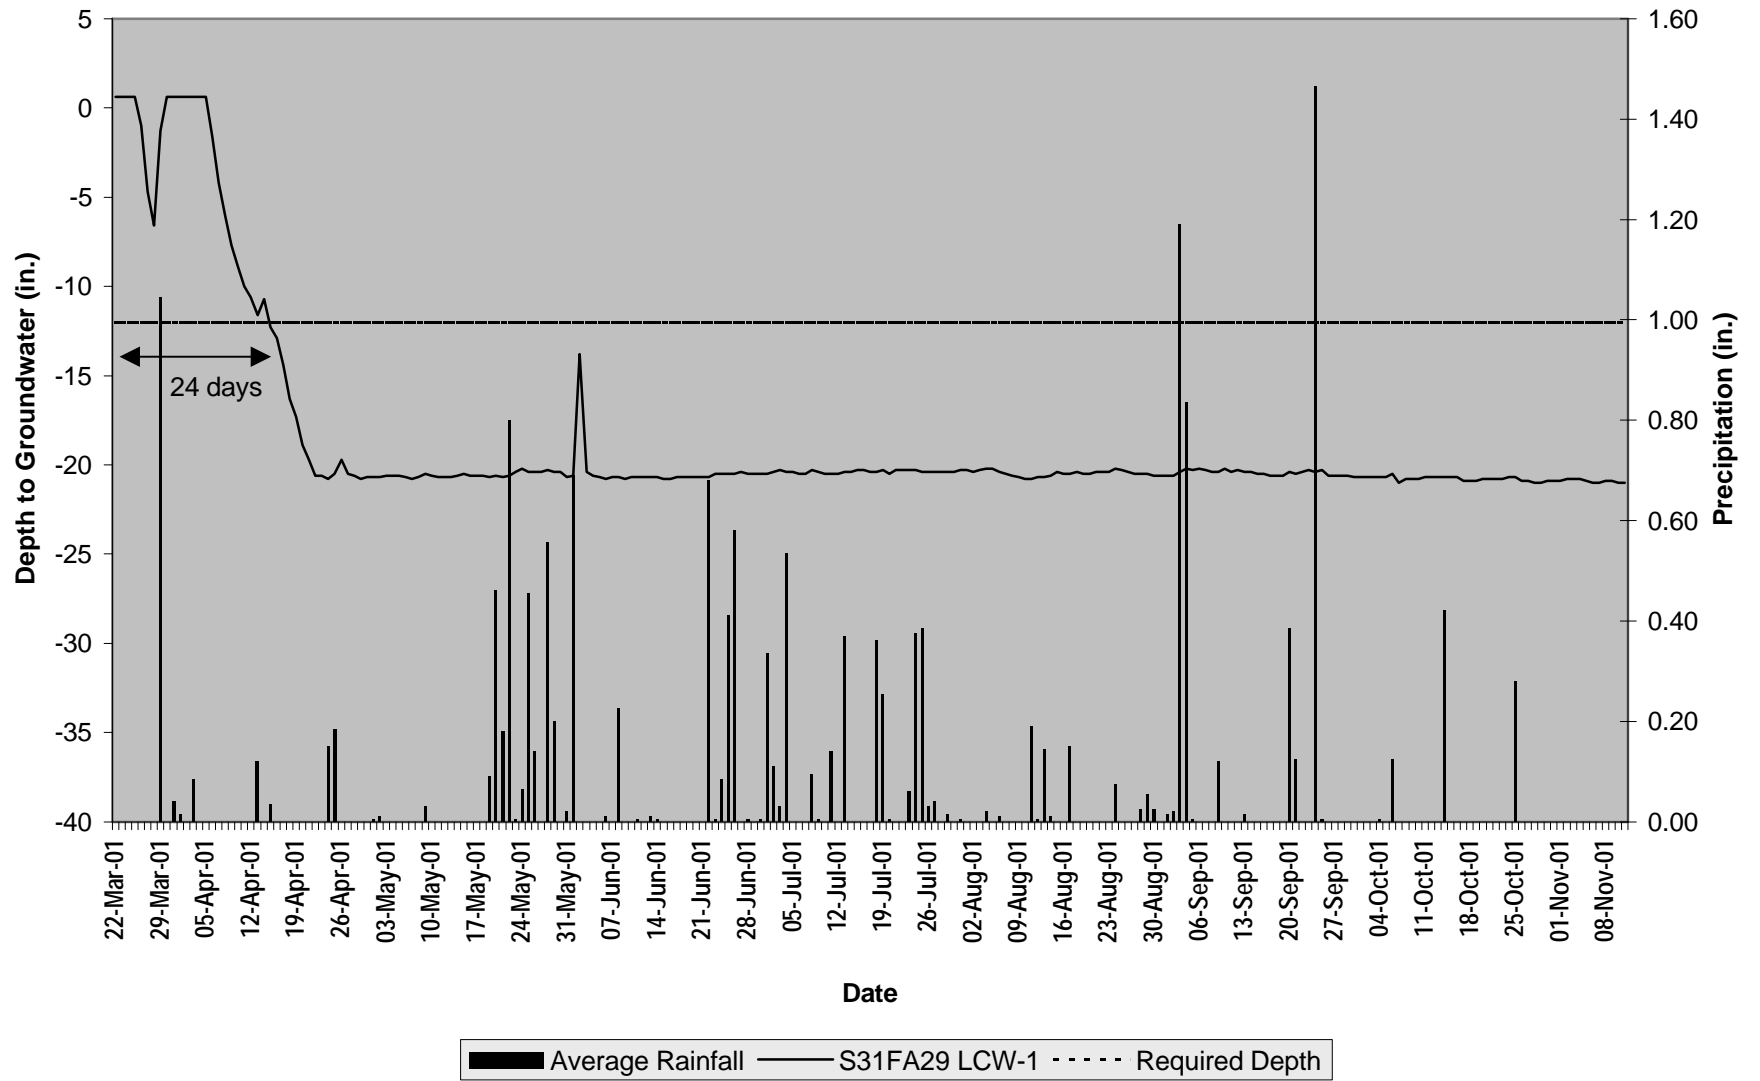
# Long Creek LCW-1

Appendix A contains charts of the water depth for each monitoring gauges and surface gauges. Precipitation is shown on each graph as bars. These graphs show the reaction at each monitoring location of the groundwater level to specific rainfall events. If 5% of the growing season is met, the maximum number of consecutive days is noted on each graph. Several of the data sets were interrupted due to dead batteries; specifically groundwater gauges 2, 14, 23, and 24. These interruptions are noted on the graphs.

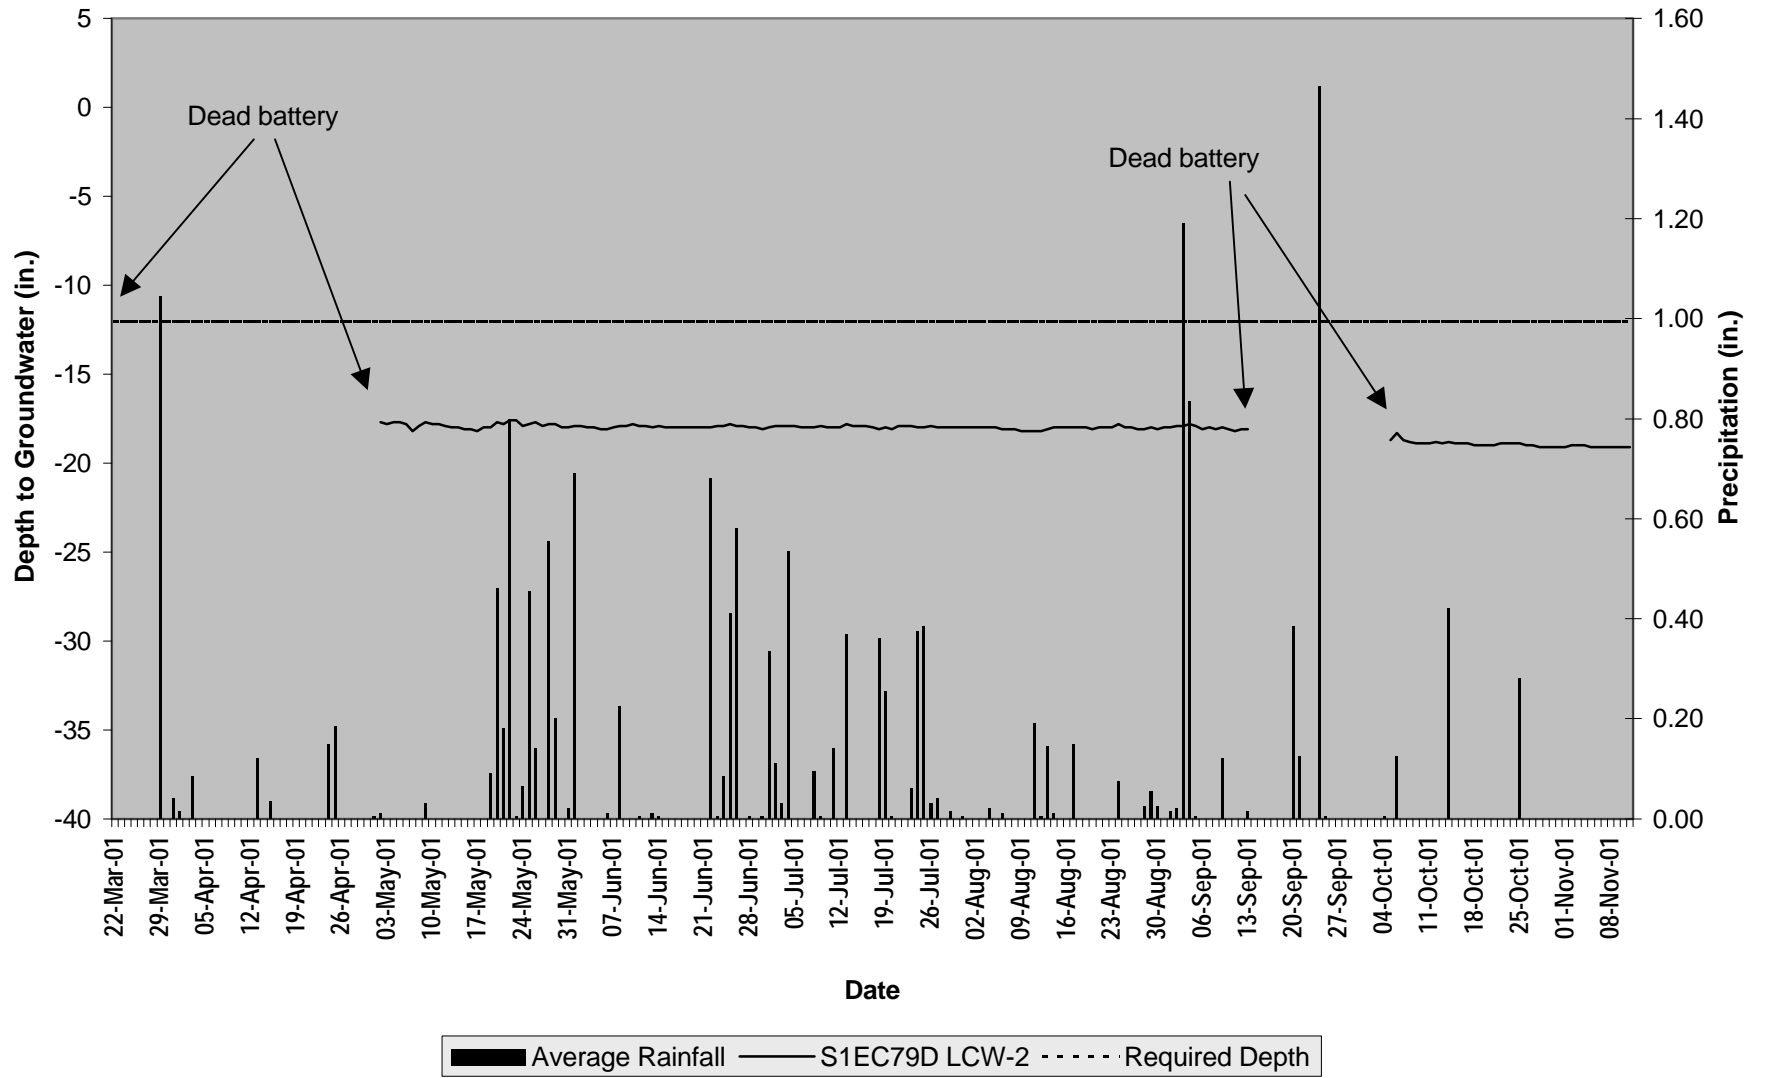
# Long Creek LCW-2

\* Gauge malfunctioned from Mar 22 – May 1. \*\* Gauge malfunctioned from Apr 12 – May 1.
