ANNUAL REPORT FOR 2001

Mashoes Road Mitigation Site

Dare County

Project No. 8.T051402

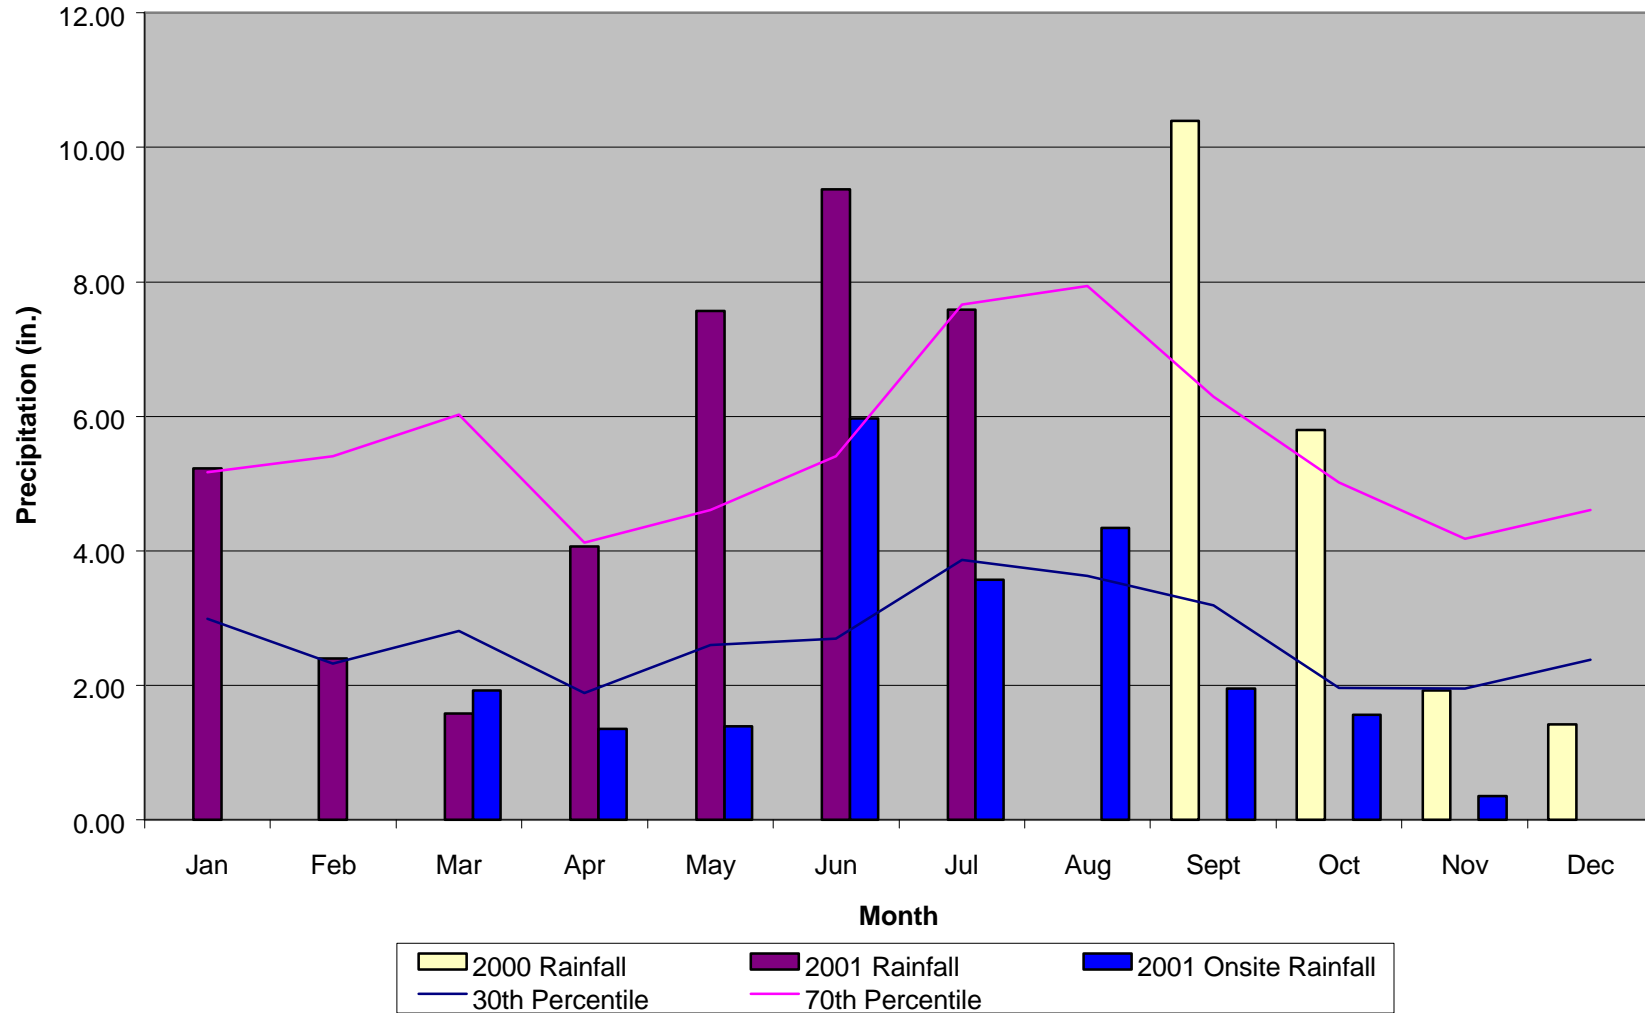
**FIGURE 4: Mashoes Road 30-70 Percentile Graph
Dare County**

Figure 4 represents an examination of the local climate in comparison with historical data in order to determine whether 2001 was “average” in terms of climate conditions. The figure compares the rainfall from 2001 with that of historical rainfall (data collected between 1931 and 1999). All rainfall data was collected from the NC State Climate Office. The graph shows 2000 rainfall totals recorded at the Manteo Airport from September through December; the graphs also shows 2001 rainfall totals recorded at the Manteo Airport through July. Information from the Manteo Airport for the months of August through December was not available at this writing of this report. Rainfall data for August through December 2001 will be presented in the 2002 Annual Monitoring Report. On-site rain gauge information is also shown for the duration of the growing season (March through November).

According to the on-site rain gauge, 2001 has been a dry year overall. Most readings fall below or barely within the 30th percentile. However, the rainfall data obtained from the Manteo airport shows that rainfall was average to above average for 2001. Figure 5 shows a discrepancy between monthly totals on site versus the data from the Manteo airport. For 2001, March was below normal, whereas, May and June were higher than normal. Overall so far, 2001 has been an average year in terms of precipitation.

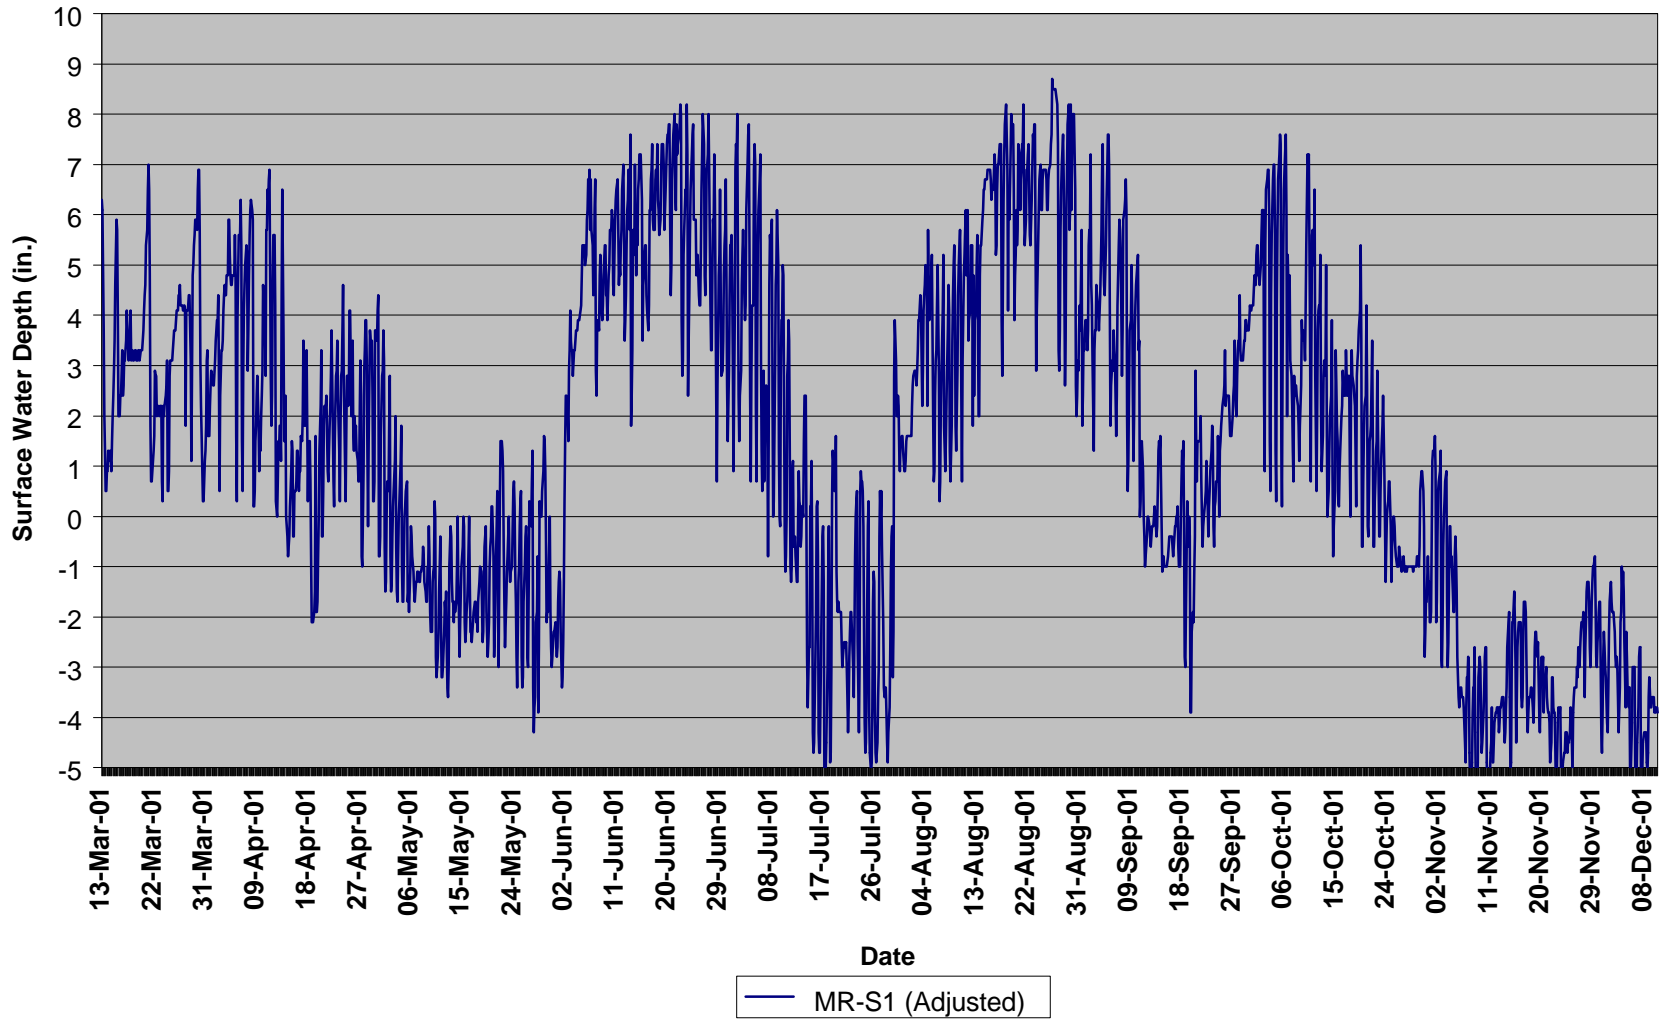
Mashoes Road - Surface Gauge S1

Appendix A contains a plot of the groundwater depth for each monitoring gauge. The maximum number of consecutive days that the gauge met success above this 12-inch depth is noted on each graph. Data determined to be erroneous was omitted; therefore, some gaps appear in the plots.

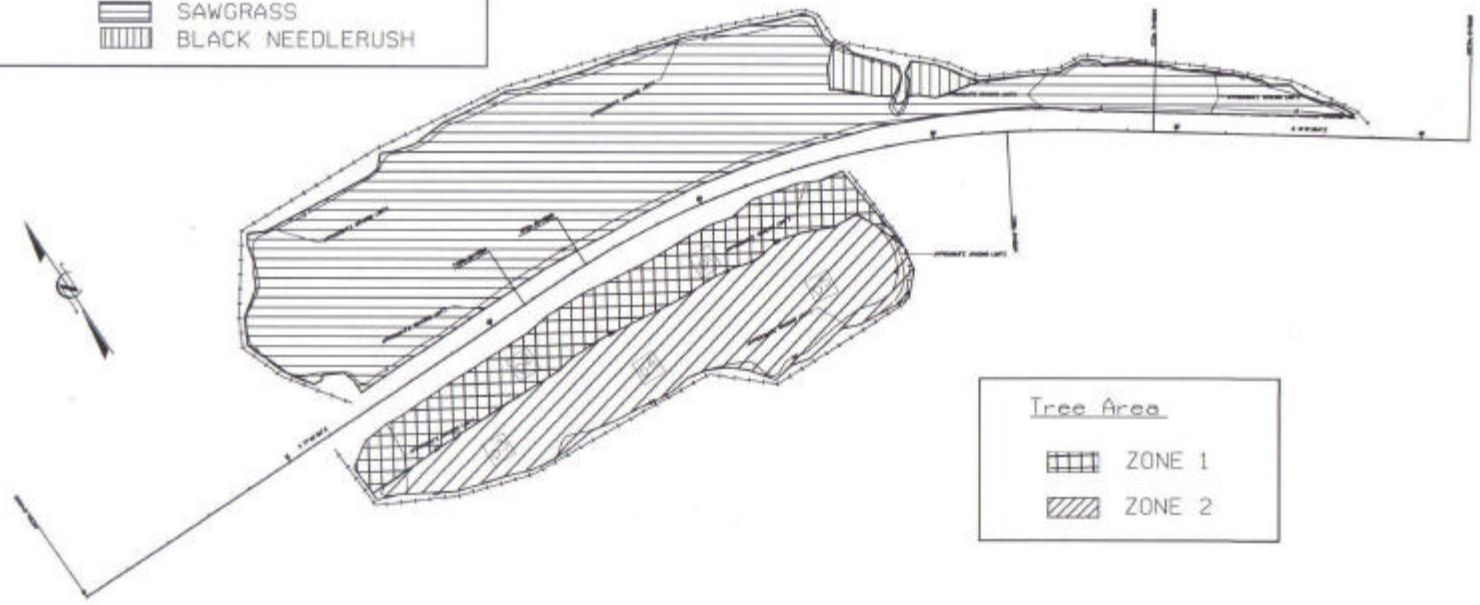
Dare County, North Carolina
 Mashoes Road Mitigation Site
 Planting Plan

Marsh Area

SAWGRASS
-

BLACK NEEDLERUSH

Tree Area

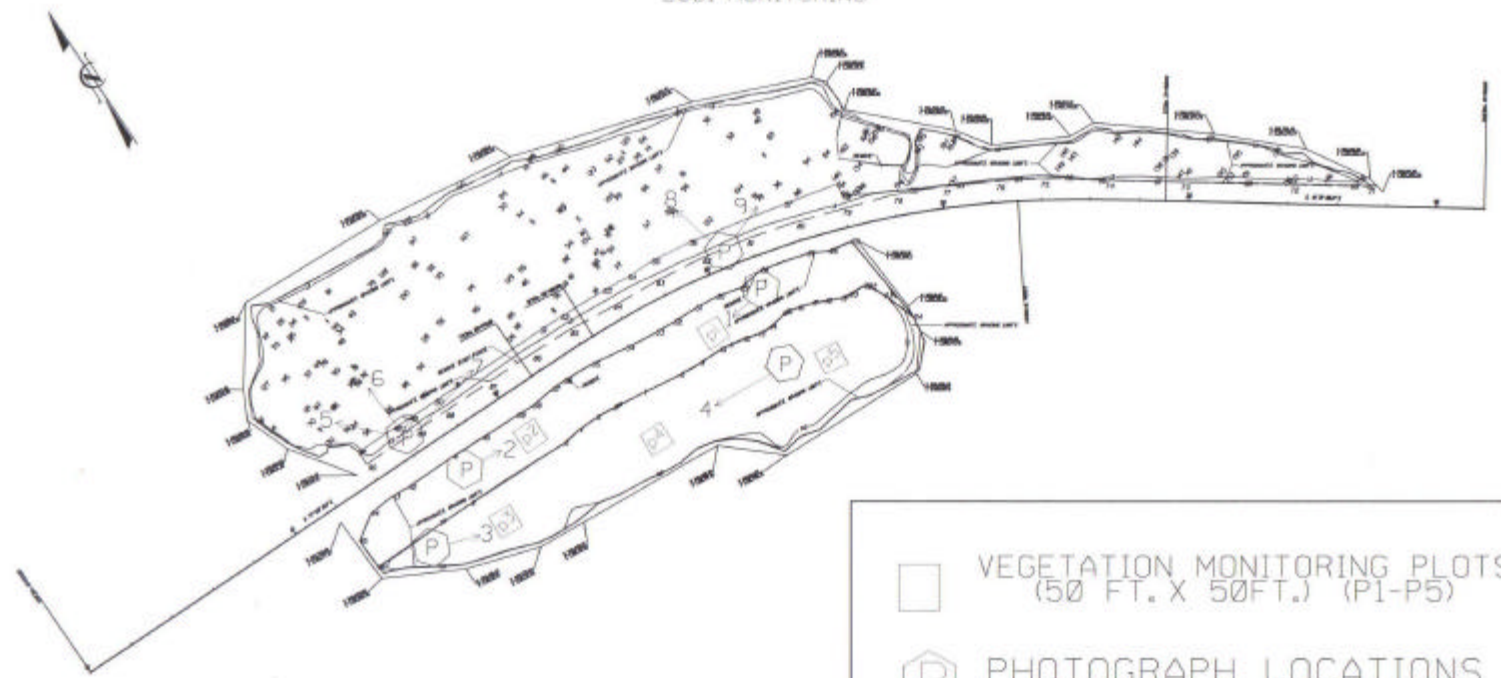
DARE COUNTY, NORTH CAROLINA
 MASHOES ROAD MITIGATION SITE
 Photo and Vegetation Plot Locations
 2001 MONITORING

VEGETATION MONITORING PLOTS (50 FT. X 50 FT.) (P1-P5)
 	PHOTOGRAPH LOCATIONS
