ANNUAL REPORT FOR 2001

***Mud Creek Mitigation Site
Henderson County
Project No. 8.T842404
TIP No. A-10 WM***

Prepared By:
Natural Systems Unit & Roadside Environmental Unit
North Carolina Department of Transportation
December 2001

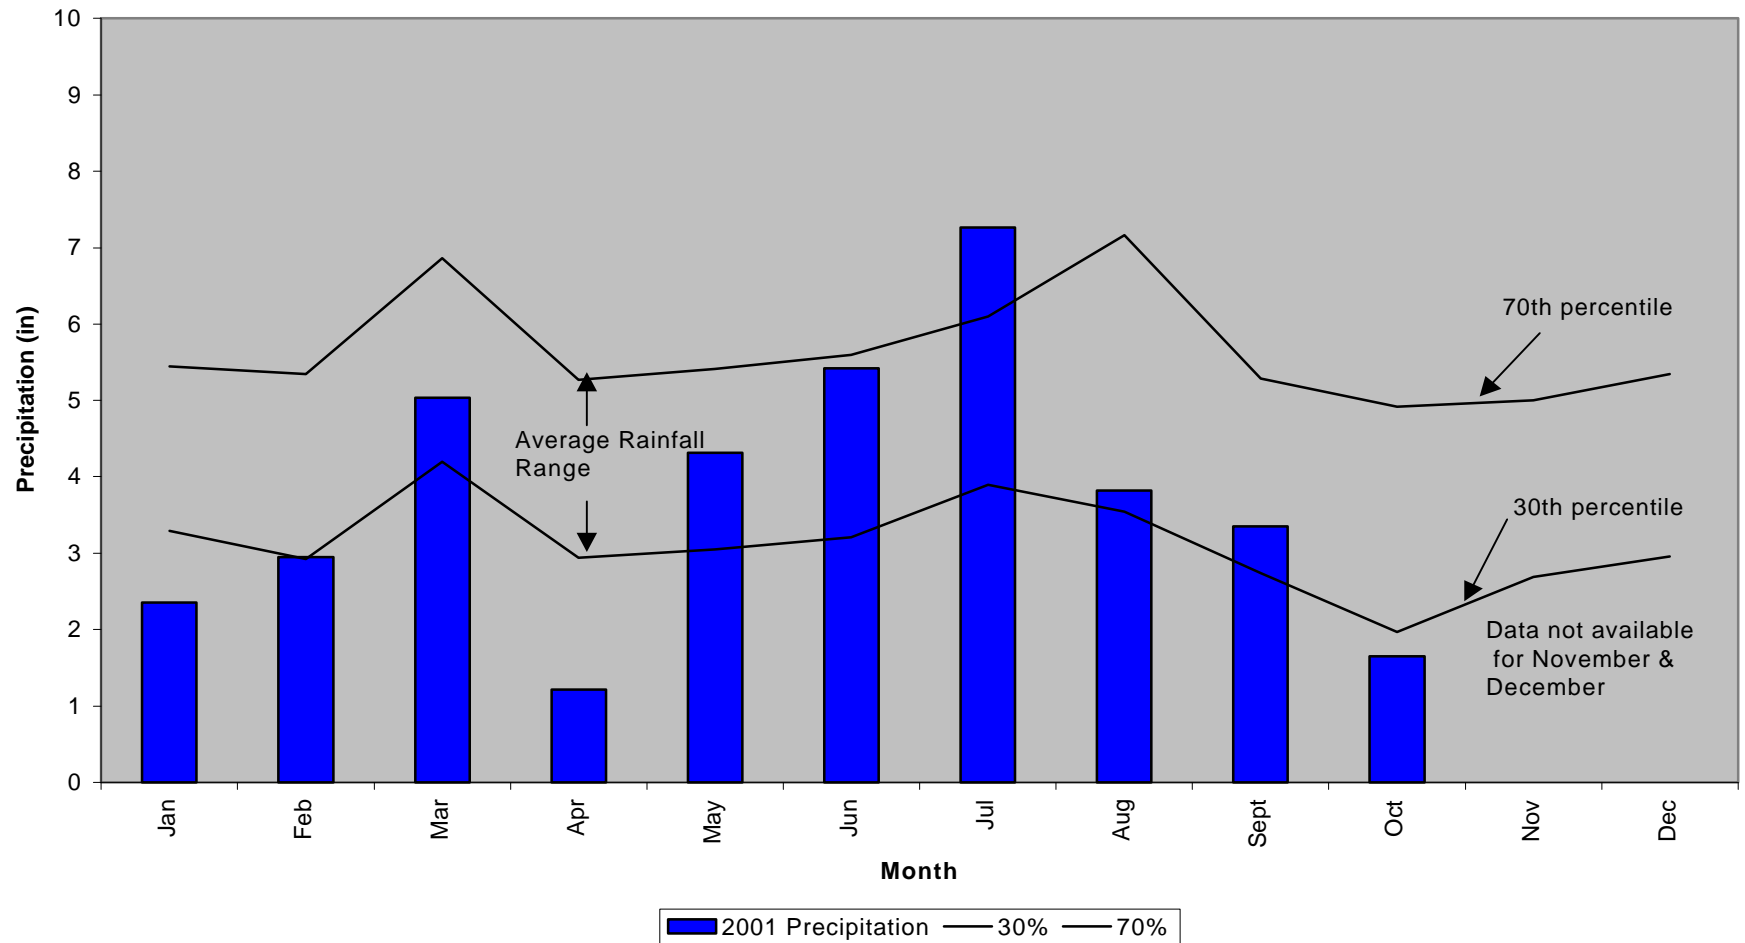
FIGURE 3

Figure 4 is a comparison of the 2001 monthly rainfall with the historical rainfall for the area. The lines represent the 30th and 70th percentiles of monthly precipitation for Hendersonville, North Carolina. These percentiles are based on rainfall data collected

between 1966 and 1996 from a National Climatic Data Center official gauge and serve as the historical data for the area. The percentiles create the “normal range” for rainfall for the vicinity.

The bars on the graph represent the total monthly rainfall from January through November of 2001. The 2001 rain data was provided by the on-site Infinity rain gauge. The historic rainfall data was obtained from the North Carolina State Climatic Office (NCSCO) in Hendersonville, North Carolina.

Data for Henderson County shows that the area experienced normal rainfall during the months of March, May, June, August, and September. Henderson County was drier than average during January, February, April, and October. July was moderately above average. November and December data was not included since the end of the growing season is October 29th.

Mud Creek 30 - 70 Percentile Graph Hendersonville, NC

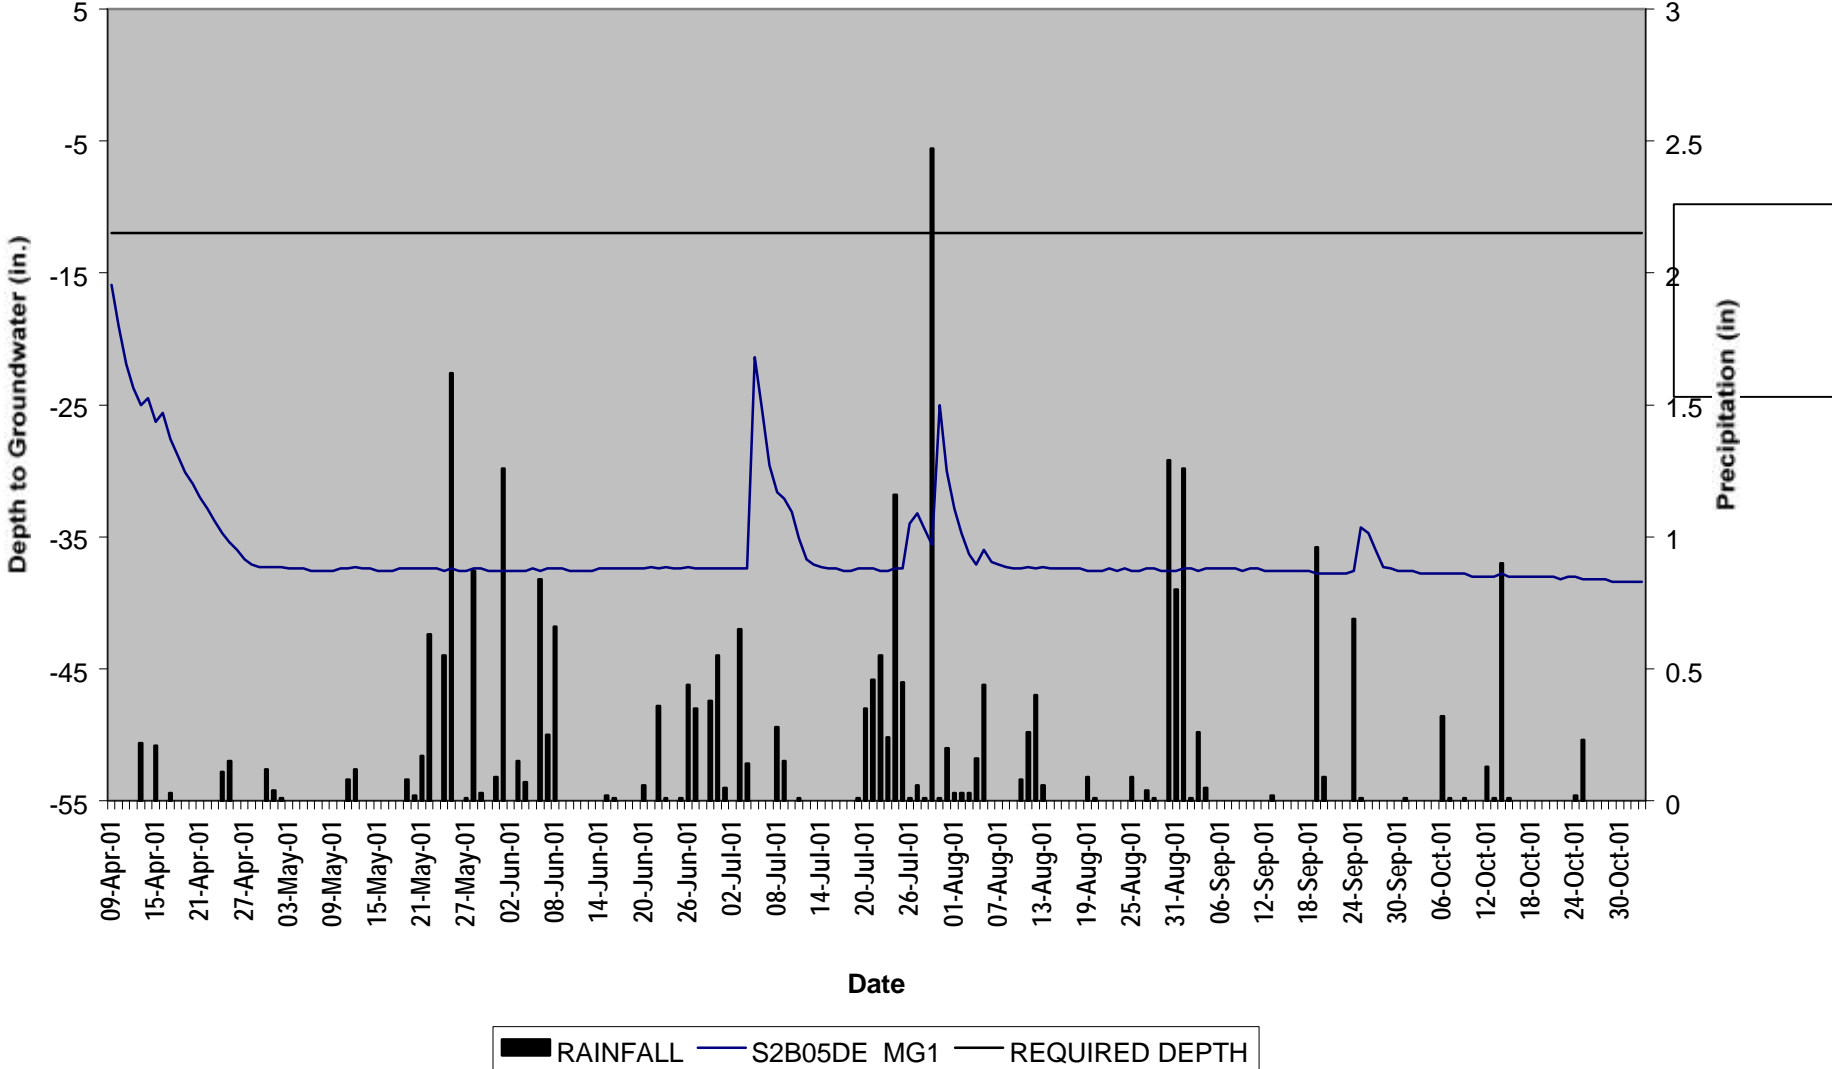
2001 Mud Creek MG1

During the 2001 growing season, groundwater was never within twelve inches of the surface at MG-1, MG-2, MG-6, and MG-8. For the remaining gauges, groundwater levels were within twelve inches of the surface less than 5% of the growing season, a decline in performance over the monitoring period for 2000: MG-3 (two days), MG-4 (three days), MG-5 (six days) MG-7 (two days), MG-9 (one day), and MG-10 (ten days) for monitoring year 2001.

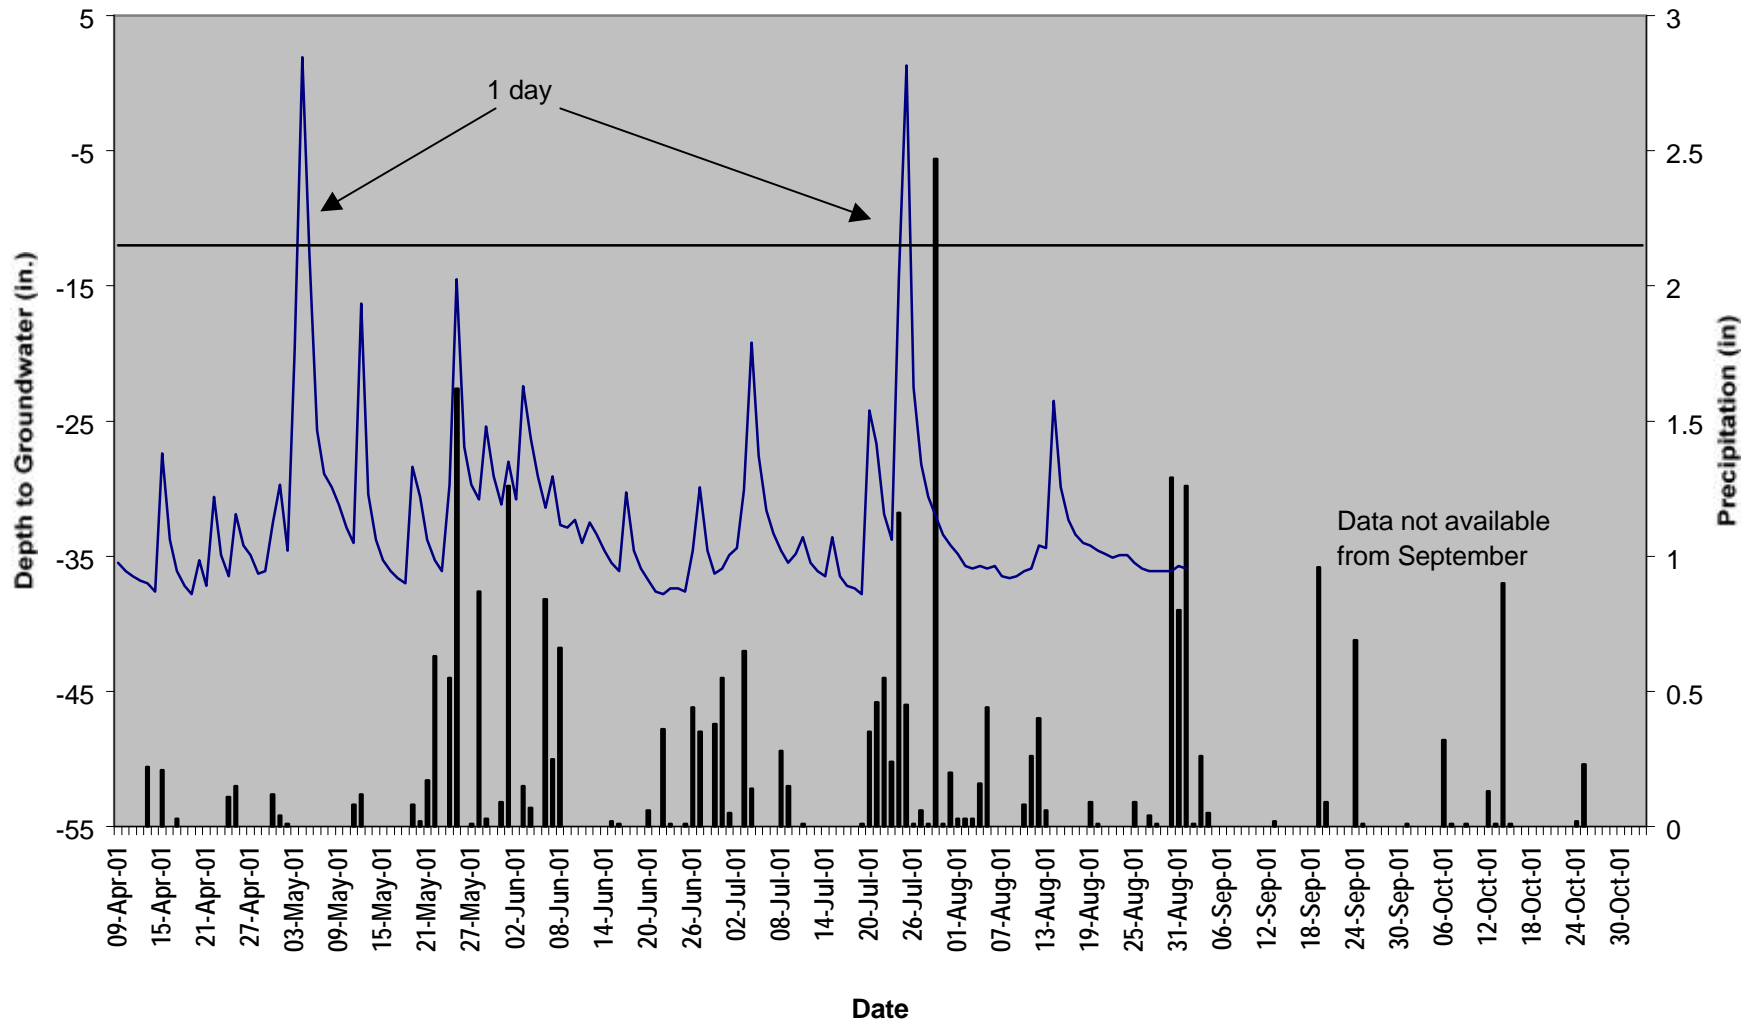
2001 Mud Creek MG-9

Also of note is that MG-4, MG-5, and MG-6 is located in an area, which was delineated as a wetland and confirmed by the USACE on December 6, 1995. In addition, data for MG-9 was not available from the beginning of September to the end of the growing season.

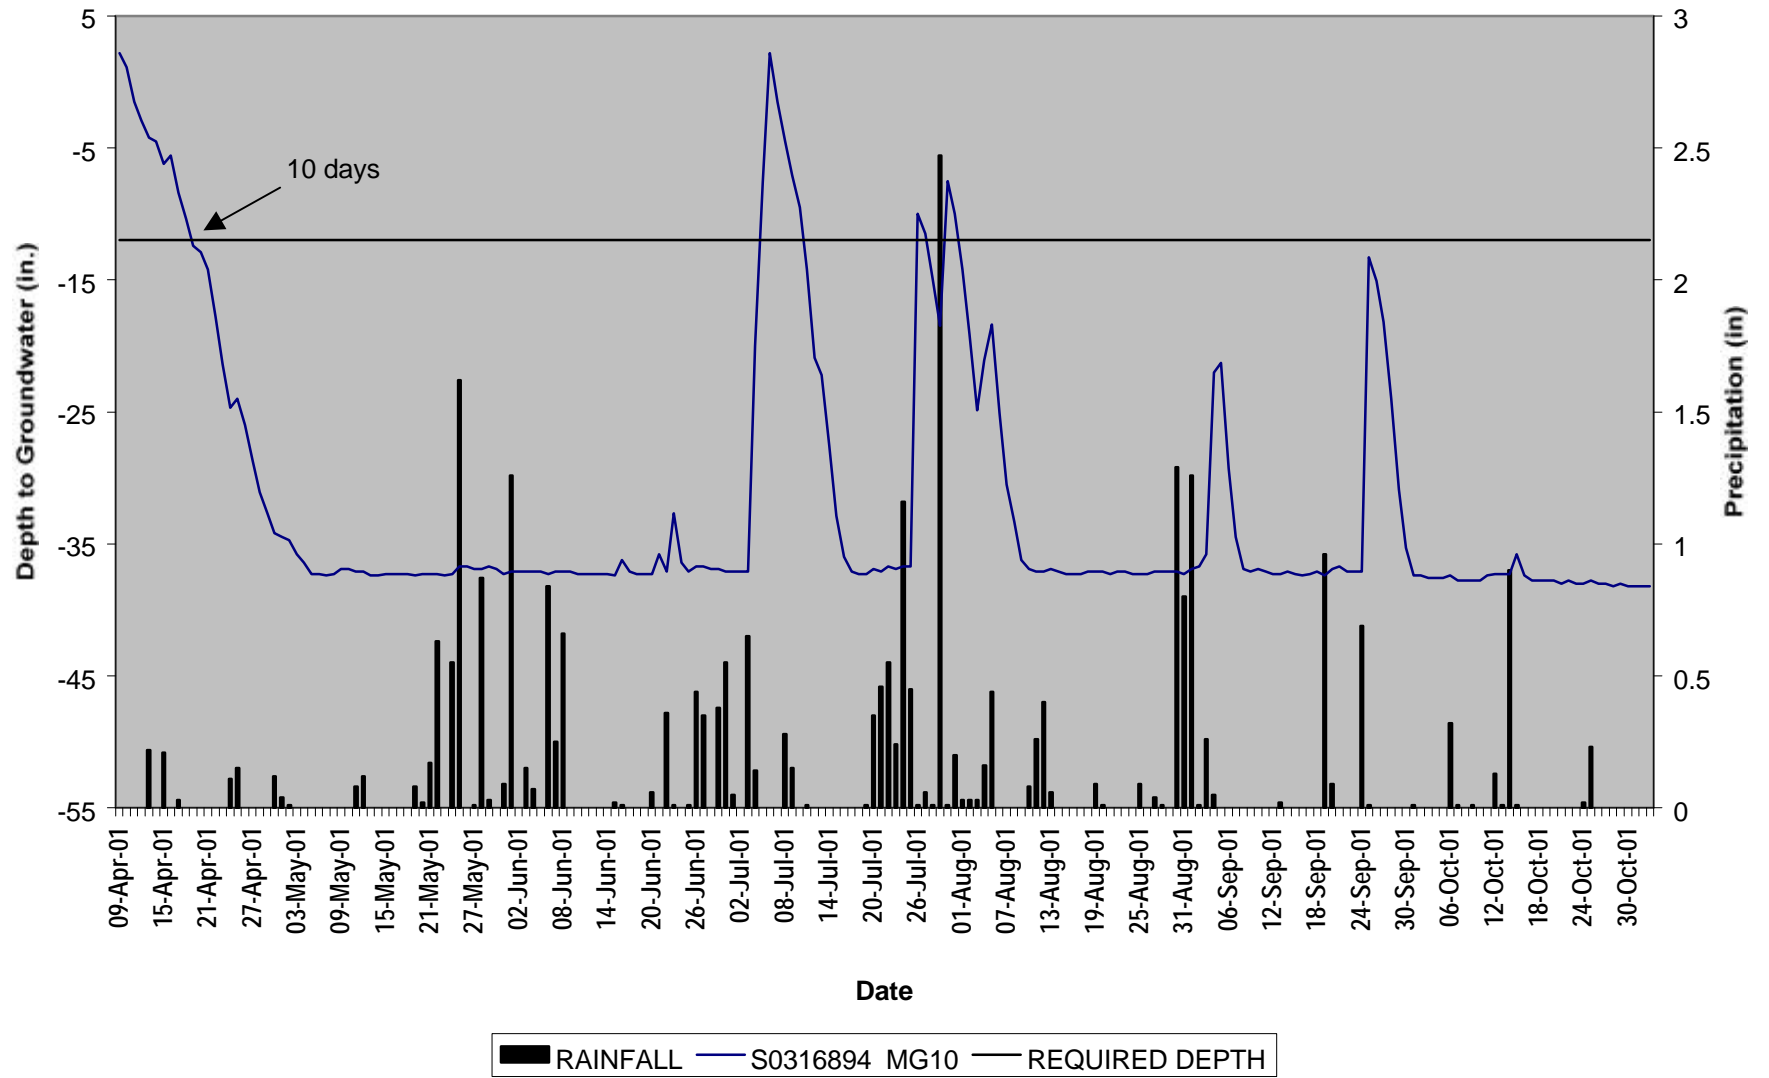
2001 Mud Creek MG-10

For the 2001 monitoring period no gauges indicated wetland hydrology. MG-10 displayed the overall highest reading of ten days, yet was still below 5%. Of the remaining nine gauges MG-1, MG-2, MG-3, MG-7 and MG-8 are located in areas of constructed wetland. MG-4 is located in an existing wetland that has been impacted. MG-5 and MG-6 are located in an existing wetland that has not been impacted. MG-9 is located in one of the lower portions of the site.

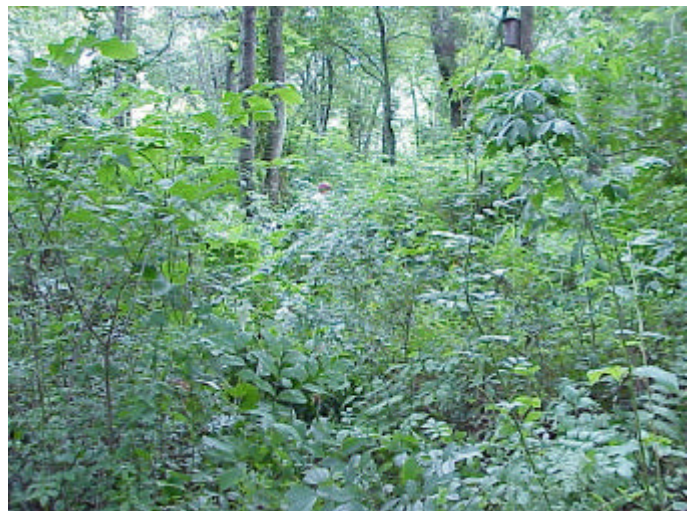
Photo 6 (Transect)

Transect: A 100' x 30' (0.07 acre) transect was installed within the Wetland Enhancement Area during the July 2001 monitoring visit. GPS coordinates for this transect could not be obtained due to the dense tree canopy cover. The approximate location of the transect is shown on the attached map. The following species were located and identified within this transect: 25 Green Ash, 5 Tulip Poplar, 5 Blackgum, 10 River Birch, and 5 Willow Oak.
