ANNUAL REPORT FOR 2001

New Light Creek Mitigation Site

Wake County

Project No. 8.U401721

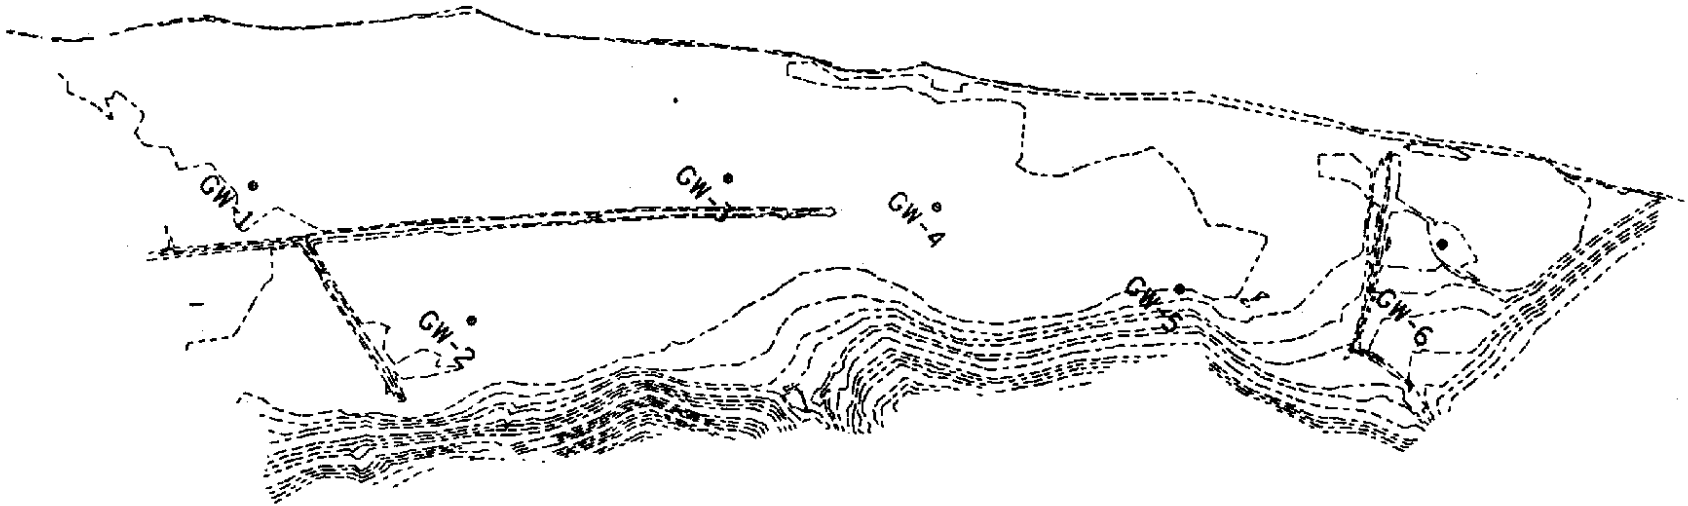
Figure 2. Monitoring Gauge Location Map

In March of 1999, six monitoring gauges were installed across the site (Figure 2). The automatic monitoring gauges record daily readings of groundwater depth. This represents the third full growing season that the monitoring gauges have been in place.

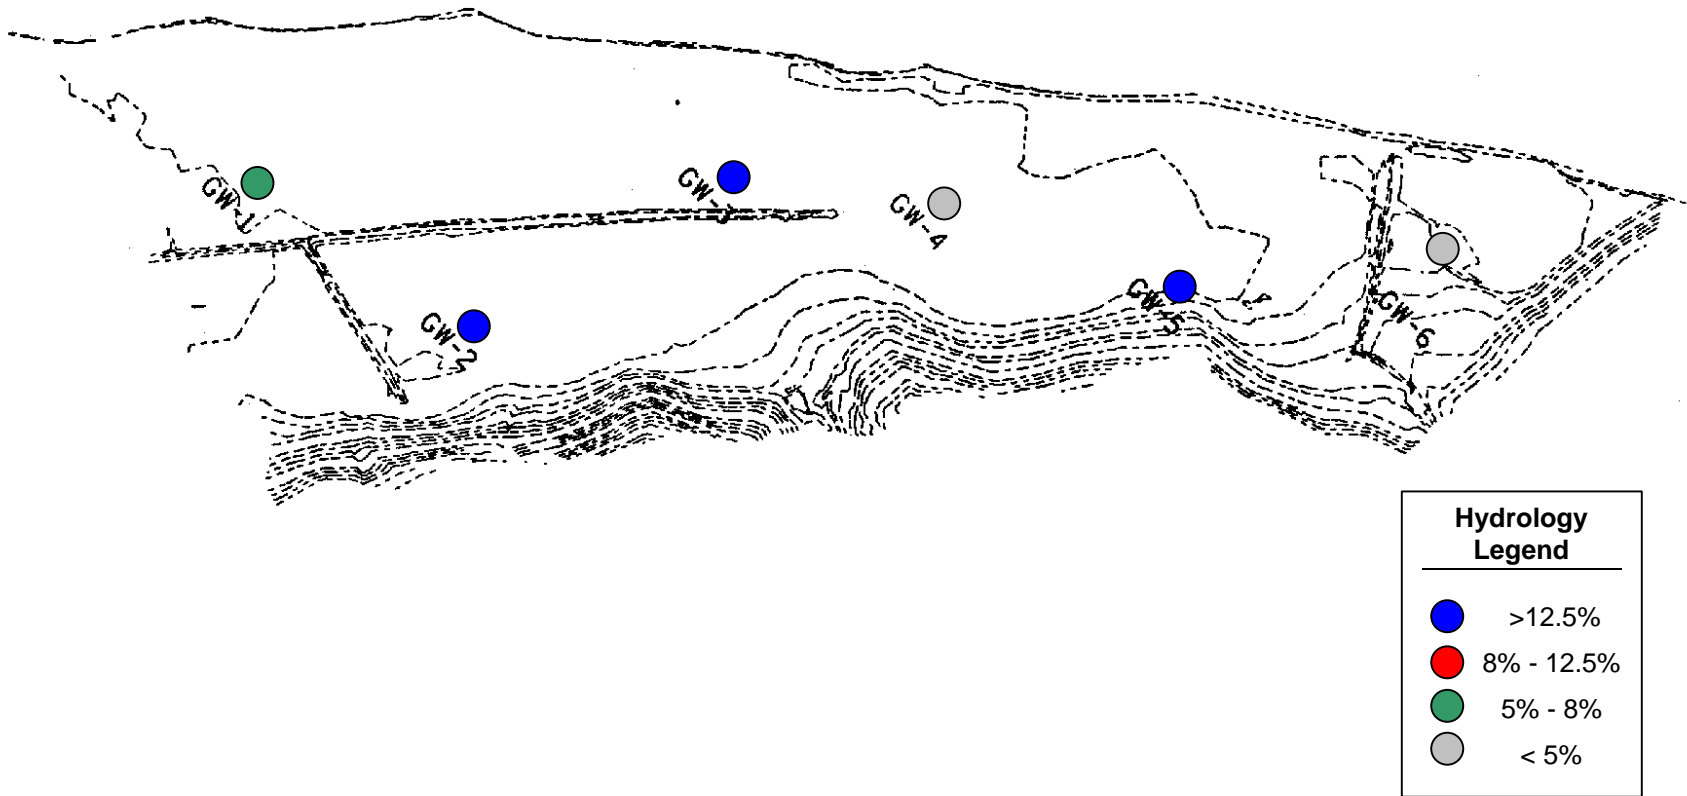
Figure 3. Monitoring Gauge Hydrologic Results

Figure 3 represents a graphical representation of the hydrologic results. Gauges highlighted in blue indicate wetland hydrology for more than 12.5% of the growing season. Gauges highlighted in red indicate saturation between 8 and 12.5% of the season, while those in green indicate saturation between 5 and 8% of the season. Gauges highlighted in gray indicate no wetland hydrology (less than 5% of the growing season).

2001 represents the third full growing season that the hydrologic data has been examined. Three gauges, GW-2, GW-3, and GW-5, have met the success criteria of consecutive days exceeding at least 12.5% of the growing season. Gauge GW-5 indicates ponding has occurred in the area during the growing season. GW-1 indicates saturation between 5 to 8% of the growing season. Gauge GW-6 does not indicate successful hydrology.

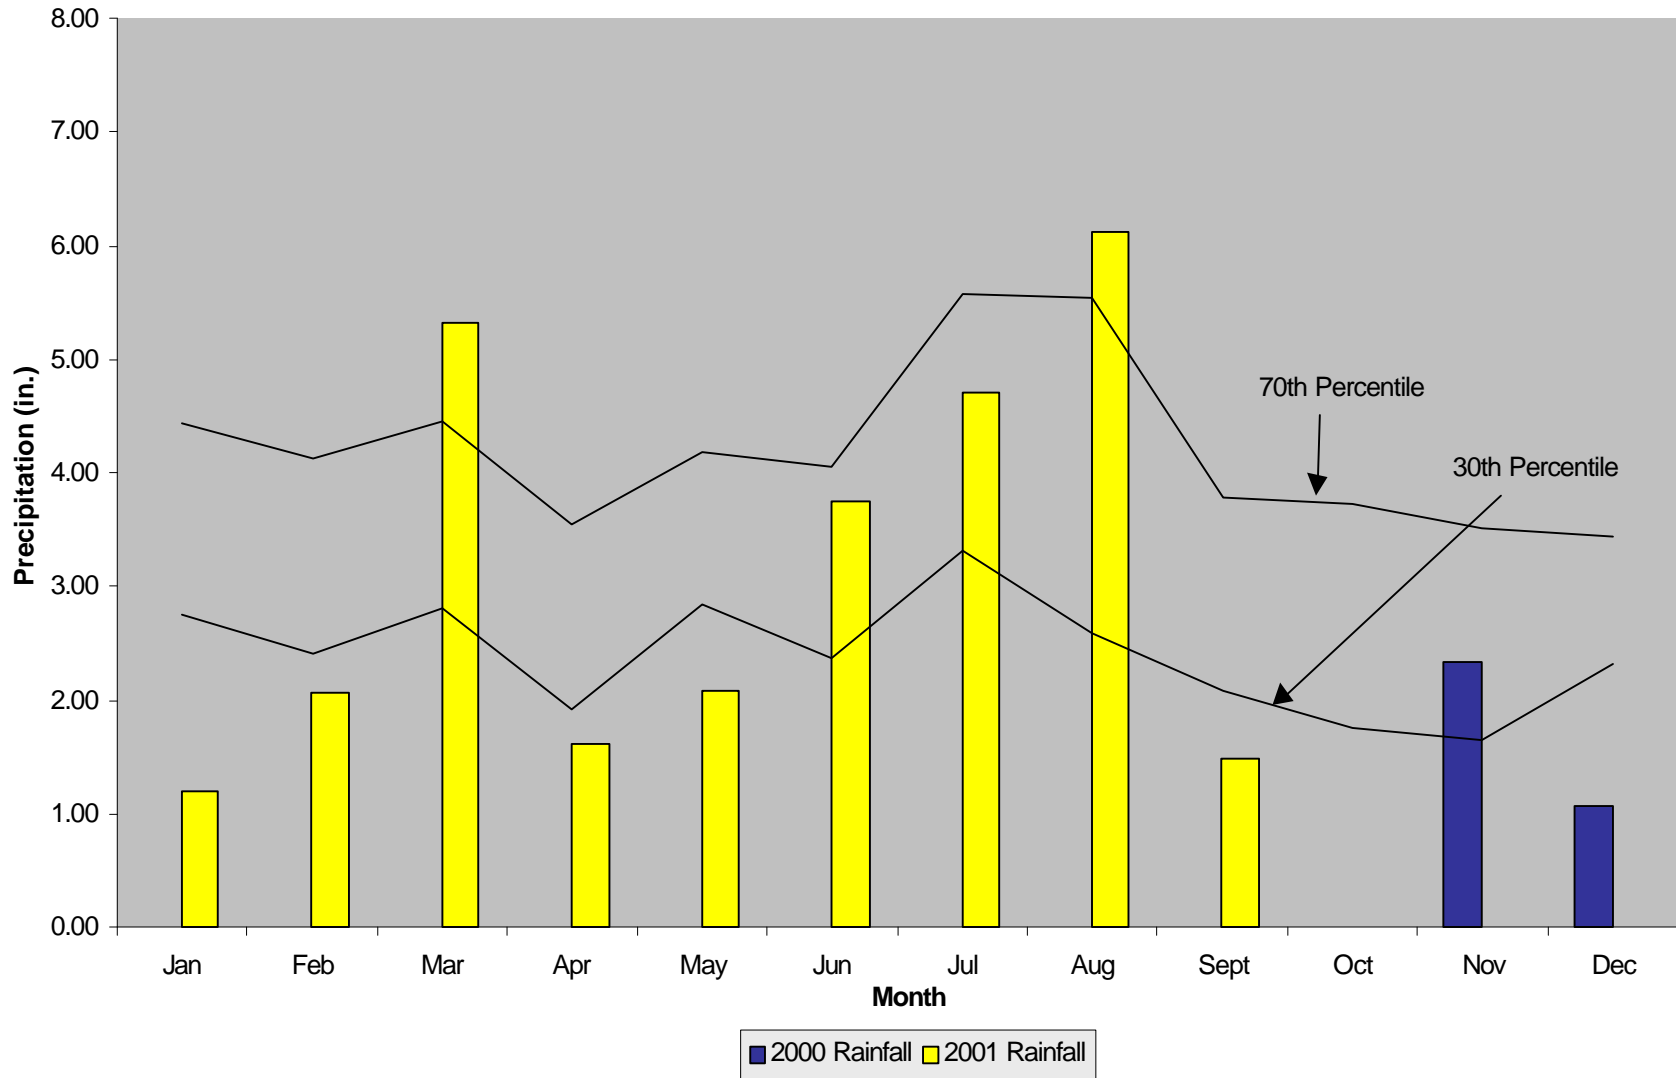
Figure 4. New Light Creek 30-70 Percentile Graph, Raleigh, NC

Figure 4 represents an examination of the local climate in comparison with historical data in order to determine whether 2001 was “average” in terms of climate conditions. The two lines represent the 30th and 70th percentiles of monthly precipitation for Raleigh. The bars are the monthly rainfall totals for October 2000 through September 2001. The historical data was collected by the National Climatic Data Center, while the on site gauges provided the recent rainfall data. Months with below average rainfall include: October (2000), December (2000), January, February, April, May, and September. November (2000), June and July experienced normal rainfall. March and August experienced above normal rainfall. Gauge 1 meet the success criteria from March 26 through April 10 which may be associated with the above normal rainfall in March. Overall the site experienced below average rainfall in 2001 which may be associated with two of the gauges decrease success rating from the 2000 monitoring year.

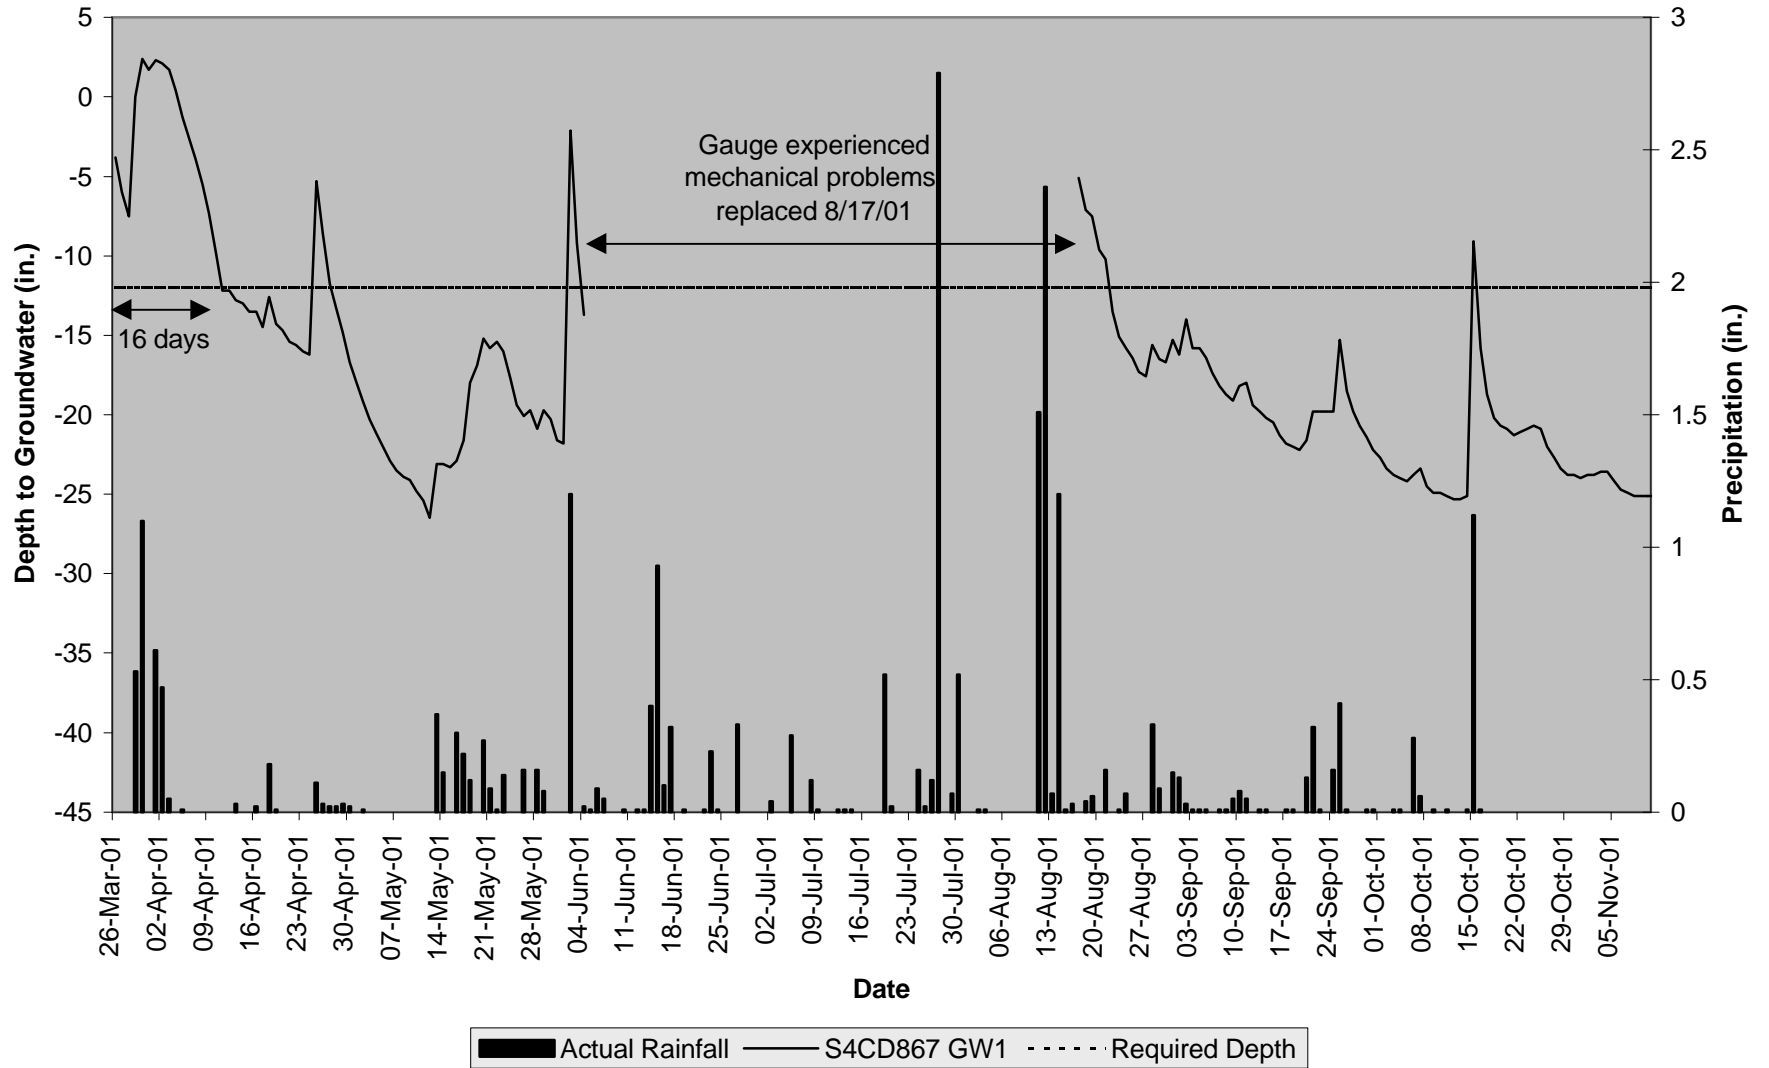
New Light Creek GW-1

Specific gauge problem: GW-1 experienced mechanical problems from June 5 through replacement on August 17.

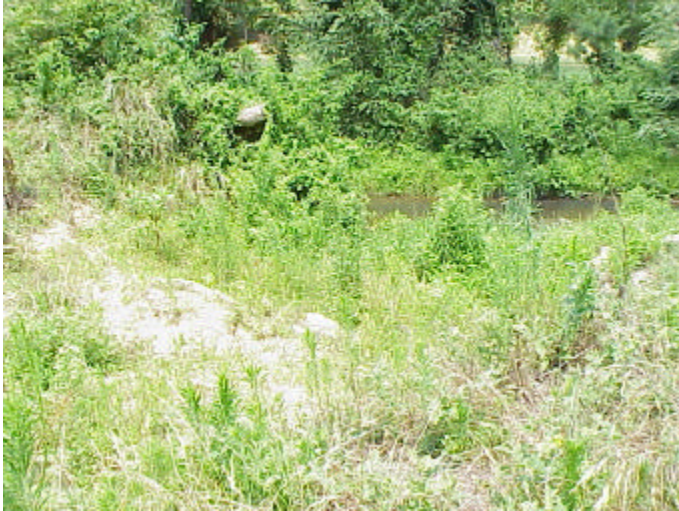
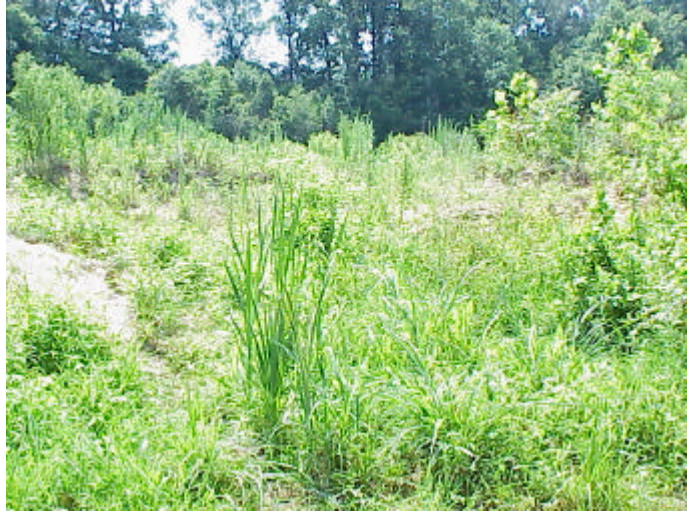
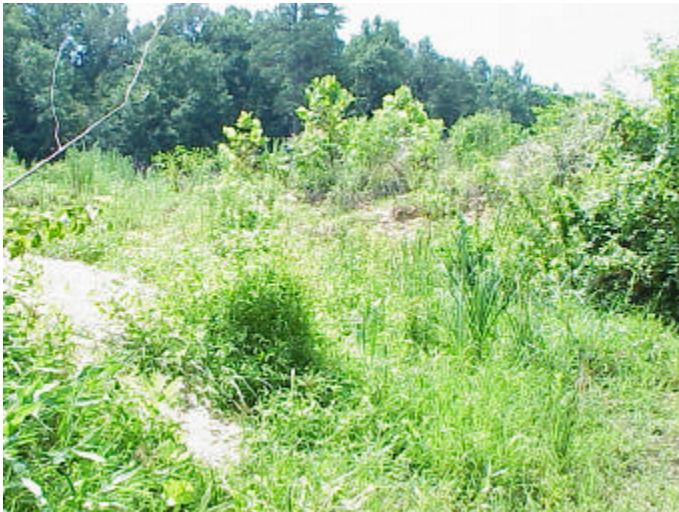
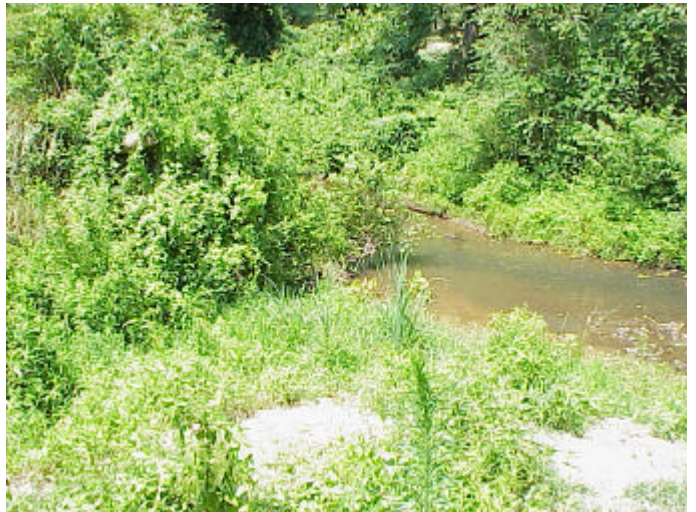
NCDOT and USACE personnel inspected the washout along the streambank in June 2000. It was agreed that NCDOT would repair the washout. This work was not done. A site inspection in September 2000 revealed this washout to be stabilizing on its own. NCDOT has continued to monitor this area to determine if this slope will stabilize in given time. The streambank was inspected and photographed during the 2001 monitoring visit and no other signs of erosion were observed (see pictures 7, 8, 9, and 10).

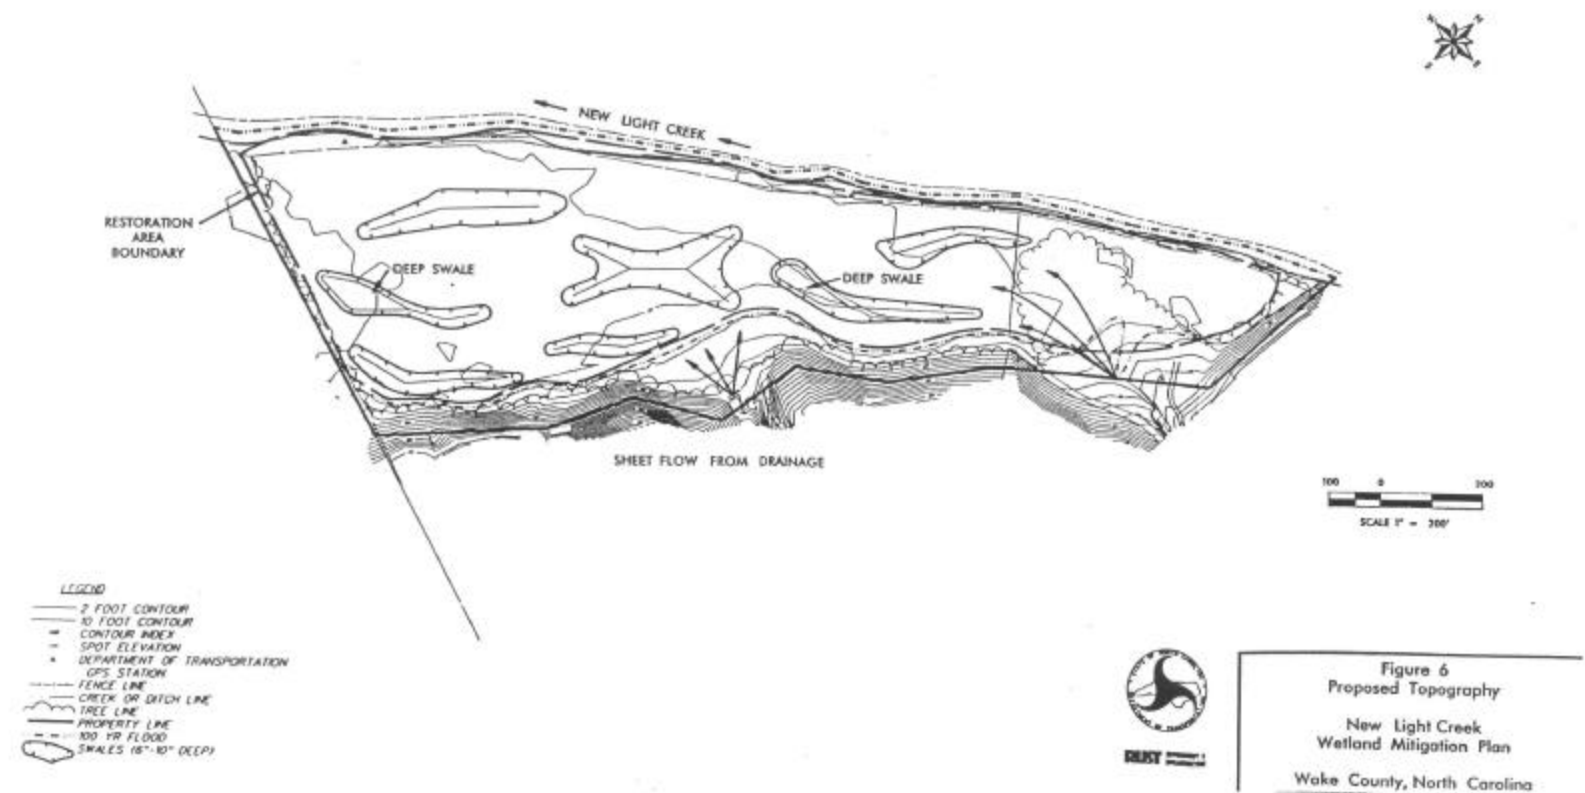
Excerpt from June 1998 Mitigation Plan

The swale in the middle of the site with a slightly lower elevation contains various wetland species including *Juncus* sp., *Scirpus* sp., *Cyperus* sp., black willow, and cattail. Standing water is present throughout this middle swale. This swale was established during construction of the site and is described and shown in the attached page and map taken from the June 1998 mitigation plan.

Prior to conversion to pasture, a number of swales/depressions were present across the site. Minor grading is proposed to reestablish microtopographic relief across the site and establish several swales or depressions to help retain surface water on the site. The general configuration of these proposed swales are shown on Figure 6. The swales will be 6 to 18 m (20 to 50 ft) wide and 30 to 90 m (100 to 300 ft) long. The middle of the swale will be about 15 to 30 cm (0.5 to 1.0 ft) below the elevation of the swale edge. Small deeper 30 cm (1.0 ft) depressions will be constructed in the downstream end of several of the swales to provide an area that experiences temporary ponding and a diverse habitat.

The location, shape, and elevations of the swales was based on the depressions within a bottomland forest area located about one-half mile south of the mitigation site. This wetland area is located on similar soils and a similar landscaped position as the mitigation site. The location of this wetland is shown on Figure 6. The general shape and dimensions of these depressions were measured using a transit and level and 100-foot tape measure. In general the swales in this area were roughly parallel to the stream irregular in shape but tending towards long and narrow. Measurements in this reference area indicated that the maximum elevation differences between the tops of hummocks and the bottom of swales is 1 foot. The average difference in elevation was 0.47 feet. The swales varied in width from 4 feet to 26 feet, and in length from 30 feet to over 300 feet.
