# ANNUAL REPORT FOR 2001

**Spring Branch Mitigation Site**

**Project No. 8.2250109**

Prepared By:  
Natural Systems Unit & Roadside Environmental Unit  
North Carolina Department of Transportation  
December 2001

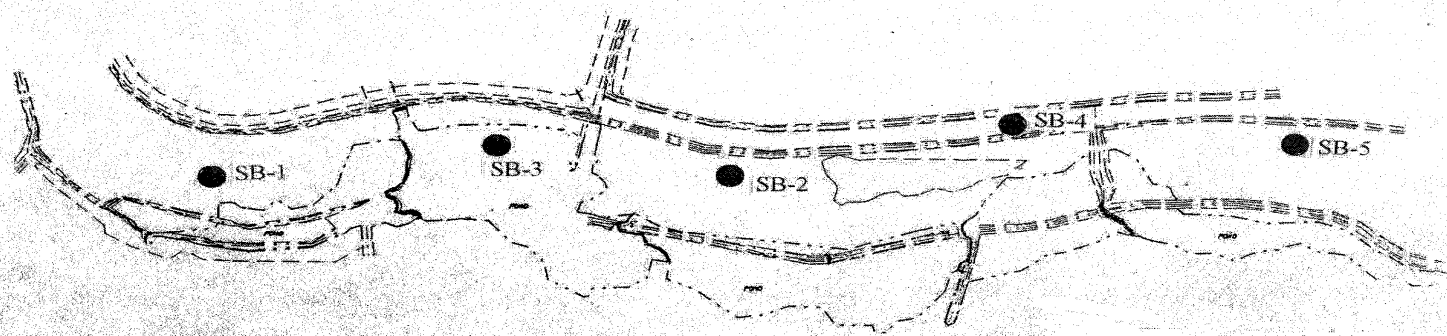
FIGURE 2  
SPRING BRANCH  
GAGE LOCATION MAP

Three monitoring wells, two surface gauges, and one rain gauge were installed in March of 1998 (Figure 2). Because of the amount of surface water on the site, each groundwater well was installed to record water levels both above and below ground level. Daily readings are taken throughout the growing season.

- SB-1 GROUNDWATER GAUGE
- SB-2 SURFACEWATER GAUGE
- SB-3 GROUNDWATER GAUGE
- SB-4 SURFACEWATER GAUGE
- SB-5 GROUNDWATER GAUGE

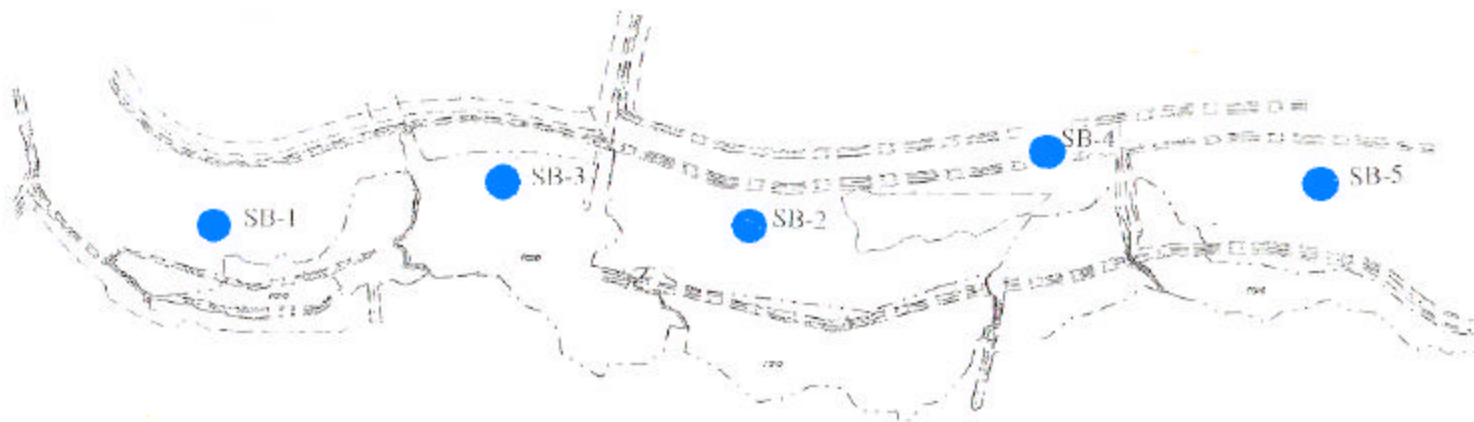
FIGURE 3  
Spring Branch Mitigation Site  
2001 Hydrologic Monitoring Results

The three well sites recorded the water table within 12 inches of the surface for more than 12.5% of the growing season. The surface water gauges indicated a consistent presence of surface water throughout the growing season. Figure 3 is a graphic representation of the 2001 monitoring results.

- Less than 5%
- 5% - 8%
- 8% - 12.5%
- Greater than 12.5%

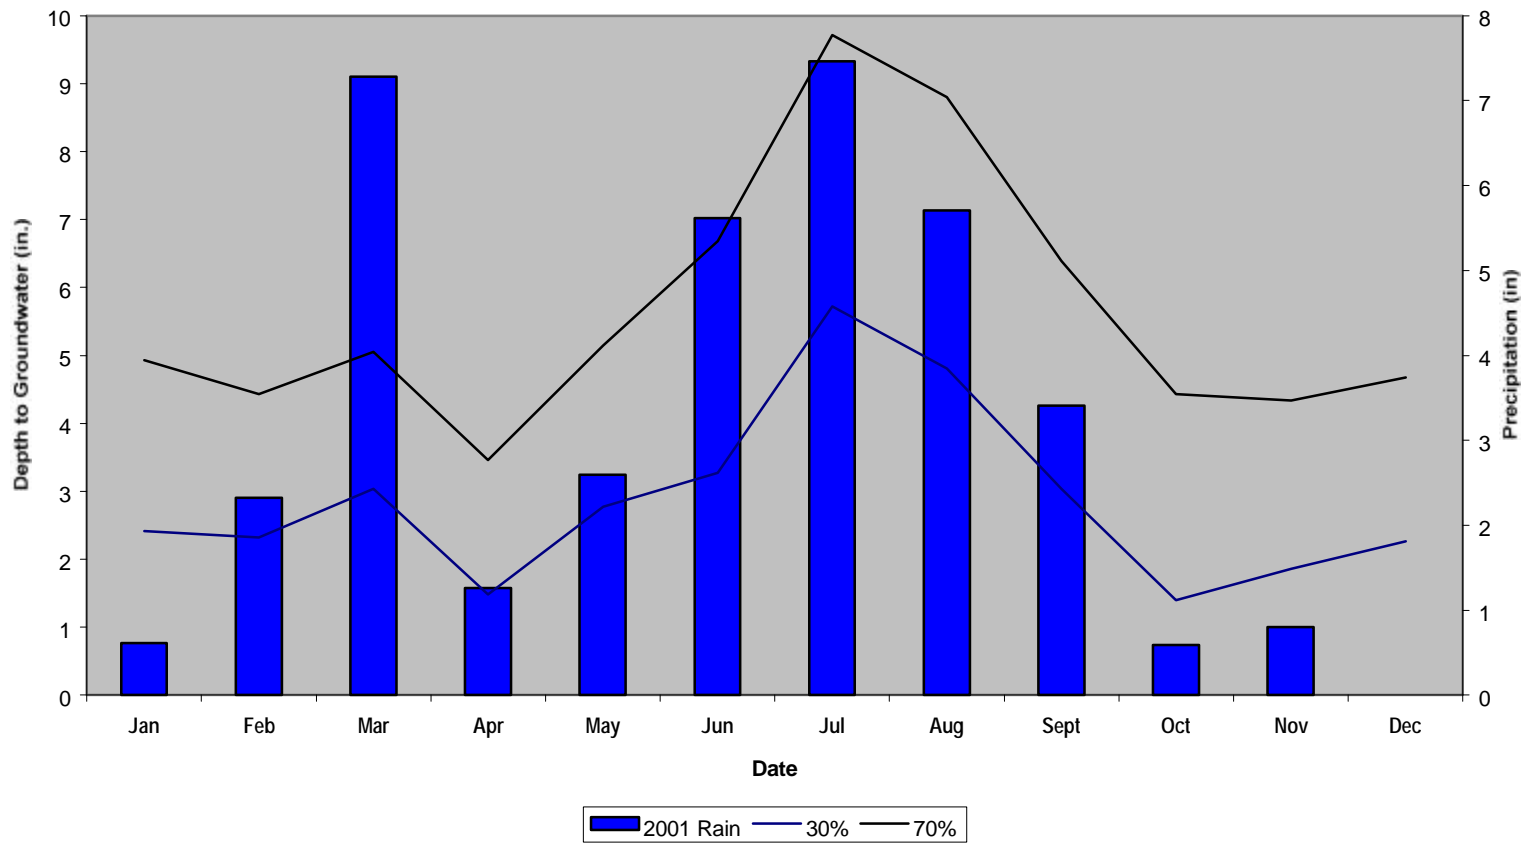
FIGURE 4

Figure 4 represents an examination of the local climate in comparison with historical data to determine if 2001 rainfall falls within the average rainfall range of the area. The historical data was provided by the National Climatic Data Center; the recent rainfall data was provided by the on-site rain gauge.

March and June were the two months that experienced greater than average rainfall for the Wilmington area. Monthly rainfall totals for the majority of the growing season were within or below the average monthly range.

2001 Spring Branch 30 - 70 Percentile Graph

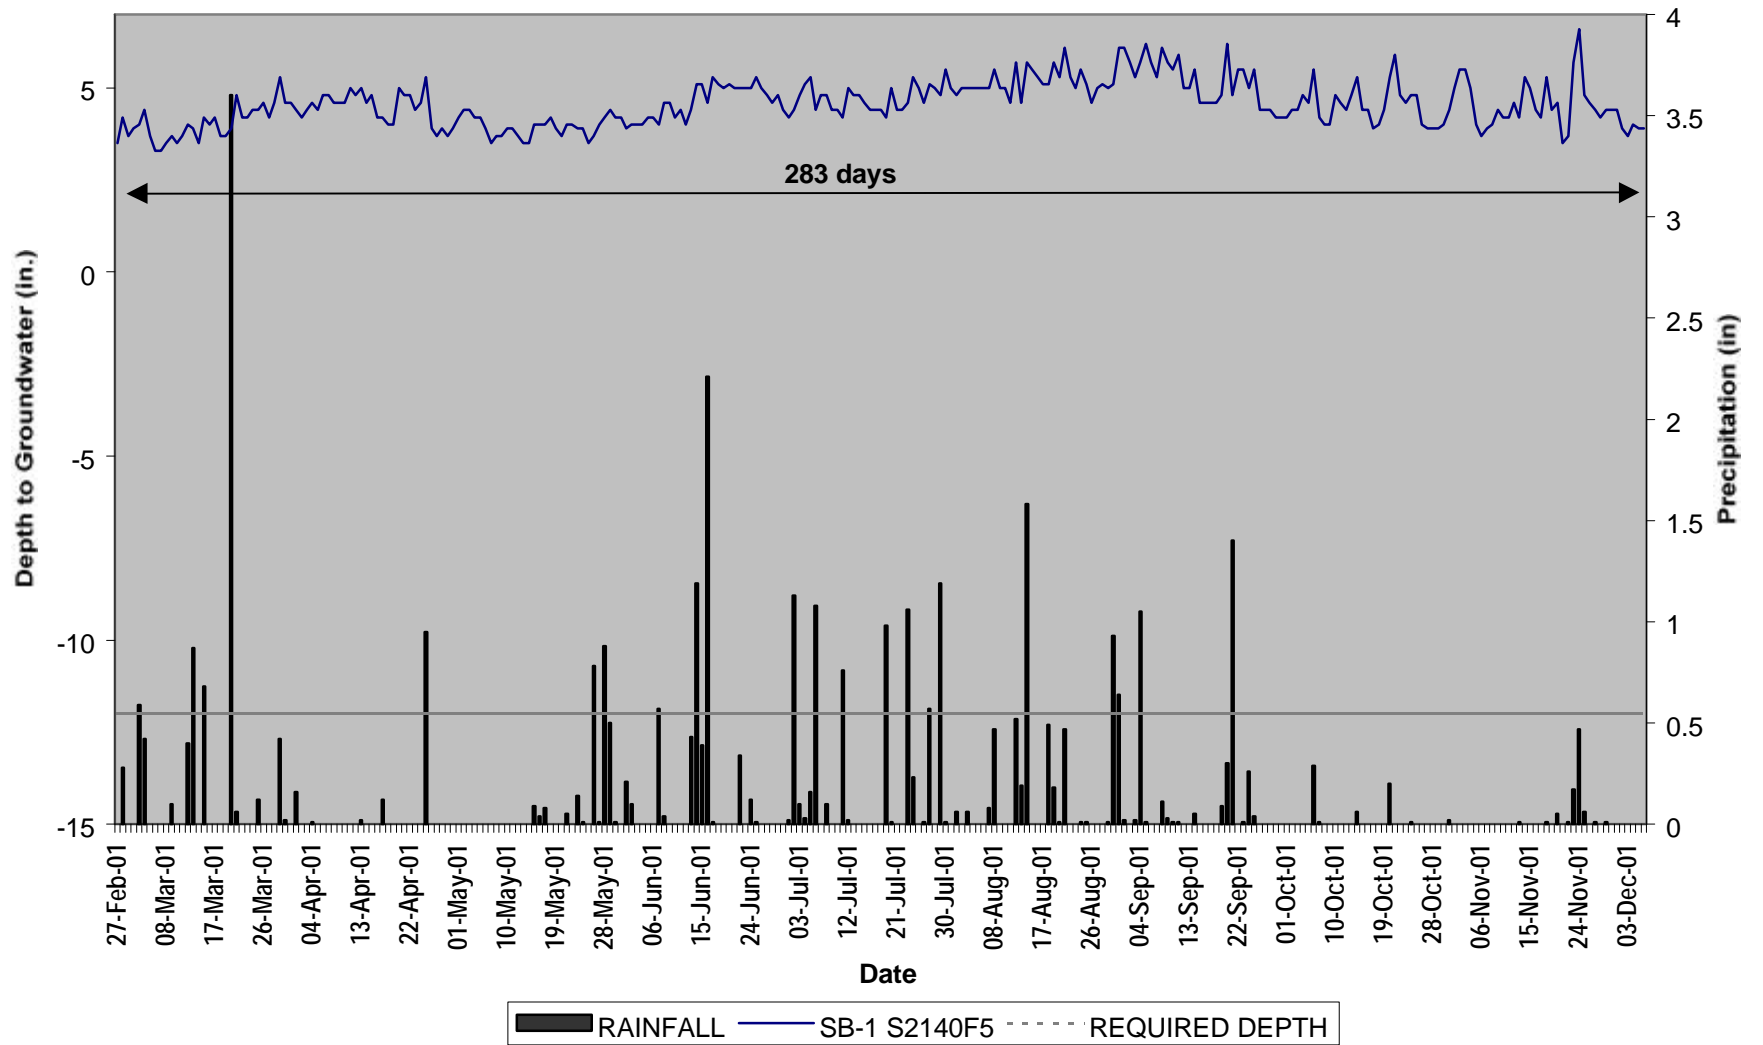
### 2001 Spring Branch SB-1

Appendix A contains a plot of the water depth for each monitoring well and surface gauge. Monitoring results are shown from February 27 to November 26. Daily precipitation data is provided on each graph.

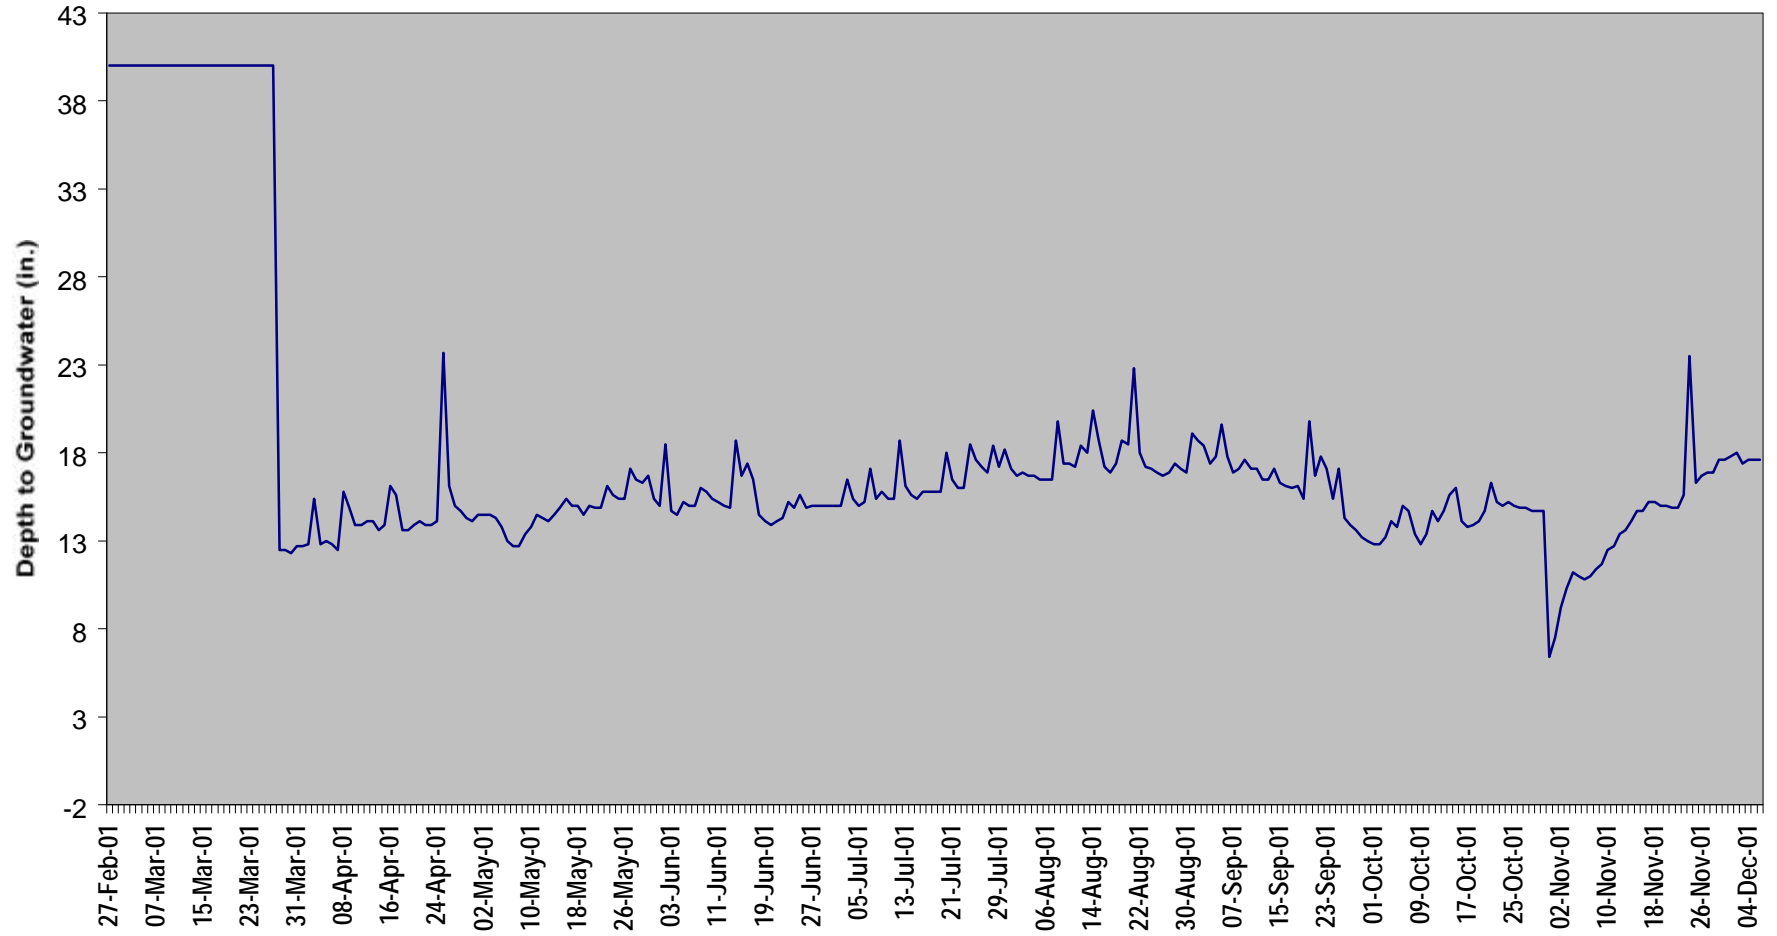
### 2001 Spring Branch SB-2

— SB-2 S2140B3

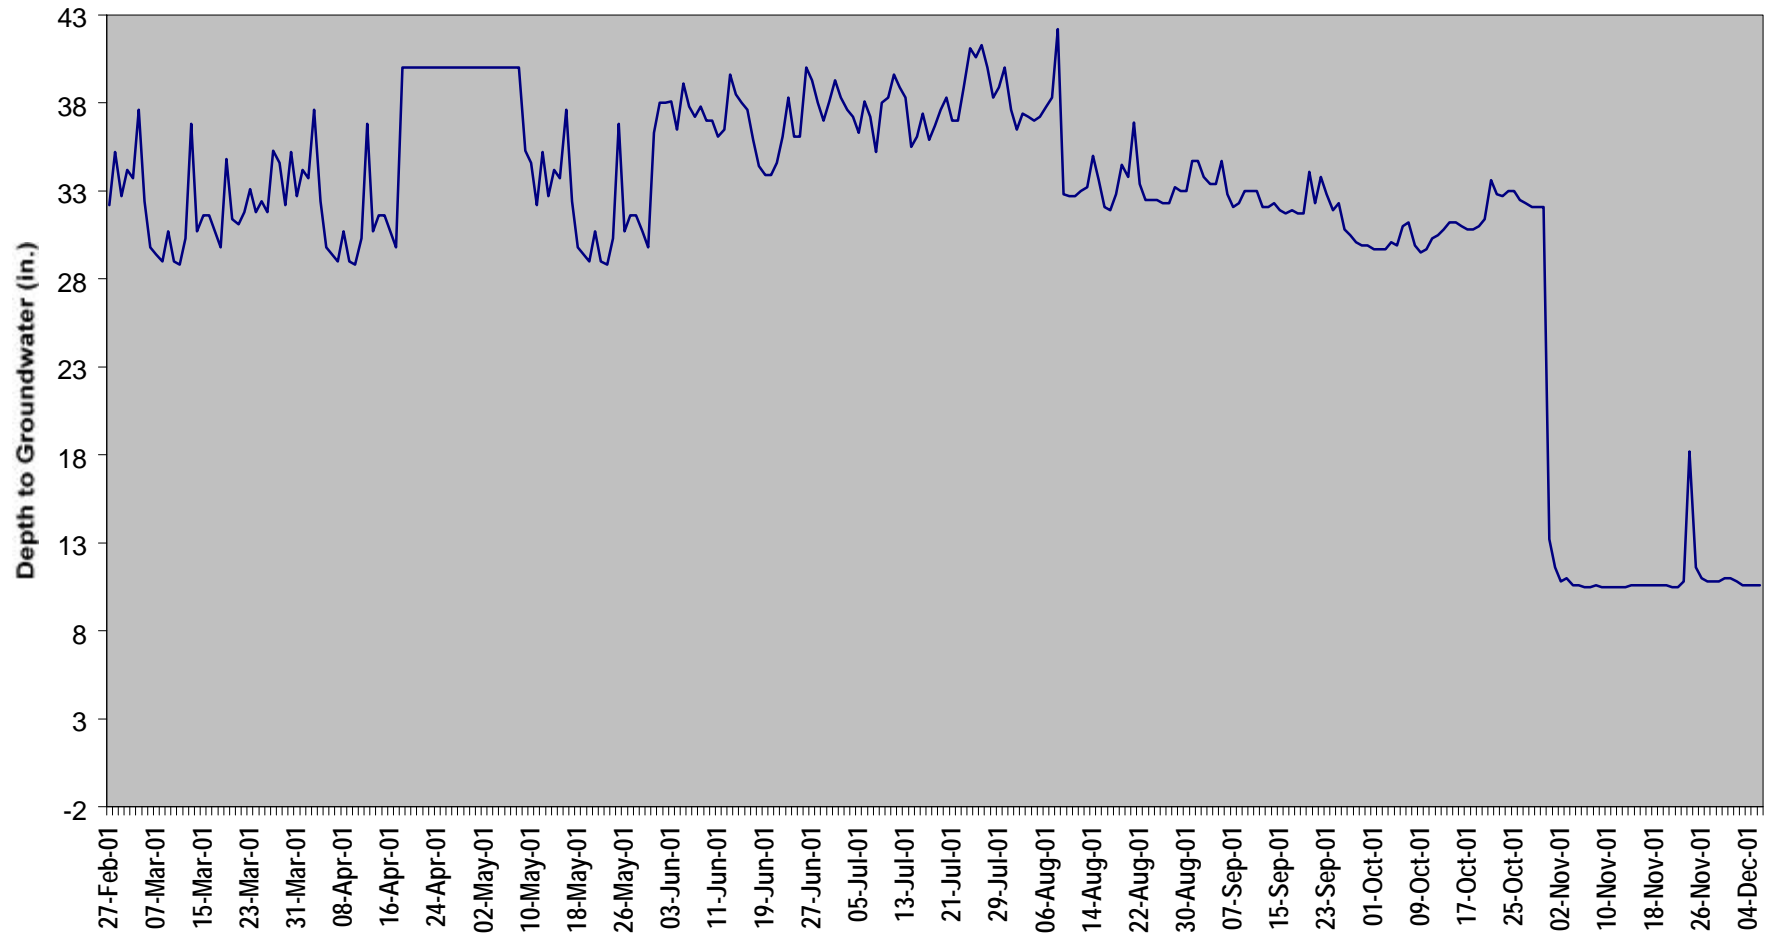
### 2001 Spring Branch SB-4

— SB-4 S317335

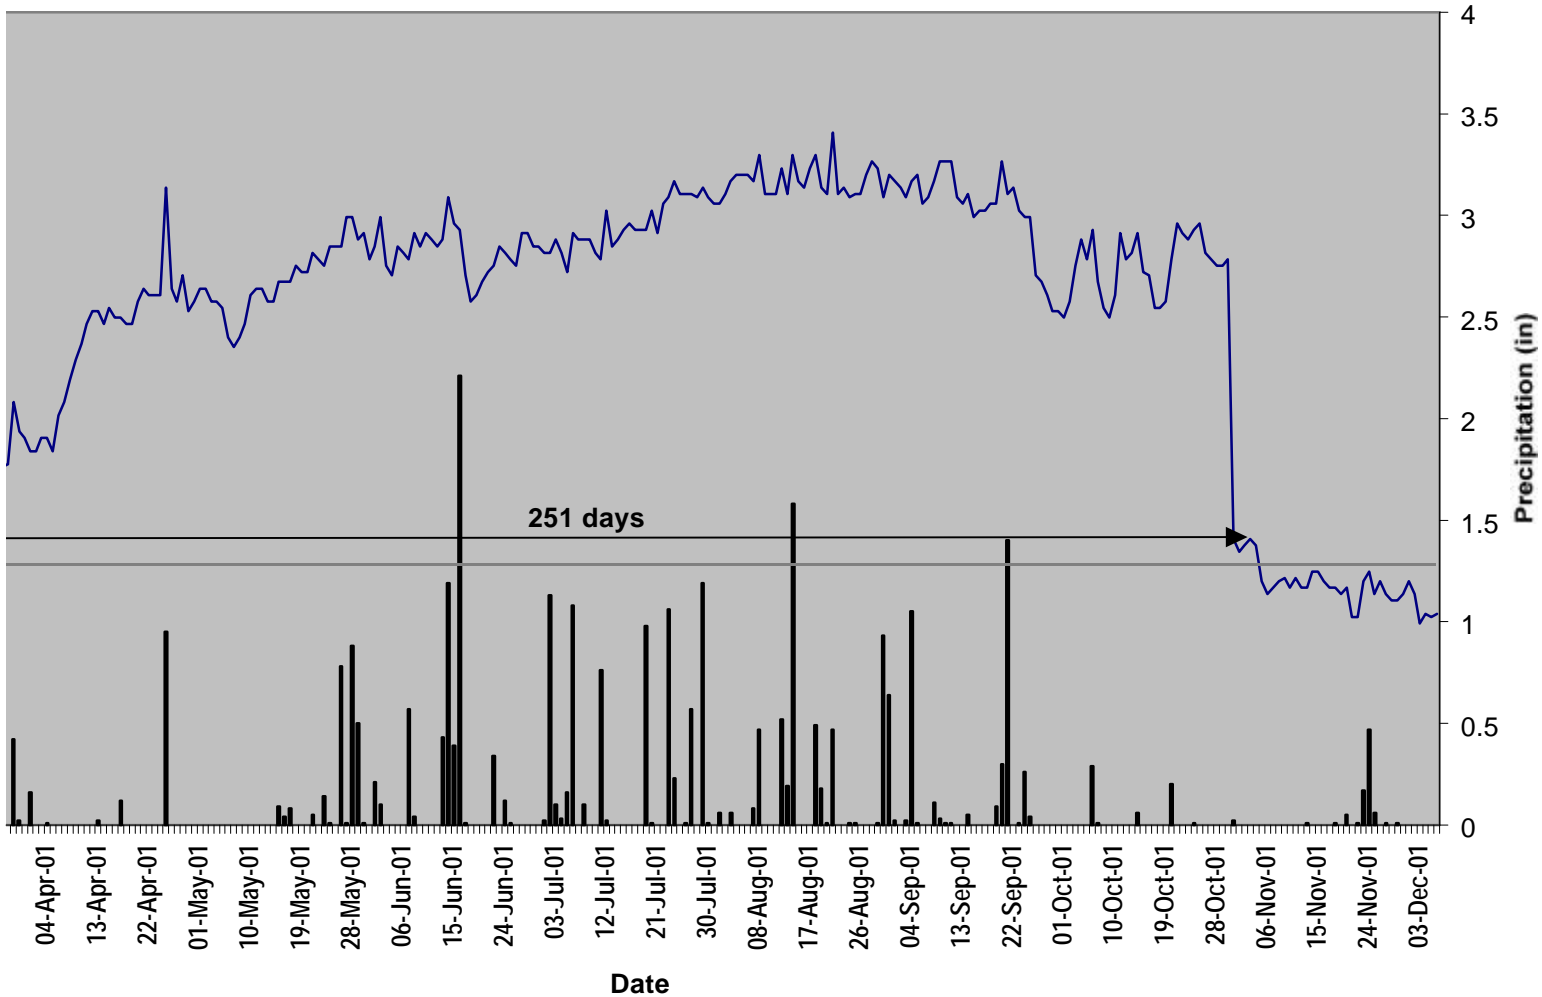
# 2001 Spring Branch SB-5

■ RAINFALL    — SB-5 S2140E9    - - - - - REQUIRED DEPTH
