ANNUAL REPORT FOR 2001

**Tucker Mitigation Site
Currituck County
Project No. 6.049009T
TIP No. R-2228WM**

Prepared By:
Natural Systems Unit & Roadside Environmental Unit
North Carolina Department of Transportation
December 2001

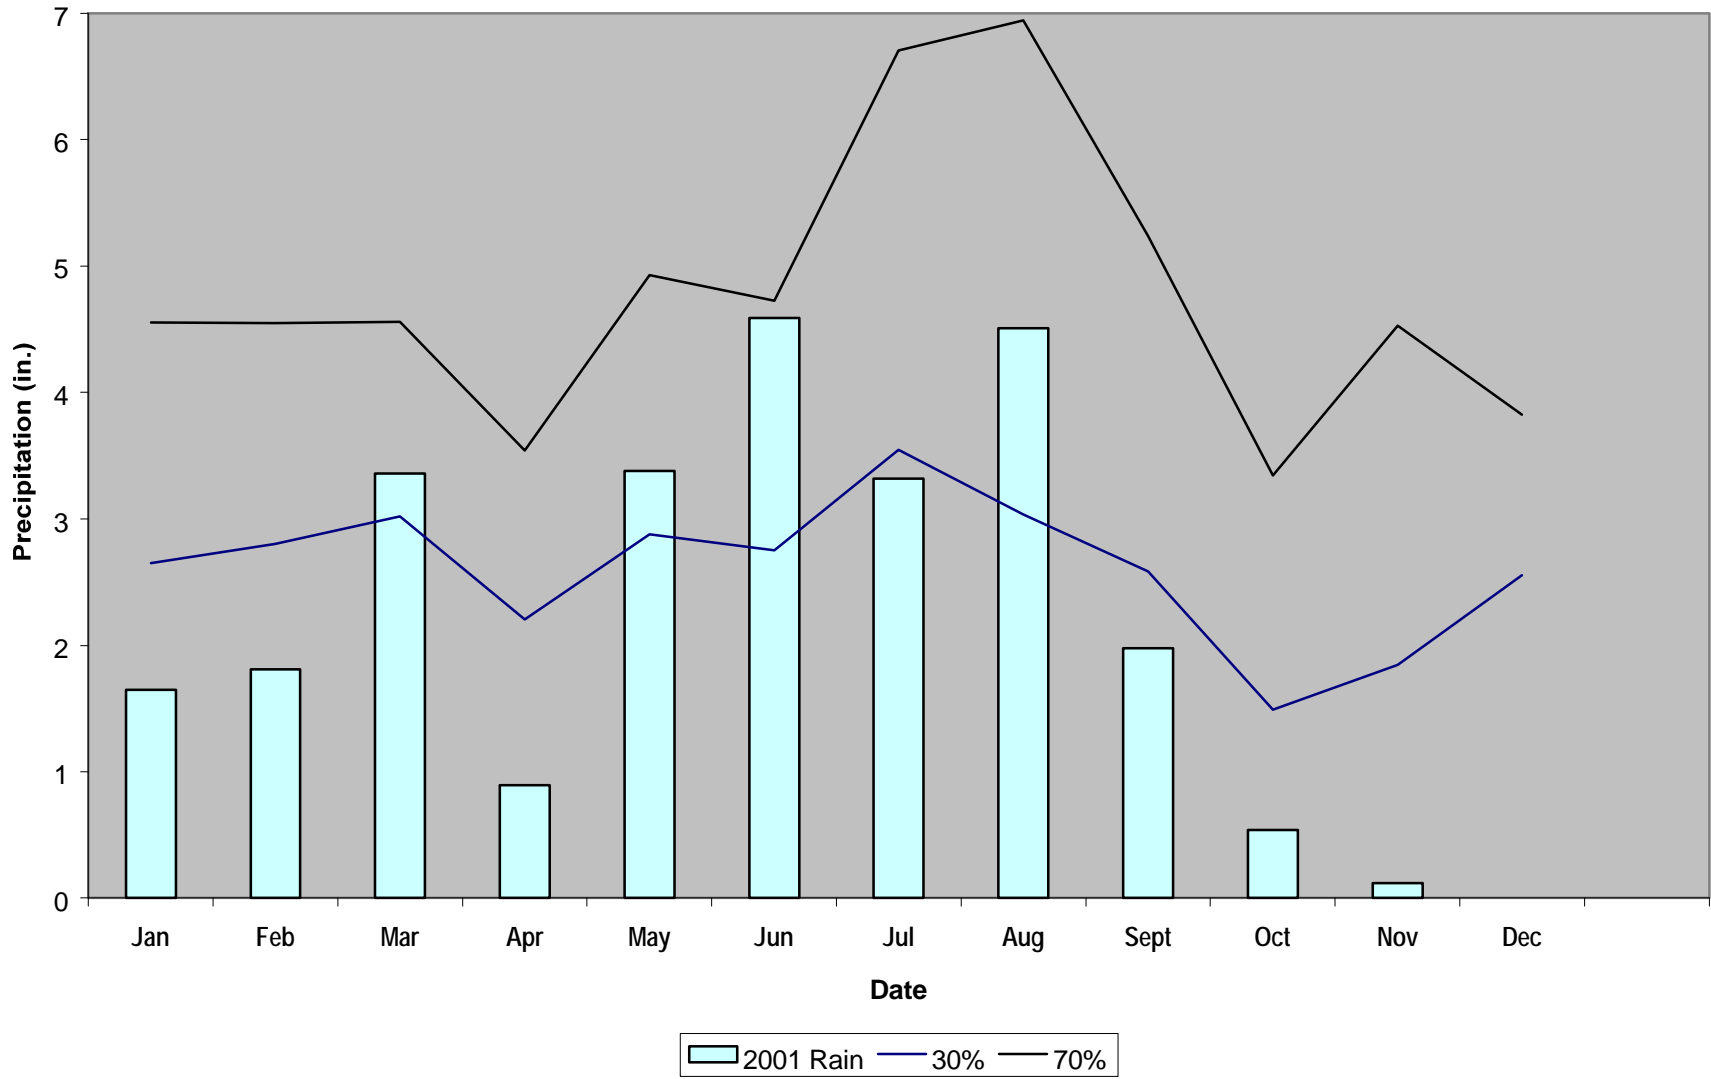
FIGURE 4

Figure 4 represents an examination of the local climate in comparison with historical data to determine whether 2001 was “normal” in terms of climate conditions. The figure compares the rainfall from 2001 with that of historical rainfall (data collected between 1948 and 1996). Historical rainfall data was provided by the NC State Climate Office. The 2001 rainfall data was collected by the on-site rain gauge. The graph shows 2001 rainfall totals from January 2001 through the end of November 2001 which includes the growing season for this site. In the year 2001, rainfall was average to below average for the entire growing season. There was no above average rainfall-month in 2001 that skewed the gauge data to show a wetter site. Of the nine months comprising the growing season, five months showed below average rainfall totals. If the yearly rainfall had been more average, one could project that gauge TT-2 could have met the success criteria.

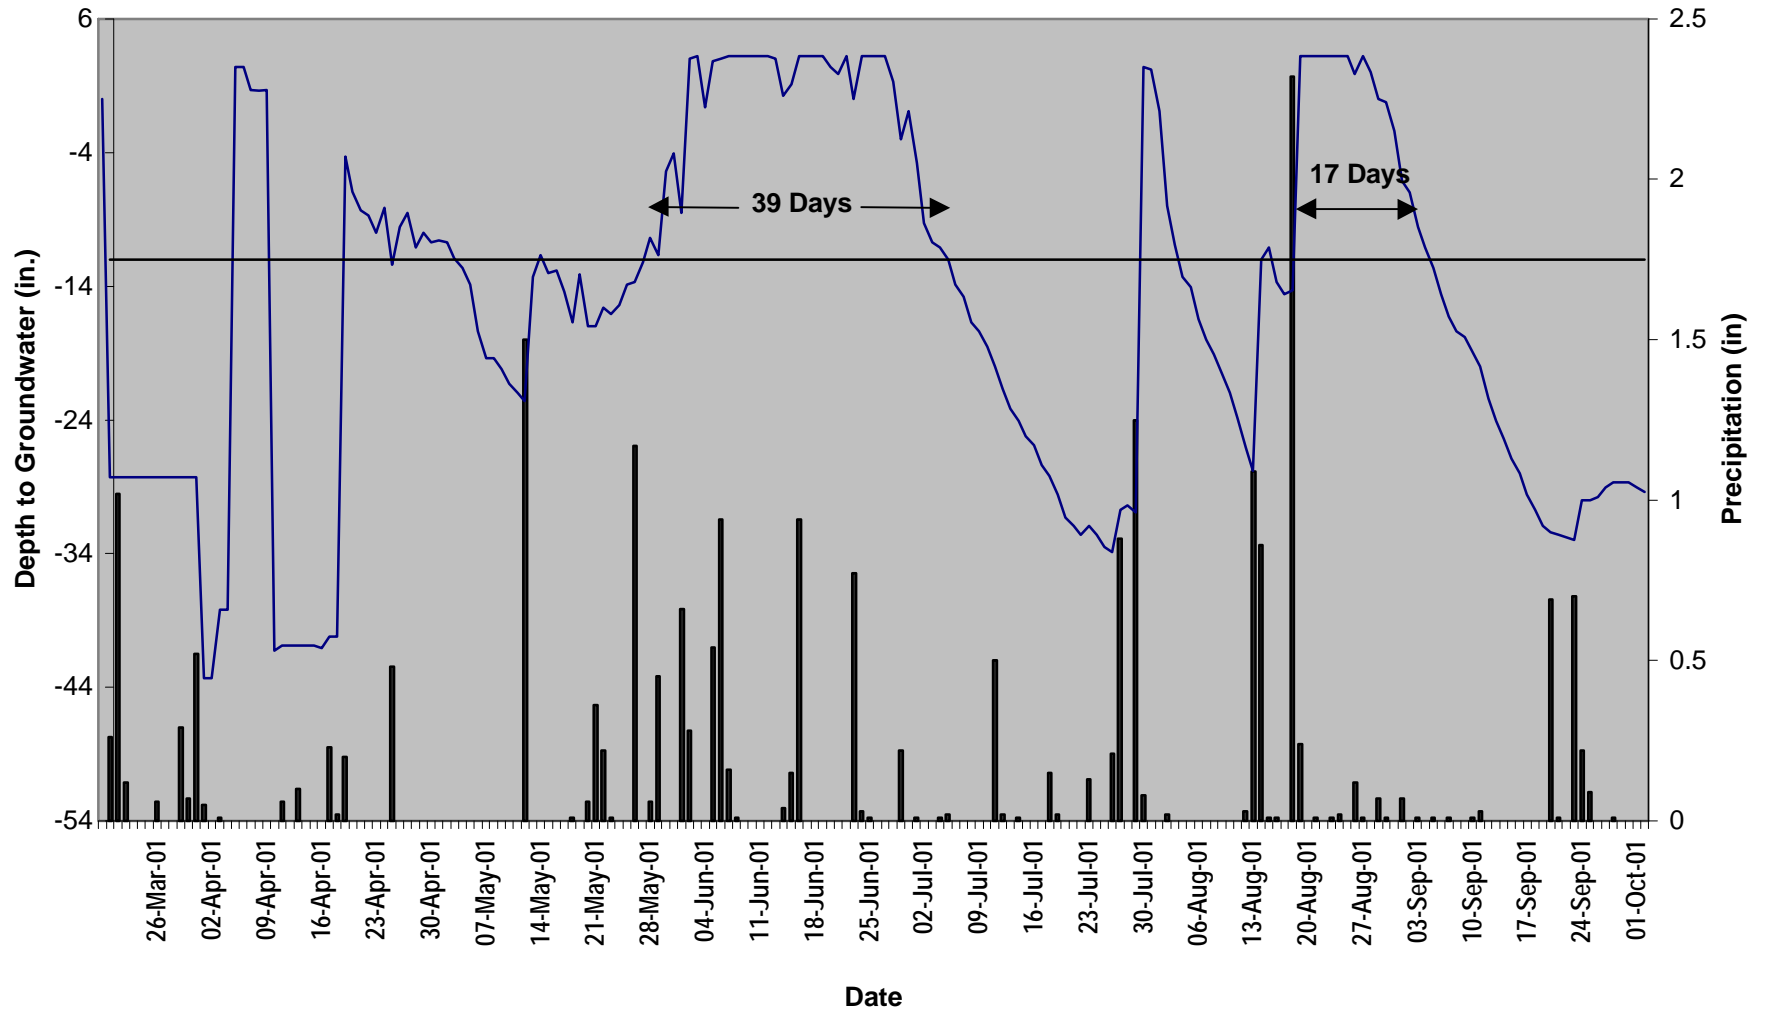
2001 Tucker TT-1

The maximum number of consecutive days that the groundwater was within twelve inches of the surface was determined for each gauge. This number was converted into a percentage of the 239-day growing season. The results are presented in Table 1. Appendix A contains a plot of the groundwater depth for each monitoring gauge and the surface water depth recorded by the surface gauge. The maximum number of consecutive days is noted on each graph. The individual precipitation events, shown on the monitoring gauge graphs as bars, represent data collected from the on-site rain gauge.

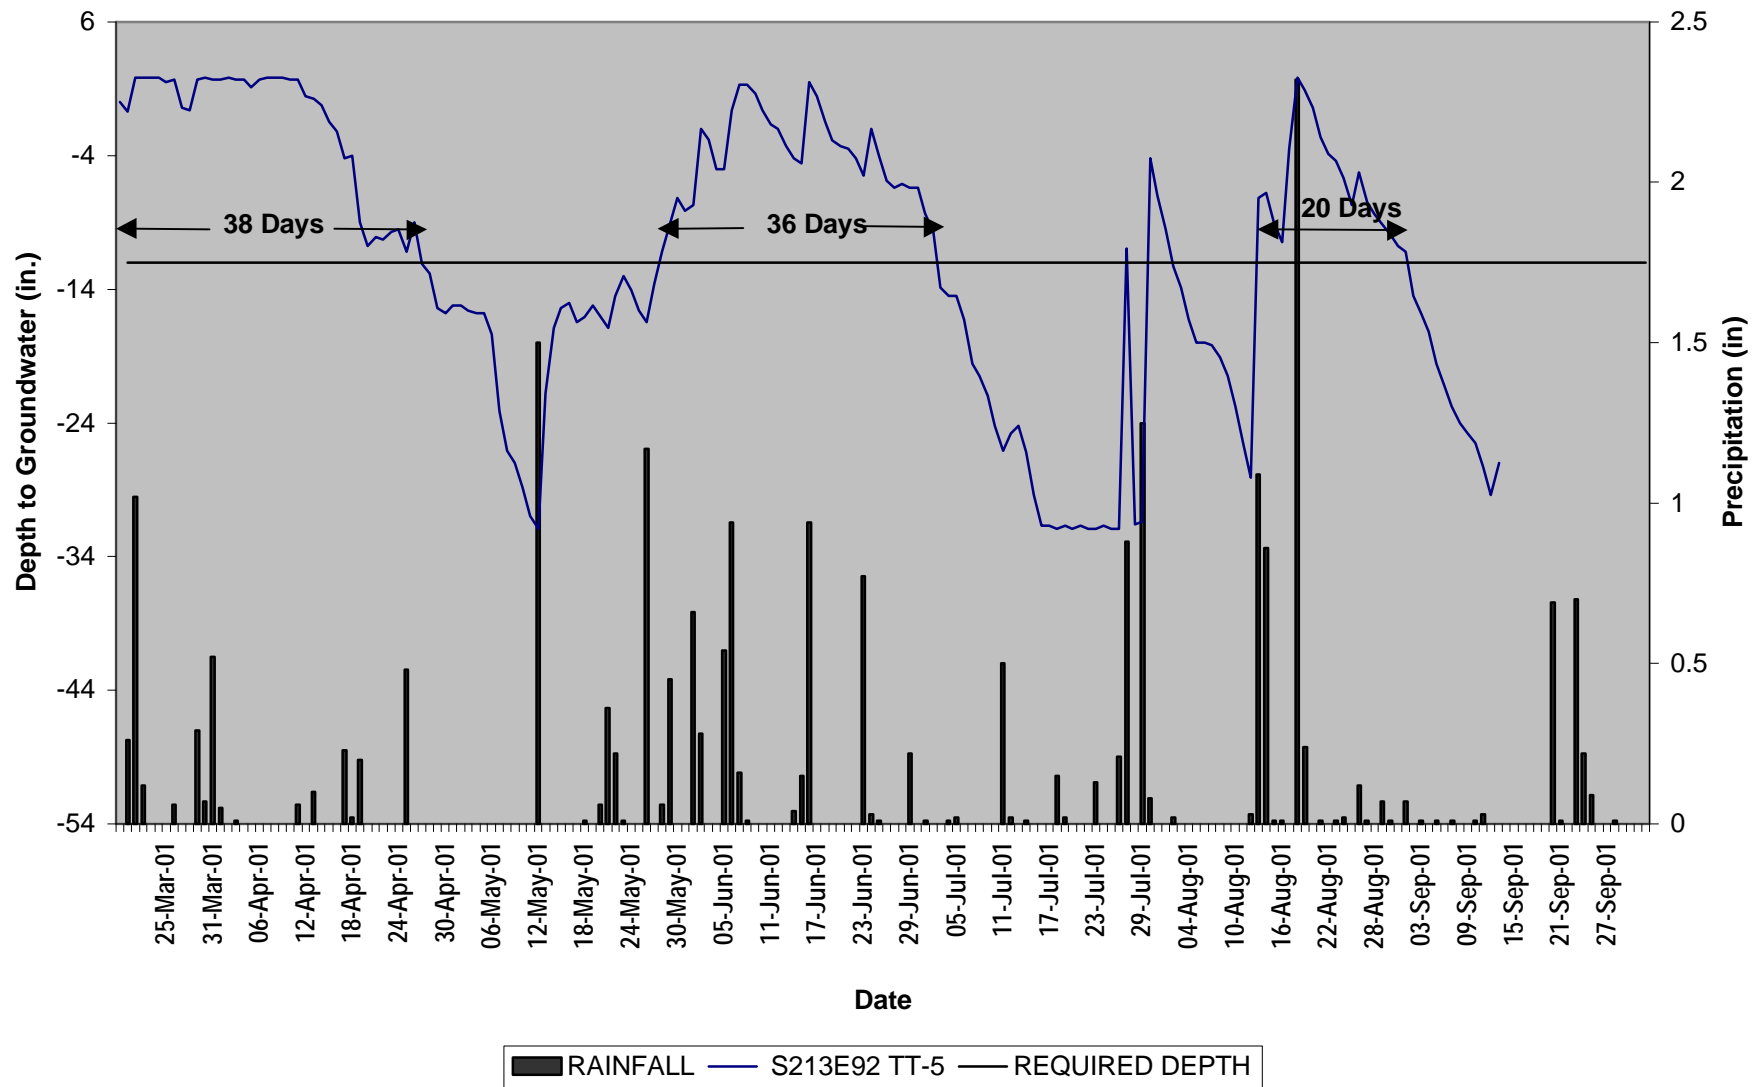
2001 Tucker TT-5

Specific problems: Dead batteries hampered the data acquisition process. Monitoring gauge TT-6 did not record groundwater elevations from August 4 to October 3rd. Several attempts to repair and reset this gauge proved unsuccessful. This gauge will be replaced prior to the next growing season in coordination with the NCDOT Geotechnical Unit. Monitoring gauge TT-5 stopped recording from September 13 until October 3rd as well due to battery problems.

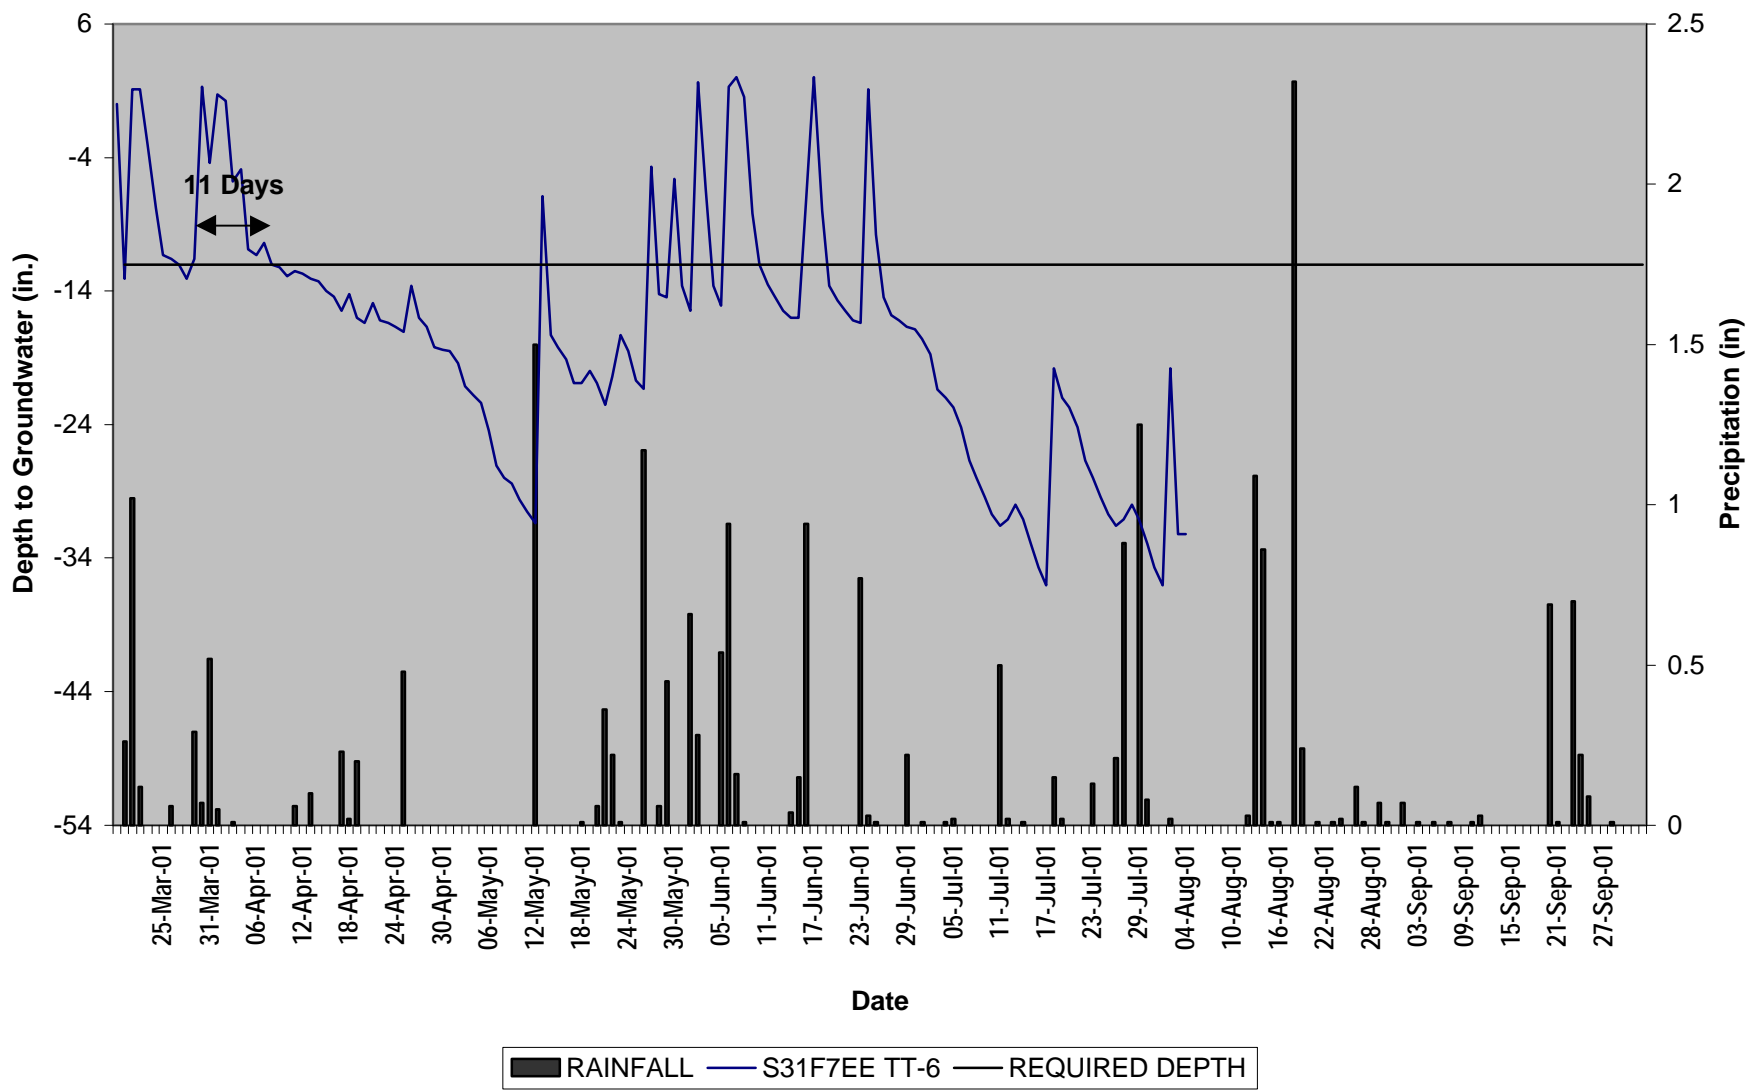
2001 Tucker TT-6

The results of the third year of monitoring indicate this site was successful. The majority of the groundwater gauges met the hydrologic success criteria. Based upon a previous field investigation, gauge TT-6 is situated in a locally high hummock rising approximately 8 inches above the surrounding area. Gauge TT-2 was the other gauge that came close to meeting saturation requirements as well.
