# ANNUAL REPORT FOR 2003

**Dutchman's Creek Mitigation Site**  
**Wake County**  
**Project No. 8.U401721**  
**TIP No. R-2000 WM**

Prepared By:  
Office of Natural Environment & Roadside Environmental Unit  
North Carolina Department of Transportation  
December 2003

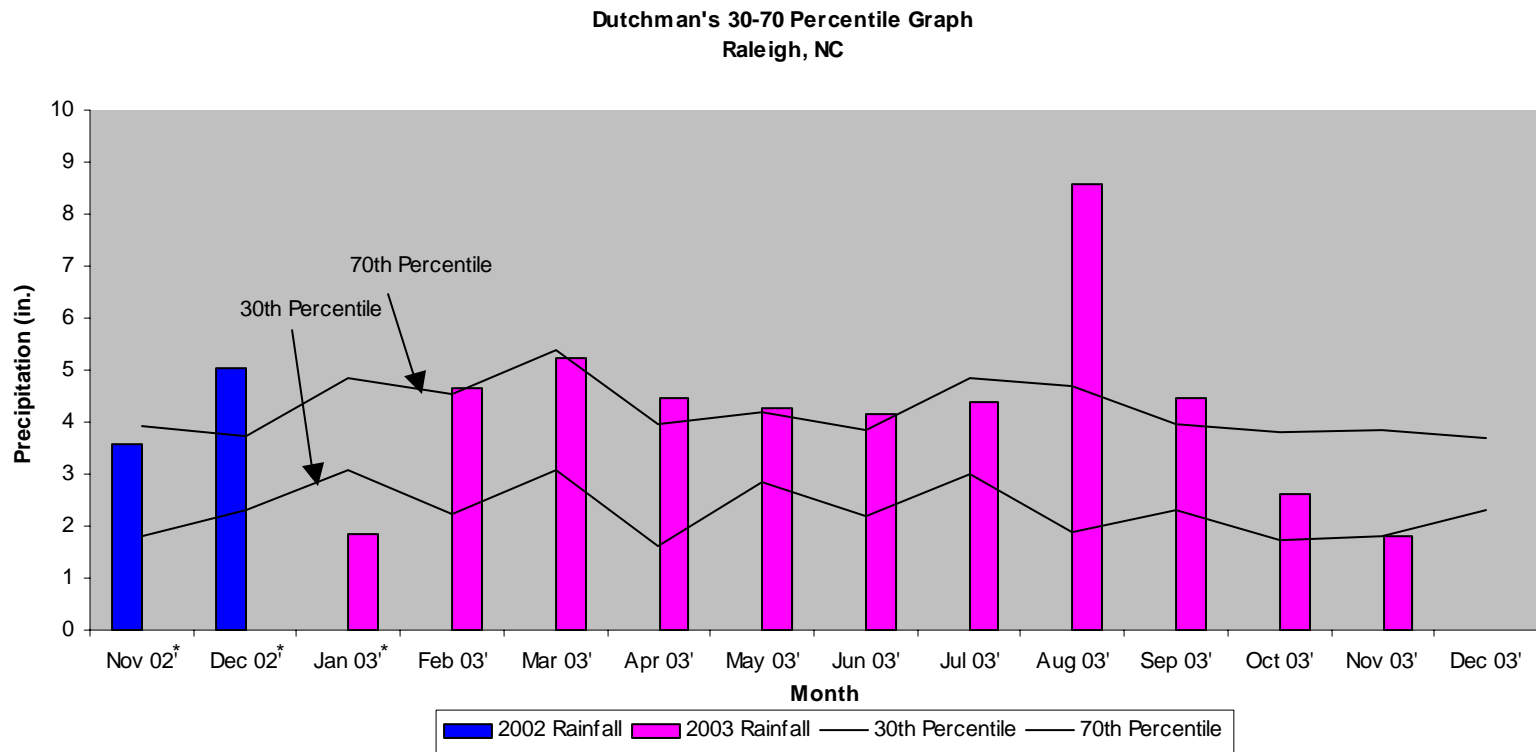
**FIGURE 4: 30-70 Percentile Graph**

Figure 4 represents an evaluation of the local climate in comparison with historical data in order to determine whether 2003 was “average” in terms of climate conditions. The two lines represent the 30<sup>th</sup> and 70<sup>th</sup> percentiles of monthly precipitation for Raleigh. The bars are the monthly rainfall totals for November 2002 through November 2003. The NC State Climate Office provided historical data from the Raleigh/Durham weather station. The onsite rain gauge experienced malfunctions, therefore the Raleigh rain gauge data was used for the months of April 2003 - November 2003.

Months with below average rainfall include January and November. November (02’), February, March, July, and October experienced average rainfall. The months of December (02’), April, May, June, August, and September all experienced above average rainfall for the year. Overall the site experienced average to above average rainfall in 2003.
