# ANNUAL REPORT FOR 2003

**Sandy Creek Mitigation Site  
Randolph County  
Project No. 8.U492301  
TIP no. I-2402WM**

Prepared By:  
Office of Natural Environment & Roadside Environmental Unit  
North Carolina Department of Transportation  
December 2003

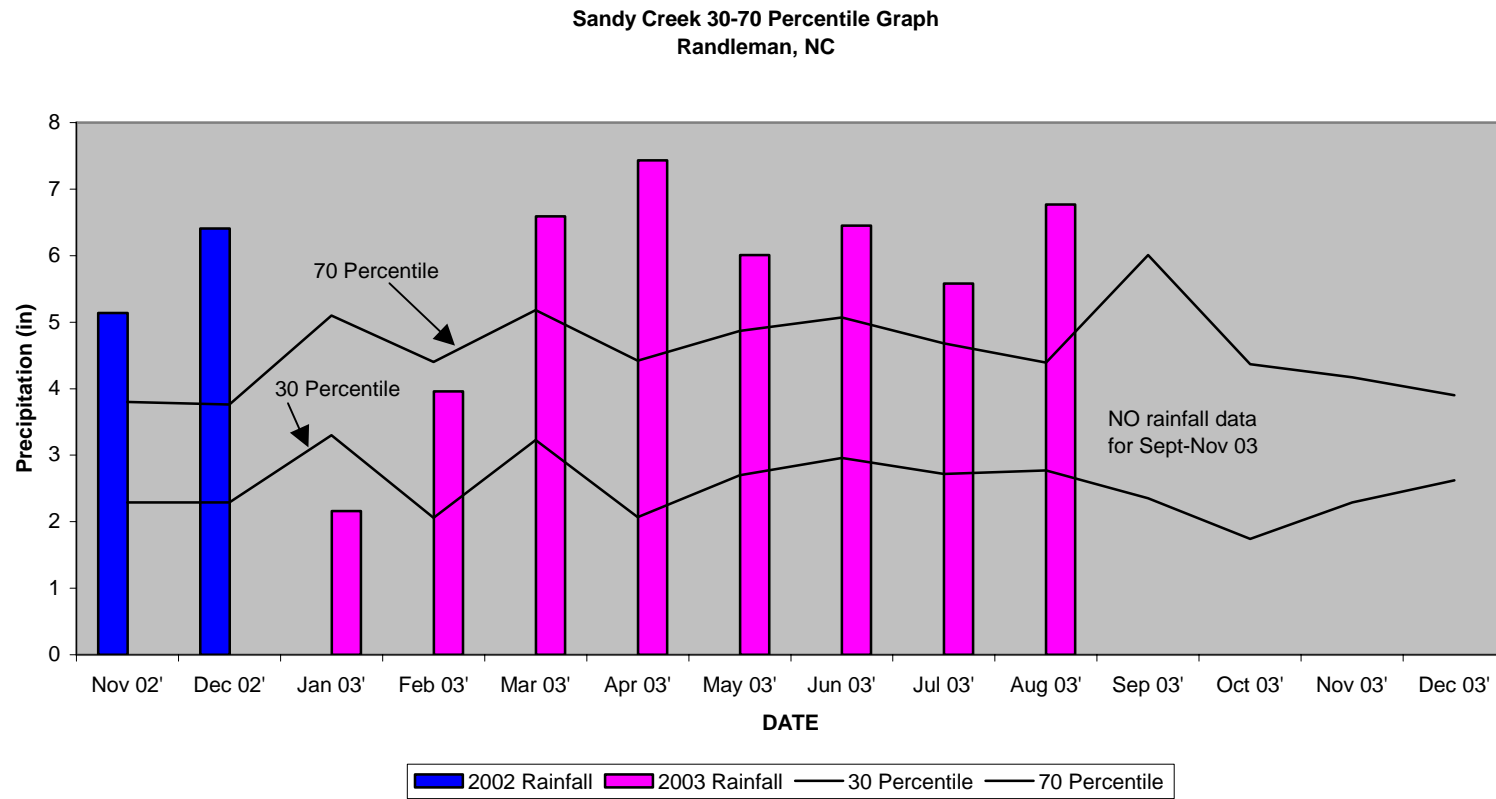
Figure 4: 30-70 Percentile Graph

Figure 4 represents an evaluation of the 2003 rainfall in comparison with historical rainfall data in order to determine whether 2003 was “average” in terms of precipitation. The historical rainfall data was collected from 1972 through 2003 (30 years). No rainfall data was collected from the weather station for September-November 2003. All rainfall data used in this analysis was obtained from the NC State Climate Office, Randleman weather station.

For the 2003-year, the only month to experience below average rainfall was January. February recorded average rainfall for the site. November (02'), December (02'), March, April, May, June, July, and August experienced above average rainfall. No data is available for the months of September-November 2003. Overall, 2003 experienced an above average rainfall year.
