# ANNUAL REPORT FOR 2004

**ABC Wetland Mitigation Site  
Beaufort County  
Project No. 8.T221801  
TIP No. R-2510WM**

Prepared By:  
Office of Natural Environment & Roadside Environmental Unit  
North Carolina Department of Transportation  
December 2004

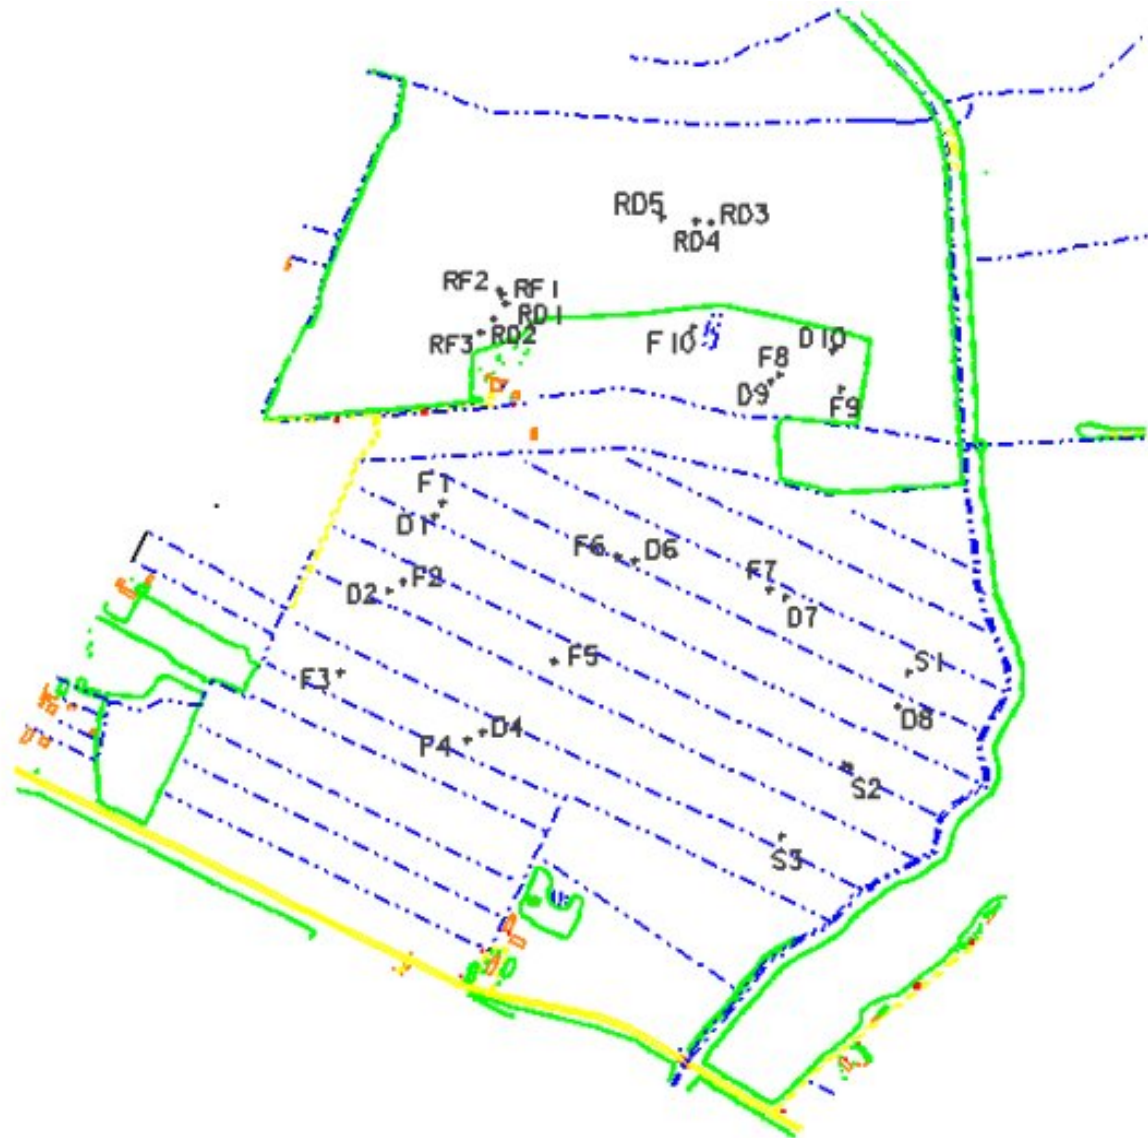
Figure 2. Monitoring Gauge Location Map

Micro-topographical features, such as semi-permanently inundated/saturated depressions and swales of various sizes, were created for the purpose of water storage, as well as habitat diversity. Eleven gauges (D1, D2, D4, D6, D7, D8, D9, D10, S1, S2, and S3) were placed within saturated depressions, while nine gauges (F1, F2, F3, F4, F5, F6, F7, F8, and F9) were placed in non-depressional areas throughout the site at ground elevation. Eight gauges were placed in similar landscape positions within the reference community. Reference gauges RD1, RD2, RD3, RD4, and RD5 were placed in depressions while gauges RF1, RF2, and RF3 were placed at base elevation.

Following construction, twenty-one groundwater gauges were placed on the site in accordance with the specifications in U.S. Army Corps of Engineers', Installing Monitoring Recorders/Piezometers in Wetlands (WRP Technical Note HY-IA-3.1, August 1993). Sixteen monitoring gauges were installed in 2001 to provide representative coverage within each of the wetland physiographic landscape areas on the site. In 2002, eight additional groundwater gauges were installed on site; three of those gauges were installed in the reference wetland. Currently, eight of the twenty-nine groundwater-gauges are located within the reference wetland, approximately 0.2 miles north of the mitigation site (Figure 2). The groundwater gauges record daily groundwater levels across the site. In addition, an onsite rain gauge records daily rainfall totals; this data is used to see how the groundwater table responds to rainfall events.
