ANNUAL REPORT FOR 2004

**Benson Grove Mitigation Site
Johnston County
Project No. 8.1402211
TIP No. R-2547WM**

Prepared By:
Office of Natural Environment & Roadside Environmental Unit
North Carolina Department of Transportation
December 2004

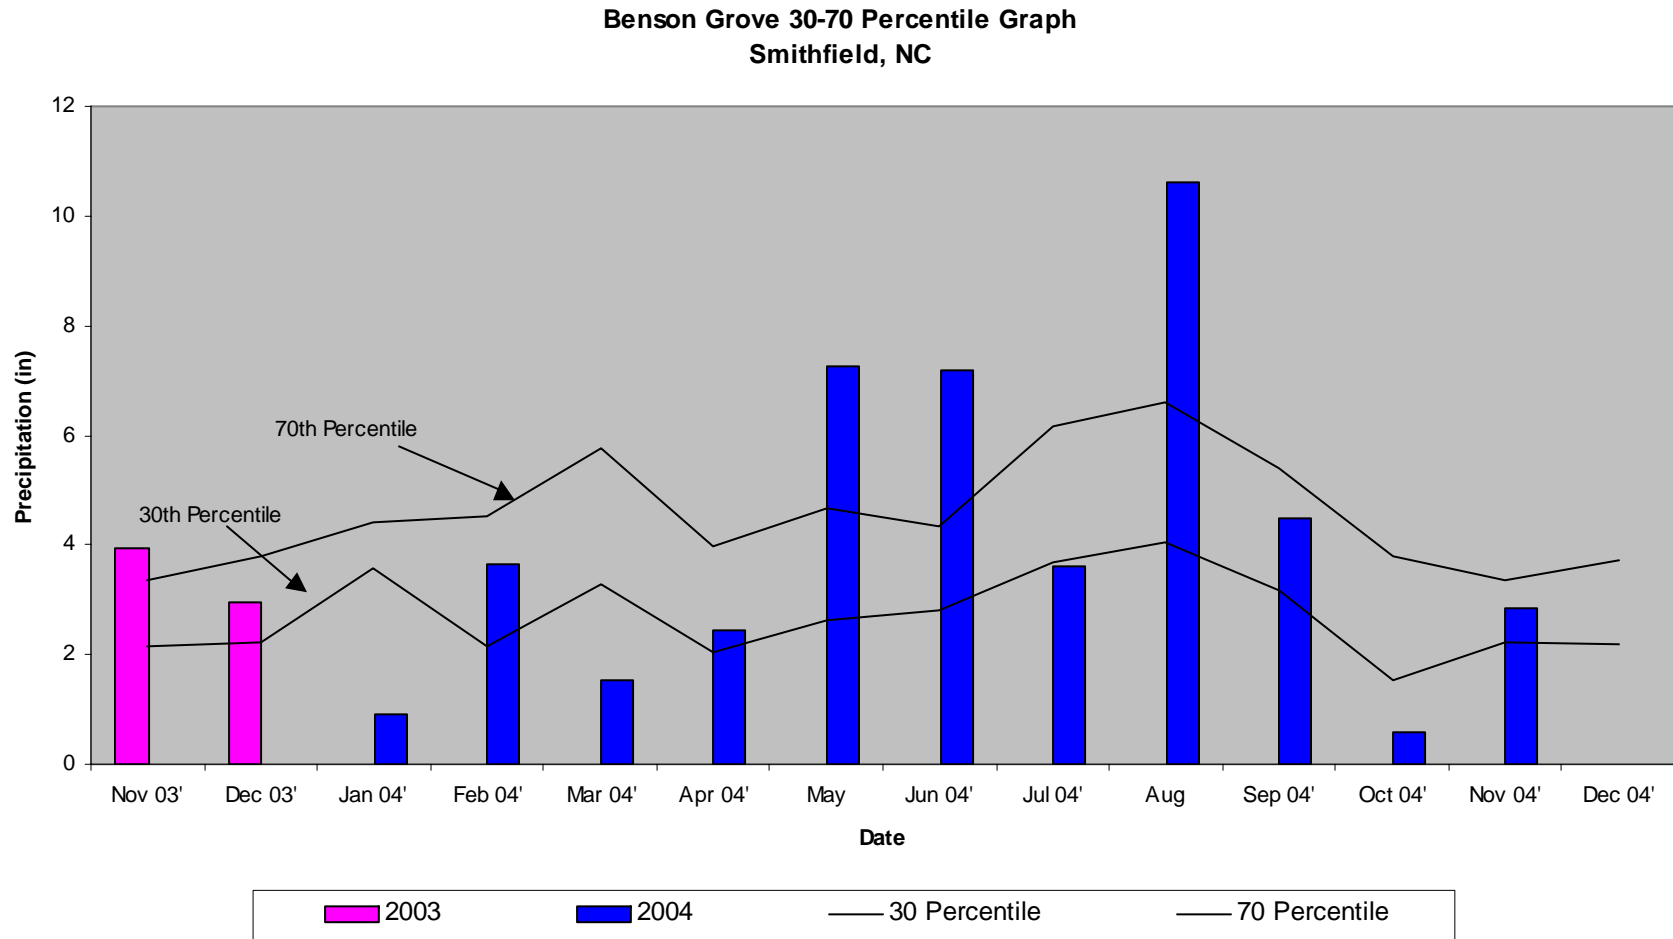
Figure 4: 30-70 Percentile Graph

Figure 4 provides an evaluation of the local climate in comparison with historical data in order to determine whether 2004 was “average” in terms of rainfall. The two lines represent the 30th and 70th percentiles of monthly precipitation for Smithfield. The bars are the monthly rainfall totals for the 2003 and 2004 hydrologic year. The historical data and monthly rainfall was collected by the National Climatic Data Center.

Months with below average rainfall include: January, March, July, and October. The months of December (03'), February, April, September and November experienced average rainfall. November (03'), May, June, and August experienced above average rainfall. Overall, the site experienced average rainfall in 2004.
