ANNUAL REPORT FOR 2004

Key Branch Mitigation Site
Anson County
WBS Element 34398.4.1
TIP No. R-2239WM

Office of Natural Environment & Roadside Environmental Unit
North Carolina Department of Transportation
December 2004

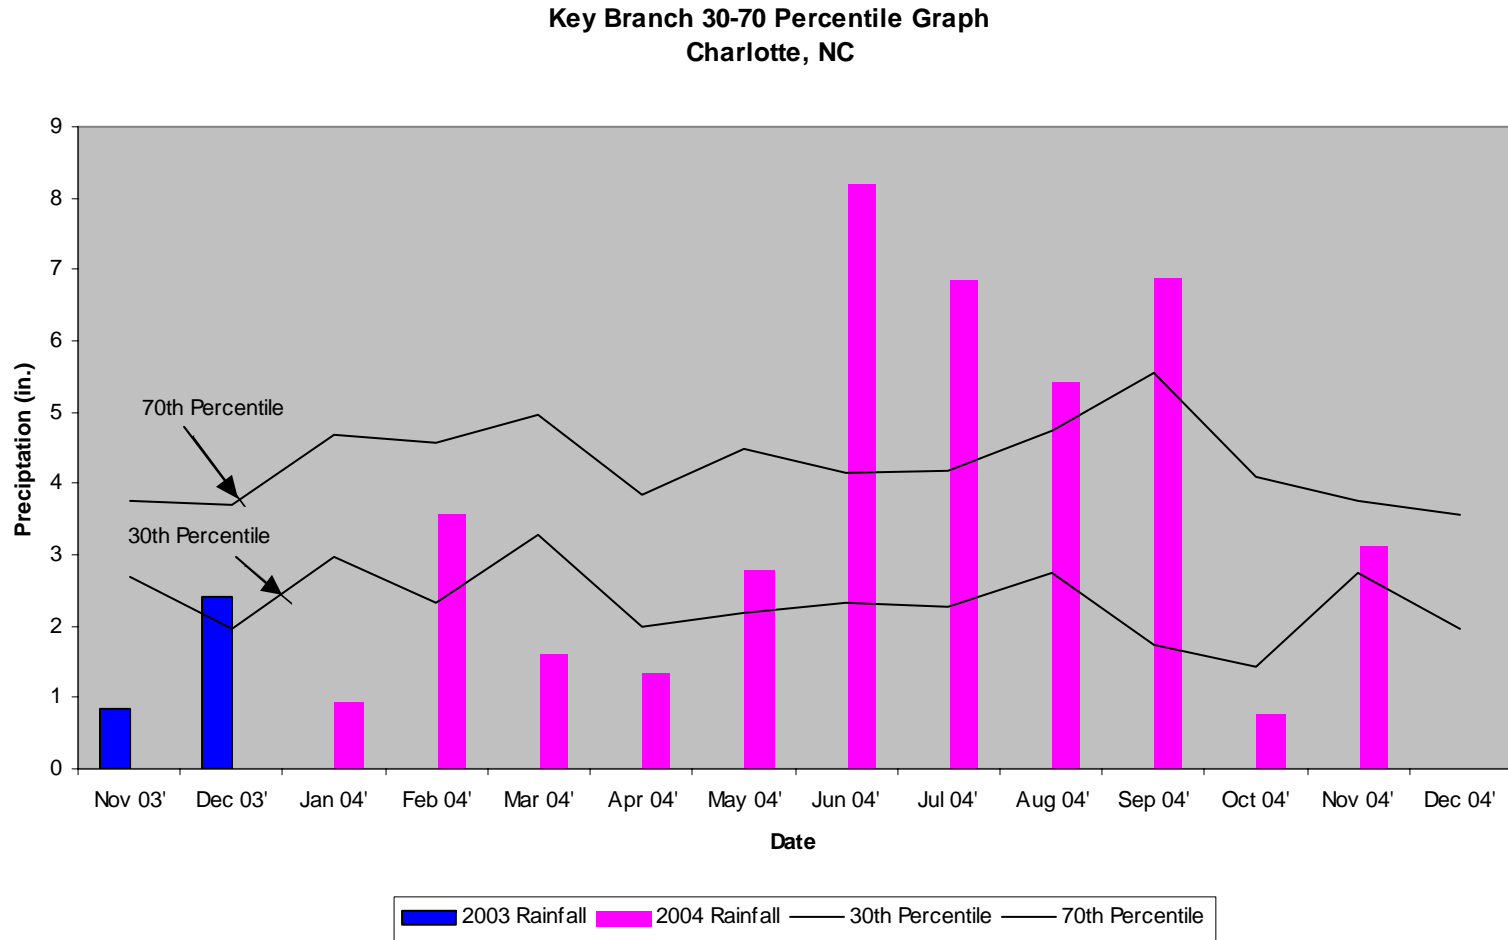
Figure 4: 30-70 Percentile Graph

Figure 4 is a comparison of 2003 and 2004 monthly rainfall to historical precipitation for the area. This comparison indicates whether 2004 was “average” in terms of climate conditions by comparing the rainfall to that of historical rainfall (data collected between 1973 and 2004). The NC State Climate Office provided all historical data.

For the 2004-year June, July, August and September experienced above average rainfall. The months of November (03'), January, March, April, and October recorded below average rainfall for the site. December (03'), February, May, and November experienced average rainfall. Overall, 2004 experienced an average rainfall year (with a drier than average spring and wetter than average summer and early fall).
