ANNUAL REPORT FOR 2004

**Mashoes Road Mitigation Site
Dare County
Project No. 8.T051402
TIP No. R-2551WM**

Prepared By:
Office of Natural Environment & Roadside Environmental Unit
North Carolina Department of Transportation
December 2004

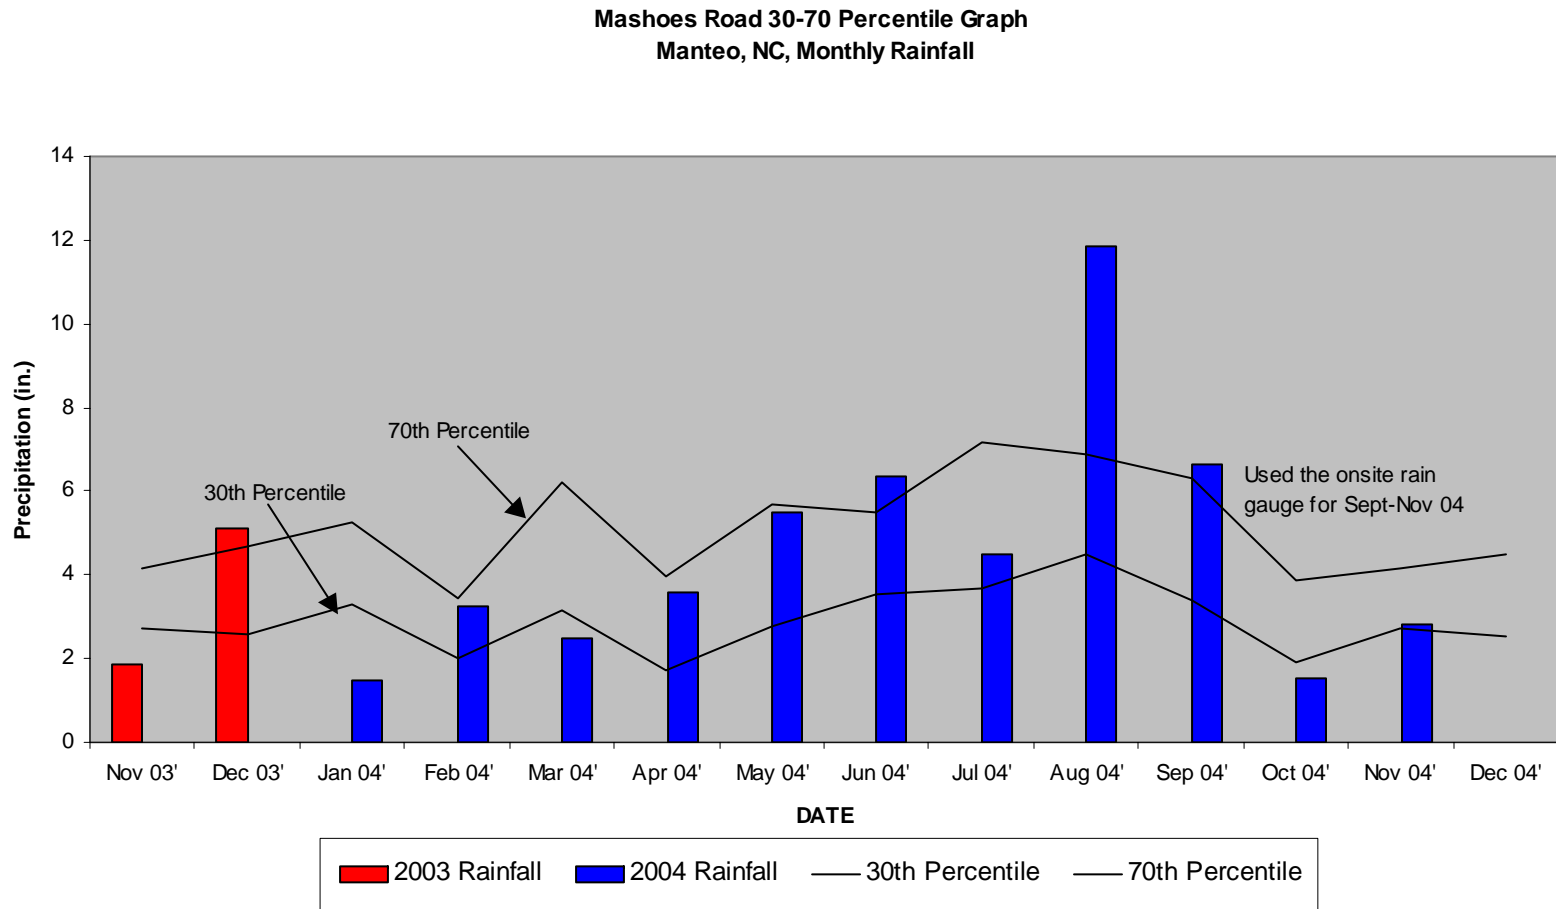
FIGURE 4. 30-70 Percentile Graph

Figure 4 provides an examination of the local climate in comparison with historical data in order to determine whether 2004 was “average” in terms of climate conditions. The two lines represent the 30th and 70th percentiles of monthly precipitation for Manteo, NC. The bars are monthly rainfall totals for 2003 and 2004. The historical data was collected from the State Climate Office of North Carolina.

For the 2004-year, November (03’), January, March, and October experienced below average rainfall. The months of February, April, May, July, and November all recorded average rainfall for the site. December (03’), June, August, and September experienced above average rainfall. The rainfall data from the onsite rain gauge was used for the months of September-November. Overall, 2004 experienced an average rainfall year.

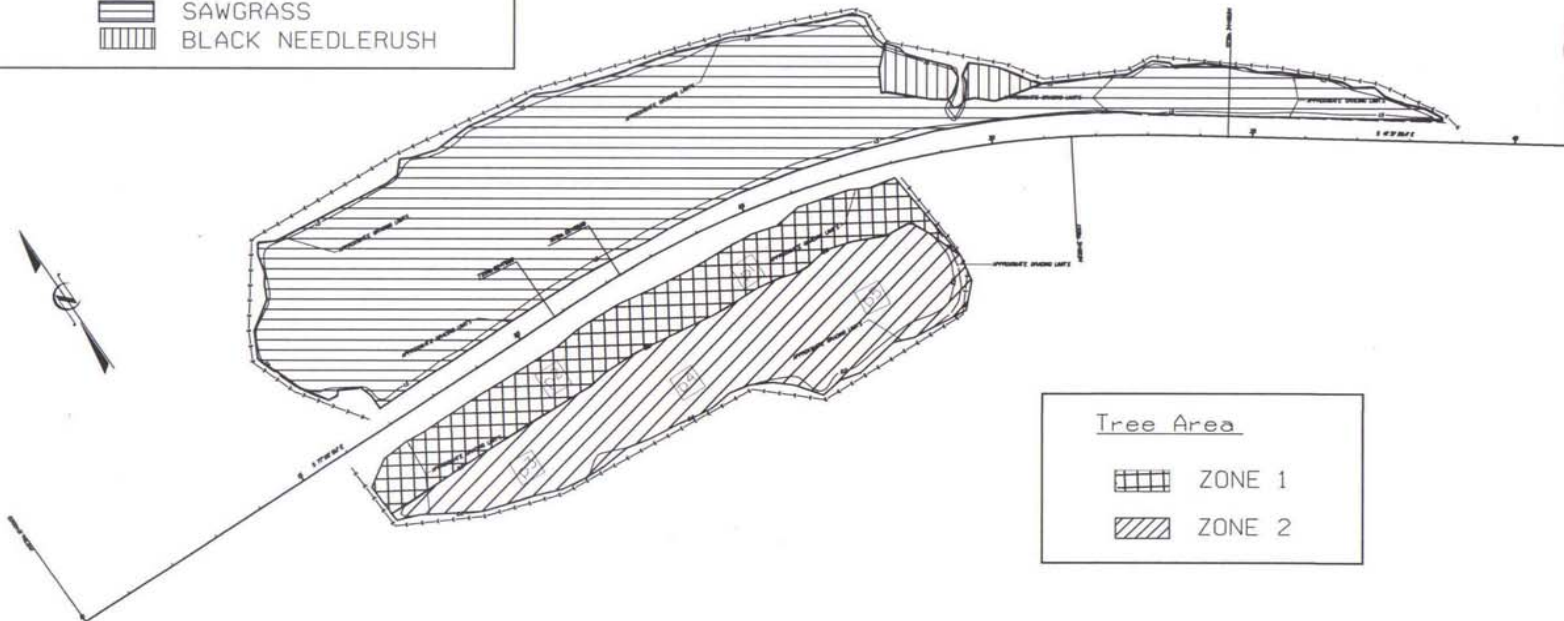
Dare County, North Carolina
Mashoes Road Mitigation Site
Planting Plan

Marsh Area

SAWGRASS

BLACK NEEDLERUSH

Tree Area

ZONE 1

ZONE 2

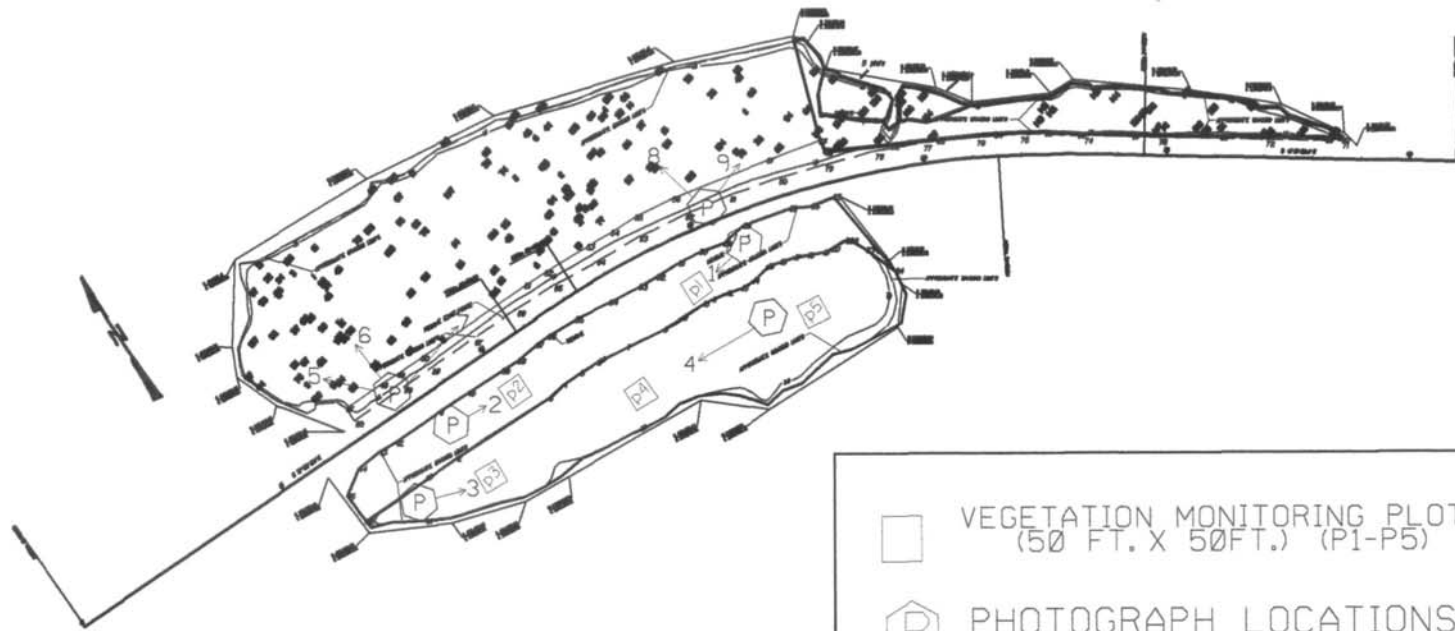
DARE COUNTY, NORTH CAROLINA
 MASHOES ROAD MITIGATION SITE
 Photo and Vegetation Plot Locations

-   VEGETATION MONITORING PLOTS
(50 FT. X 50FT.) (P1-P5)
-   PHOTOGRAPH LOCATIONS
