# ANNUAL REPORT FOR 2004

**Southwest Creek Mitigation Site  
Lenoir County  
Project No. 6.201014  
TIP No. R-2001B**

Prepared By:  
Office of Natural Environment & Roadside Environmental Unit  
North Carolina Department of Transportation  
December 2004

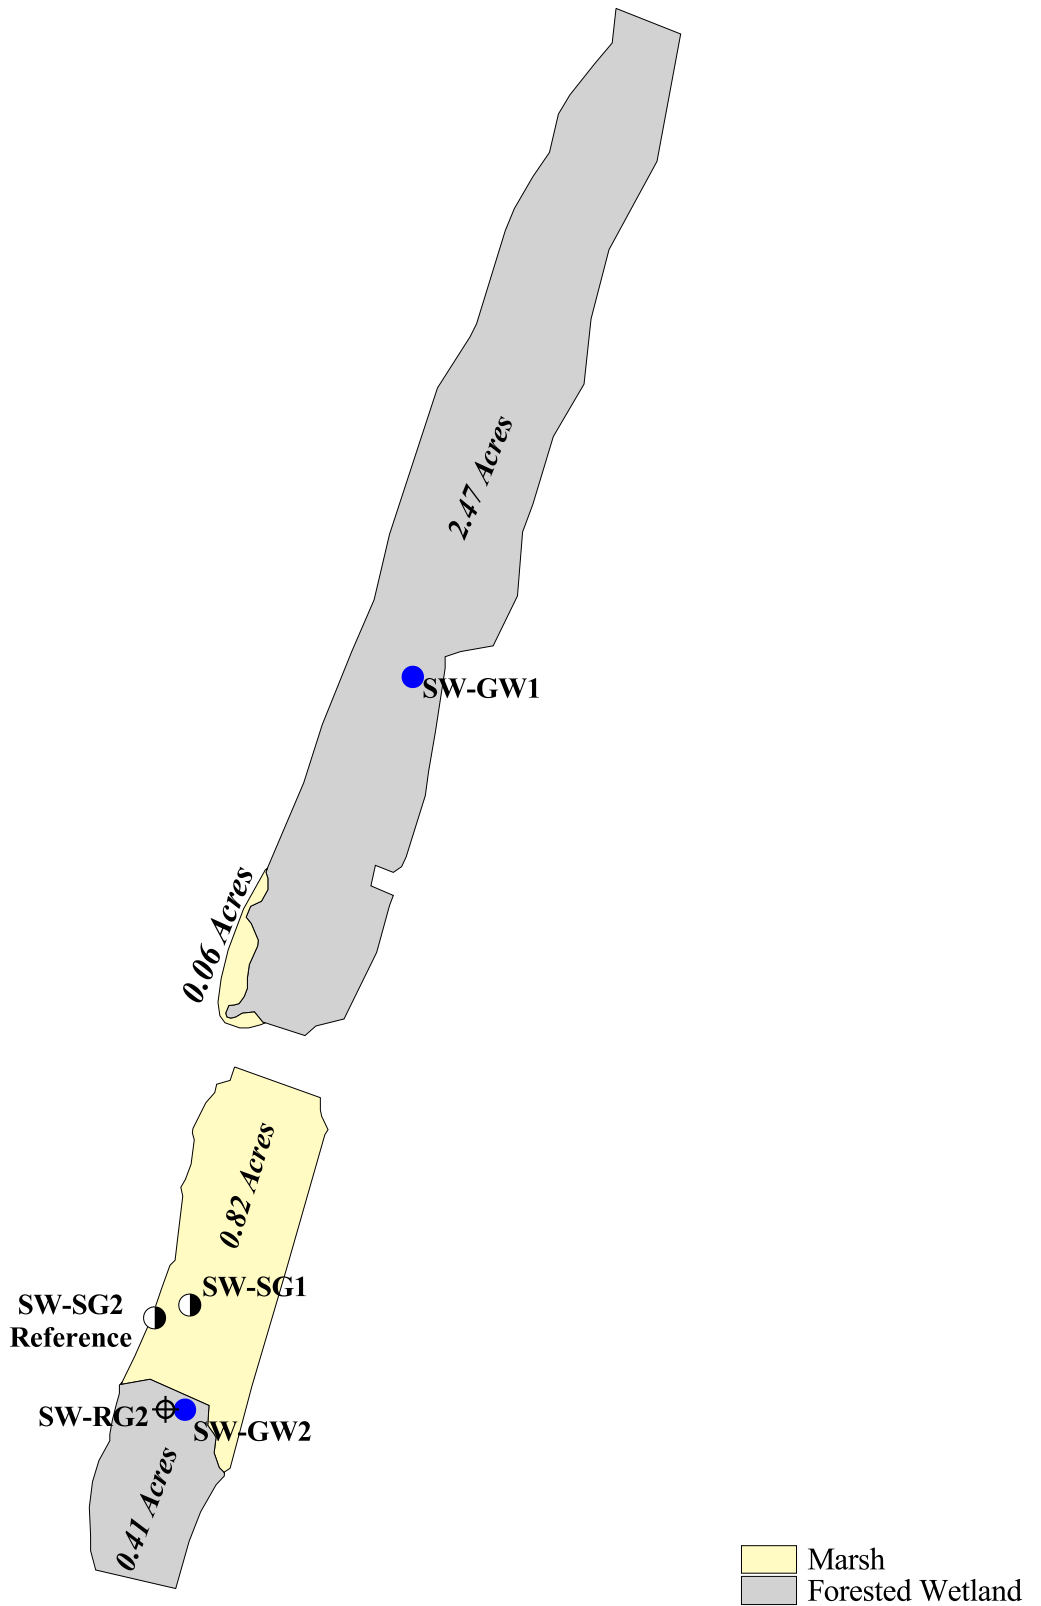
**Figure 3. 2004 Hydrologic Monitoring Gauge Results**

The total number of consecutive days that the groundwater was within twelve inches of the surface was determined at each groundwater monitoring gauge location. This number was converted into a percentage of the total growing season. Table 1 presents the hydrologic results for 2004. Figure 3 is a graphical representation of the hydrologic monitoring results for 2004.

The restored marsh gauge (SG-1) was comparable with the flooding patterns and inundation periods from the reference marsh gauge (SG-2).

Monitoring Gauge	< 5%	5-8%	8-12.5%	>12.5%	Actual %	Dates of Saturation
SW-GW1				×	38.9	March 17-May 11 Aug 13-Nov 15
SW-GW2				×	35.6	March 17-May 20 May 24-July 16 July 23-Oct 17

The 2004-year represents the second full growing season for which the hydrologic data has been examined. Both groundwater gauges in the forested wetland met the requirement for jurisdictional wetland hydrology (12.5% of the growing season). The restored marsh gauge (SG-1) was comparable with the flooding patterns and inundation periods from the reference marsh gauge (SG-2).

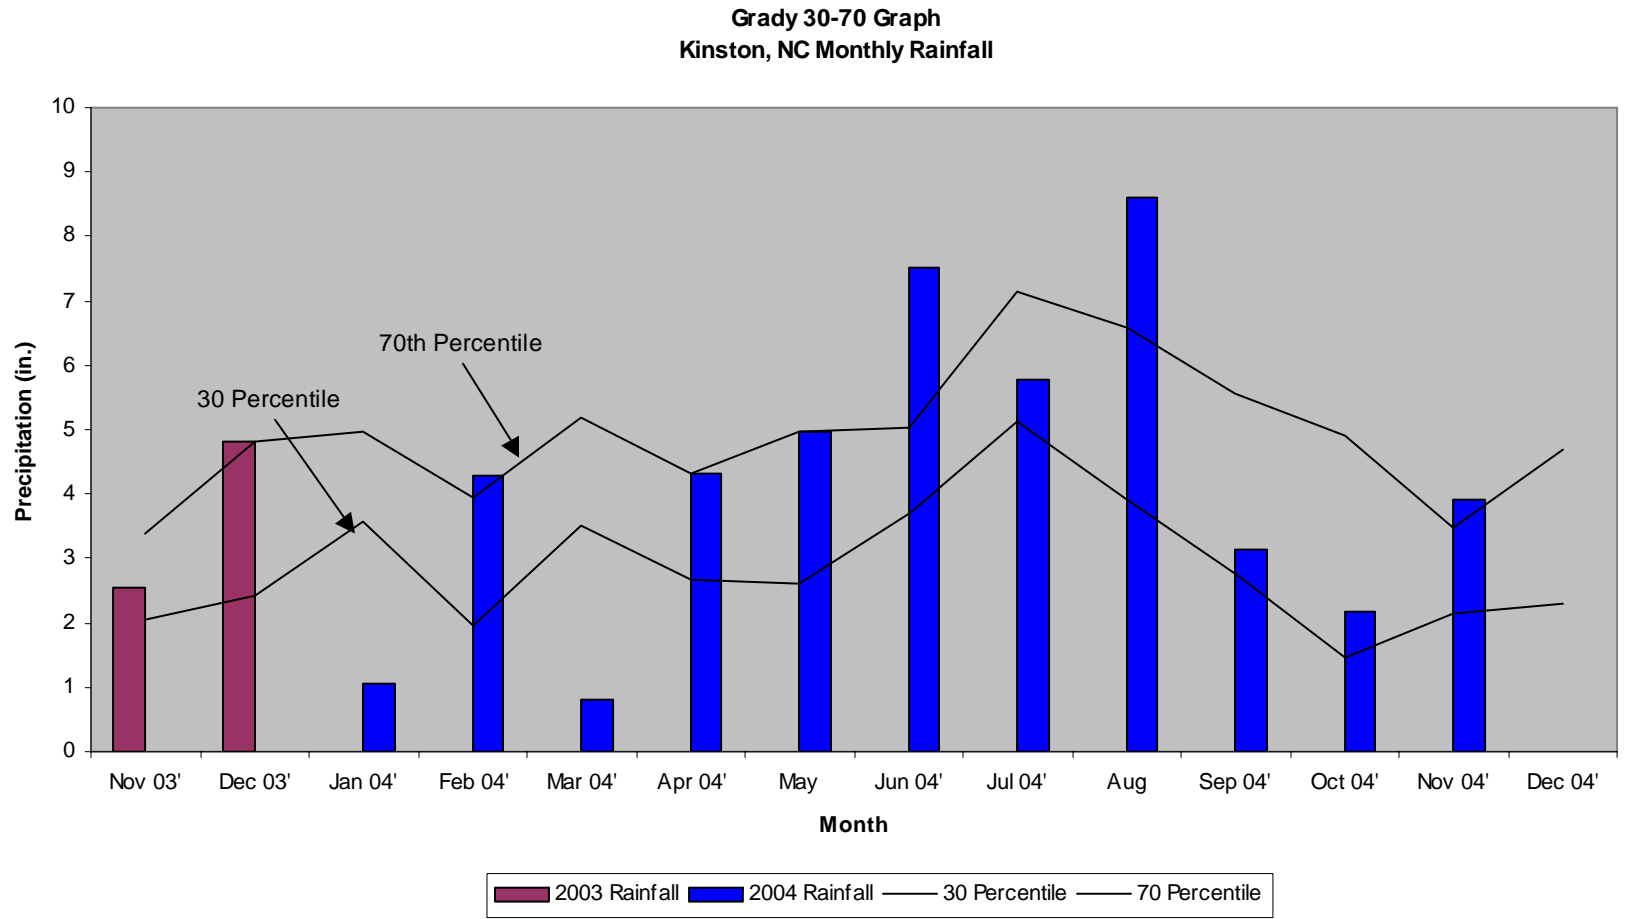
Figure 4. 30-70 Percentile Graph, Kinston, NC

Figure 4 is a comparison of monthly rainfall for the period of November 2003 through November 2004 to historical precipitation (collected between 1973 and 2004) for Kinston, North Carolina. This comparison gives an indication of how 2004 relates to historical data in terms of climate conditions. The NC State Climate Office provided all local rainfall information.

For the 2004-year, December (03') February, June, August, and November experienced above average rainfall. The months of January and February recorded below average rainfall and November (03'), April, May, July, September, and October experienced average rainfall. Overall, 2004 experienced an average to above average rainfall year.
