# ANNUAL REPORT FOR 2004

**Smith Creek Mitigation Site**  
**New Hanover County**  
**Project No. 8.2250109**  
**TIP No. U-92 A/B**

Prepared By:  
Office of Natural Environment & Roadside Environmental Unit  
North Carolina Department of Transportation  
December 2004

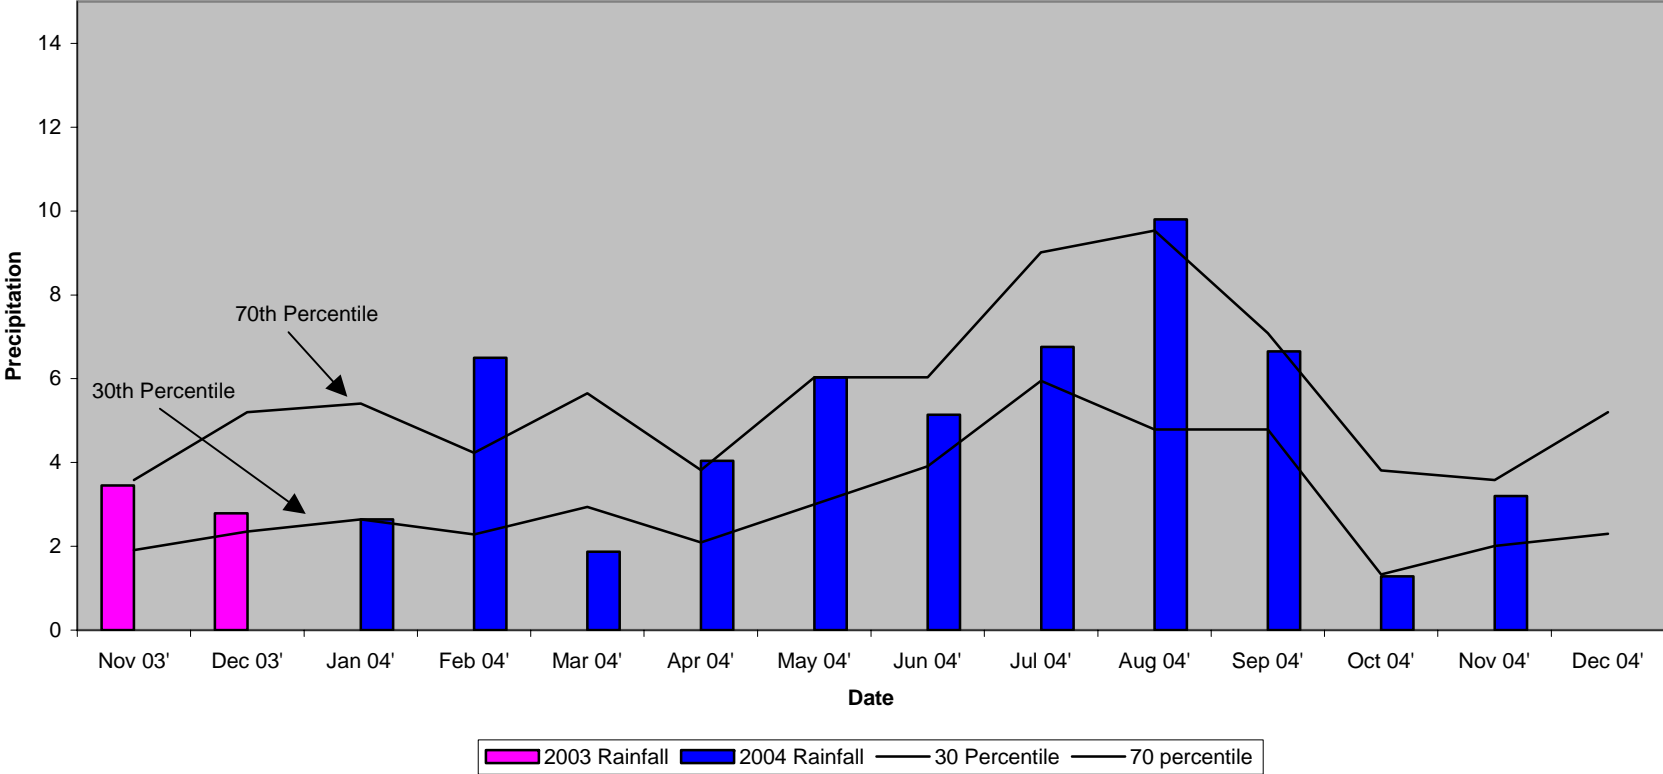
**FIGURE 3: 2004 30-70 Percentile Graph**

Figure 3 examines the local climate in comparison with historical data in order to determine whether 2004 was "average" in terms of climate conditions. The two lines represent the 30<sup>th</sup> and 70<sup>th</sup> percentiles of monthly precipitation for Wilmington, NC. The bars are monthly rainfall totals for 2003 and 2004. The historical data was collected from the State Climate Office of North Carolina.

For the 2004-year, February and August experienced above average rainfall. The months of March and October recorded below average rainfall for the site. November (03'), December (03'), January, April, May, June, July, September, and November experienced average rainfall. Overall, 2004 was an average rainfall year at the Smith Creek Mitigation Site.
