# ANNUAL REPORT FOR 2004

**Wiggins Mill Mitigation Site**  
**Wilson County**  
**Project No. 8.1330509**  
**TIP No. R-1030WM**

Office of Natural Environment & Roadside Environmental Unit  
North Carolina Department of Transportation  
December 2004

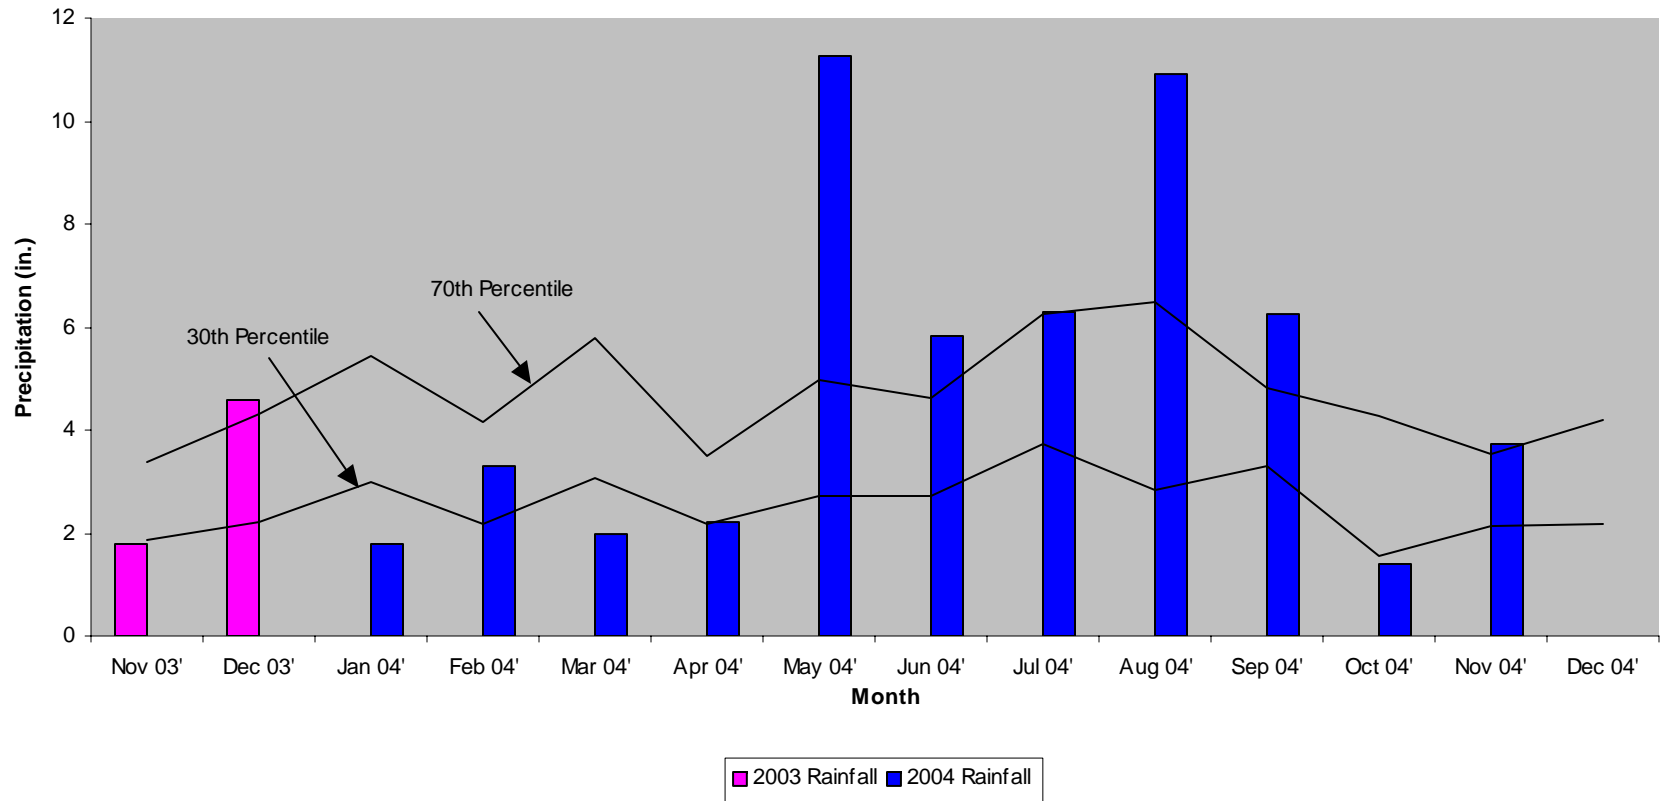
**Figure 4. 30-70 Percentile Graph**

Figure 4 is a comparison of monthly rainfall for the period of November 2003 through November 2004 to historical precipitation (collected between 1973 and 2004) for Wilson, North Carolina. This comparison gives an indication of how 2004 relates to historical data in terms of average rainfall. The NC State Climate Office provided all historical data.

For the 2004-year, November (03'), January, March, April, and October experienced below average rainfall. The months of February and July recorded average rainfall for the site. December (03') May, June, August, September, and November experienced above average rainfall. Overall, 2004 experienced an average to above average rainfall year.
