# ANNUAL REPORT FOR 2005

**Sawmill Mitigation Site  
Craven County  
Project No. 8.1170801  
TIP No. B-2531WM**

Natural Environment Unit & Roadside Environmental Unit  
North Carolina Department of Transportation  
December 2005

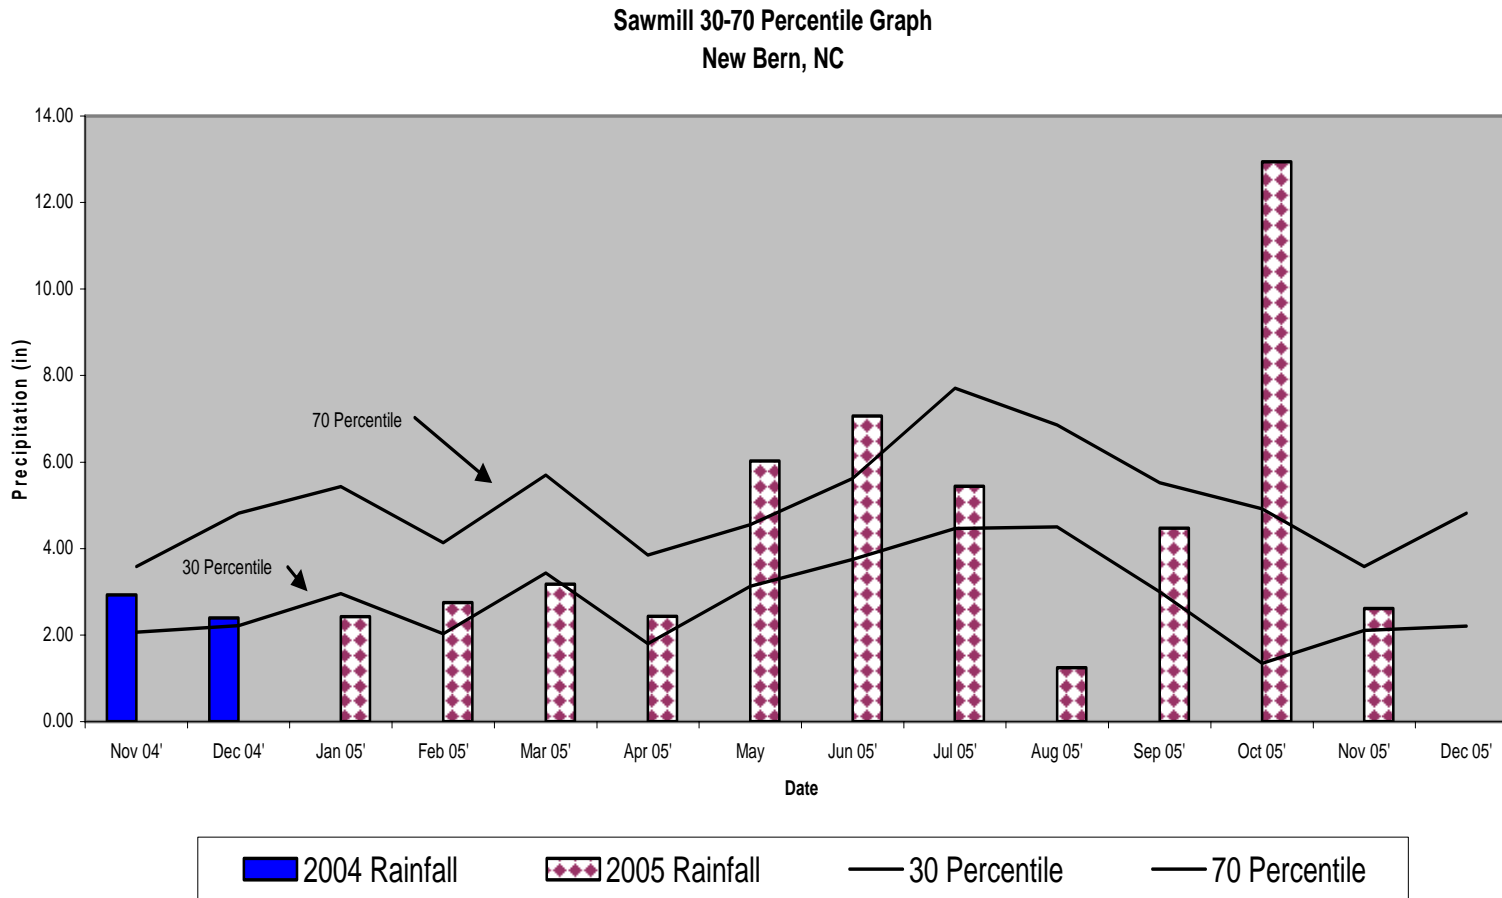
**Figure 4.** 30-70 Percentile Graph, New Bern, NC

Figure 4 is a comparison of the 2005 monthly rainfall to the historical precipitation (collected between 1975 and 2005) for New Bern, North Carolina. This comparison gives an indication of how 2005 relates to historical data in terms of climate conditions. The NC State Climate Office provided all local rainfall information.

This graph is used to indicate the general precipitation conditions for the surrounding area. Overall, the 2005-year exhibited normal rainfall. The data obtained for the 2005-year indicates that rainfall going into and at the beginning of the 2005 growing season (November to April) tended to be on the low side of normal. The rainfall for May and June were above normal. The rainfall for the remainder of the growing season tended to be normal with August being well below normal and October being well above normal.
