# ANNUAL REPORT FOR 2005

**Roanoke Island Mitigation Site  
Dare County  
Project No. 8.1052501  
TIP No. K-4003**

Prepared By:  
Natural Environment Unit & Roadside Environmental Unit  
North Carolina Department of Transportation  
December 2005

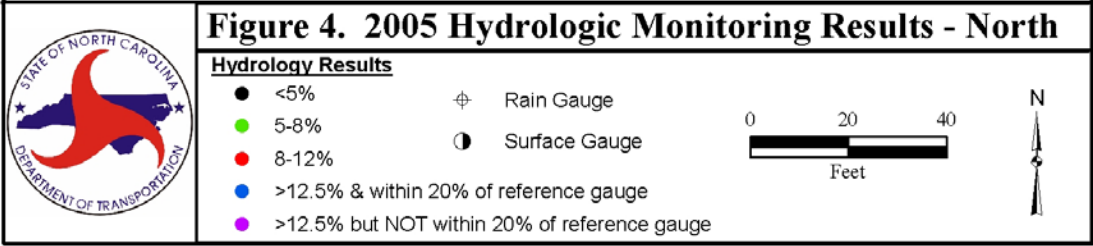
Table 1 is a summary of the hydrologic monitoring results for both the north and south tracts. The mitigation plan states that the hydrologic conditions of the constructed areas must be within 20% of those in the reference areas. Figures 4 and 5 are representations of the hydrologic monitoring results.

Gauge RINT-1 has recorded data for 221 consecutive days (85.7% of the growing season) and one data gap from March 16 through April 18. Using nearby gauges and adjacent data points to extrapolate missing data, it can be assumed that Gauge RINT-1 would have made jurisdictional hydrology for approximately 100% of the growing season.

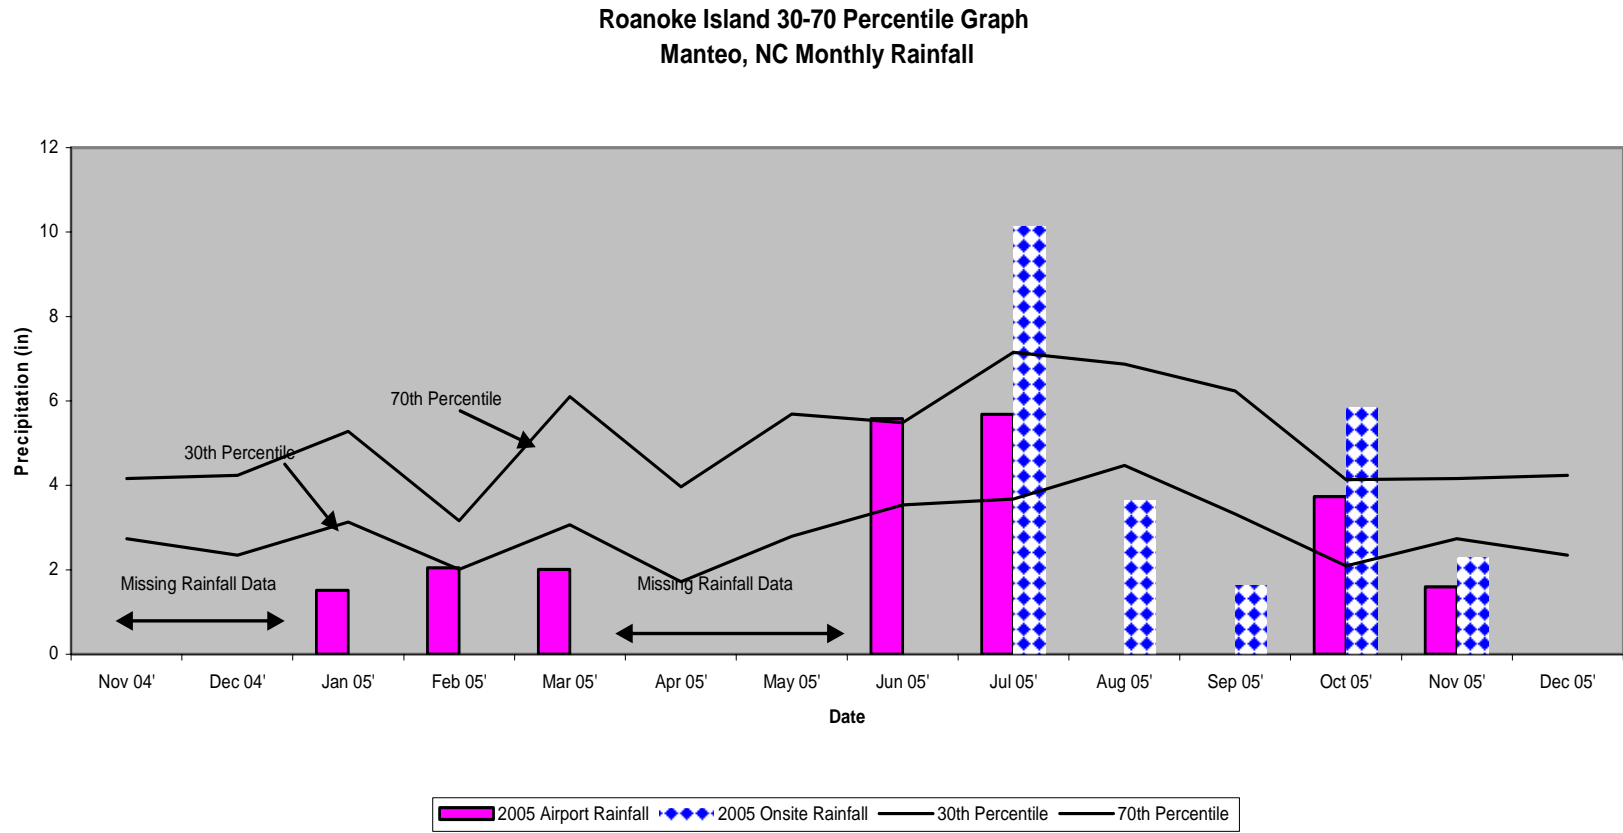
**Figure 6. 30-70 Percentile Graph: Manteo, NC**

Figure 6 provides an evaluation of the local climate in comparison with historical data in order to determine whether 2005 was “normal” in terms of climate conditions. The two lines represent the 30<sup>th</sup> and 70<sup>th</sup> percentiles of monthly precipitation for Manteo, NC. The bars are monthly rainfall totals for 2005. The historical data was collected from the State Climate Office of North Carolina. The rainfall data for the Roanoke Island Site is incomplete and can not be used to determine normalcy of rainfall. The rainfall data from the Manteo Airport is incomplete for April and August and there was no data collected in June or September. The onsite rain gauge malfunctioned during the beginning of the growing season and the data collected through June is unreliable. The gauge was replaced in June.

Due to the incomplete rainfall data both onsite and offsite only broad generalization can be made for the rainfall in 2005. Based on the available data from the Manteo Airport, it appears that the rainfall going in to the 2005 growing season (January through May) was below normal, June was normal, and November was below normal. The on-site rainfall data shows August, September, and November were below normal. There is a discrepancy between the onsite and offsite data for July.

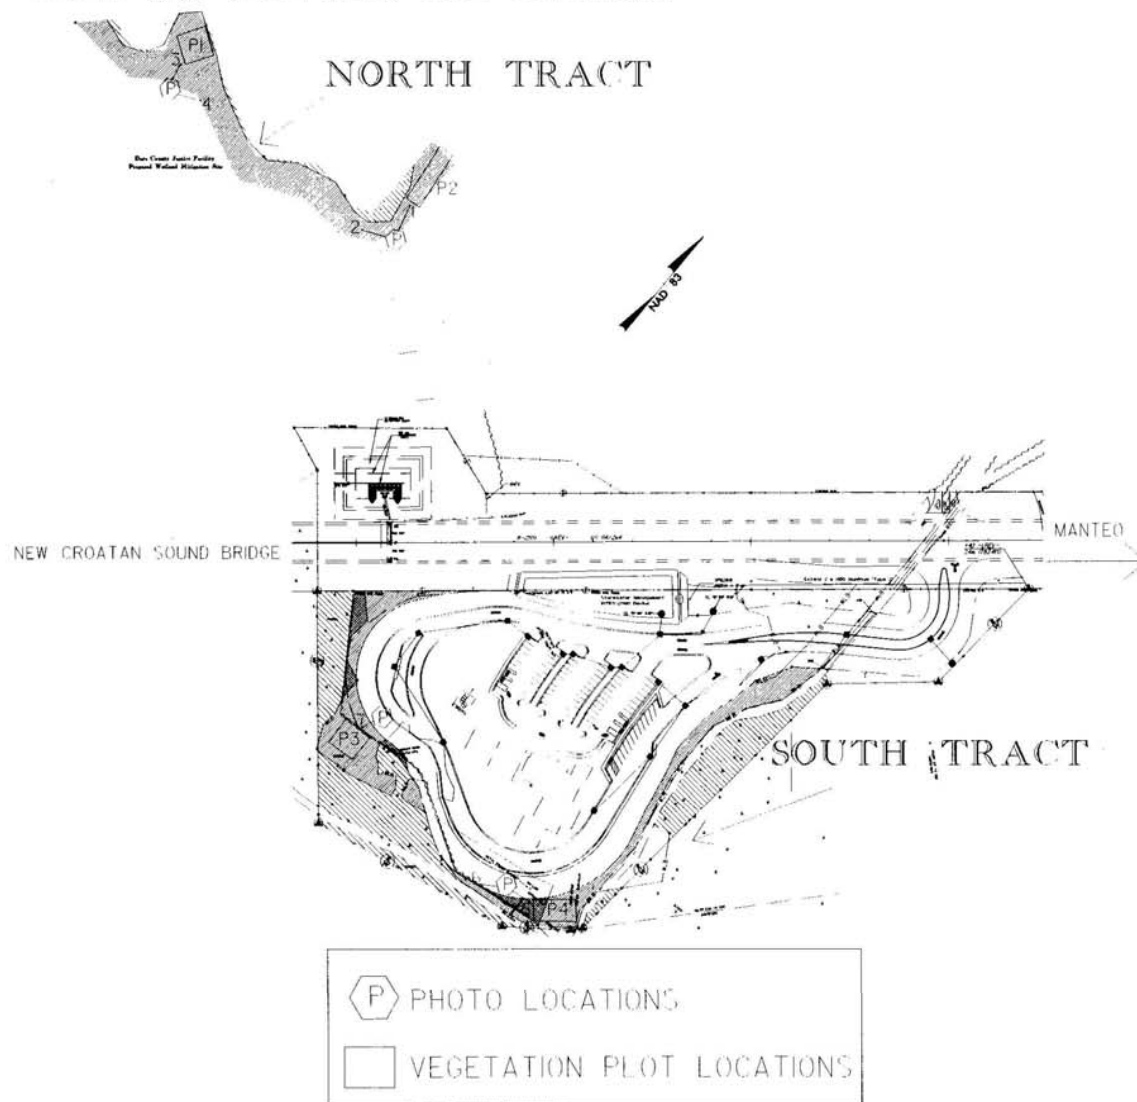
## PHOTO AND VEGETATION PLOT LOCATIONS

Plot #	Baldcypress	Wax Myrtle	Swamp Redbay	Loblolly Bay	Swamp Blackgum	Atlantic White Cedar	Total (1 year)	Total (at planting)	Density (Trees/Acre)
1	3				5		8	27	201
2	2	1			6	2	11	29	258
3	4	9					13	40	221
4	3	1			4		8	34	160
<b>Average Tree Density</b>									<b>210</b>
