# ANNUAL REPORT FOR 2005

**Deer Creek Mitigation Site  
Carteret County  
Project No. 6.16901T  
TIP No. R-2105 WM**

Prepared By:  
Natural Environment Unit & Roadside Environmental Unit  
North Carolina Department of Transportation  
December 2005

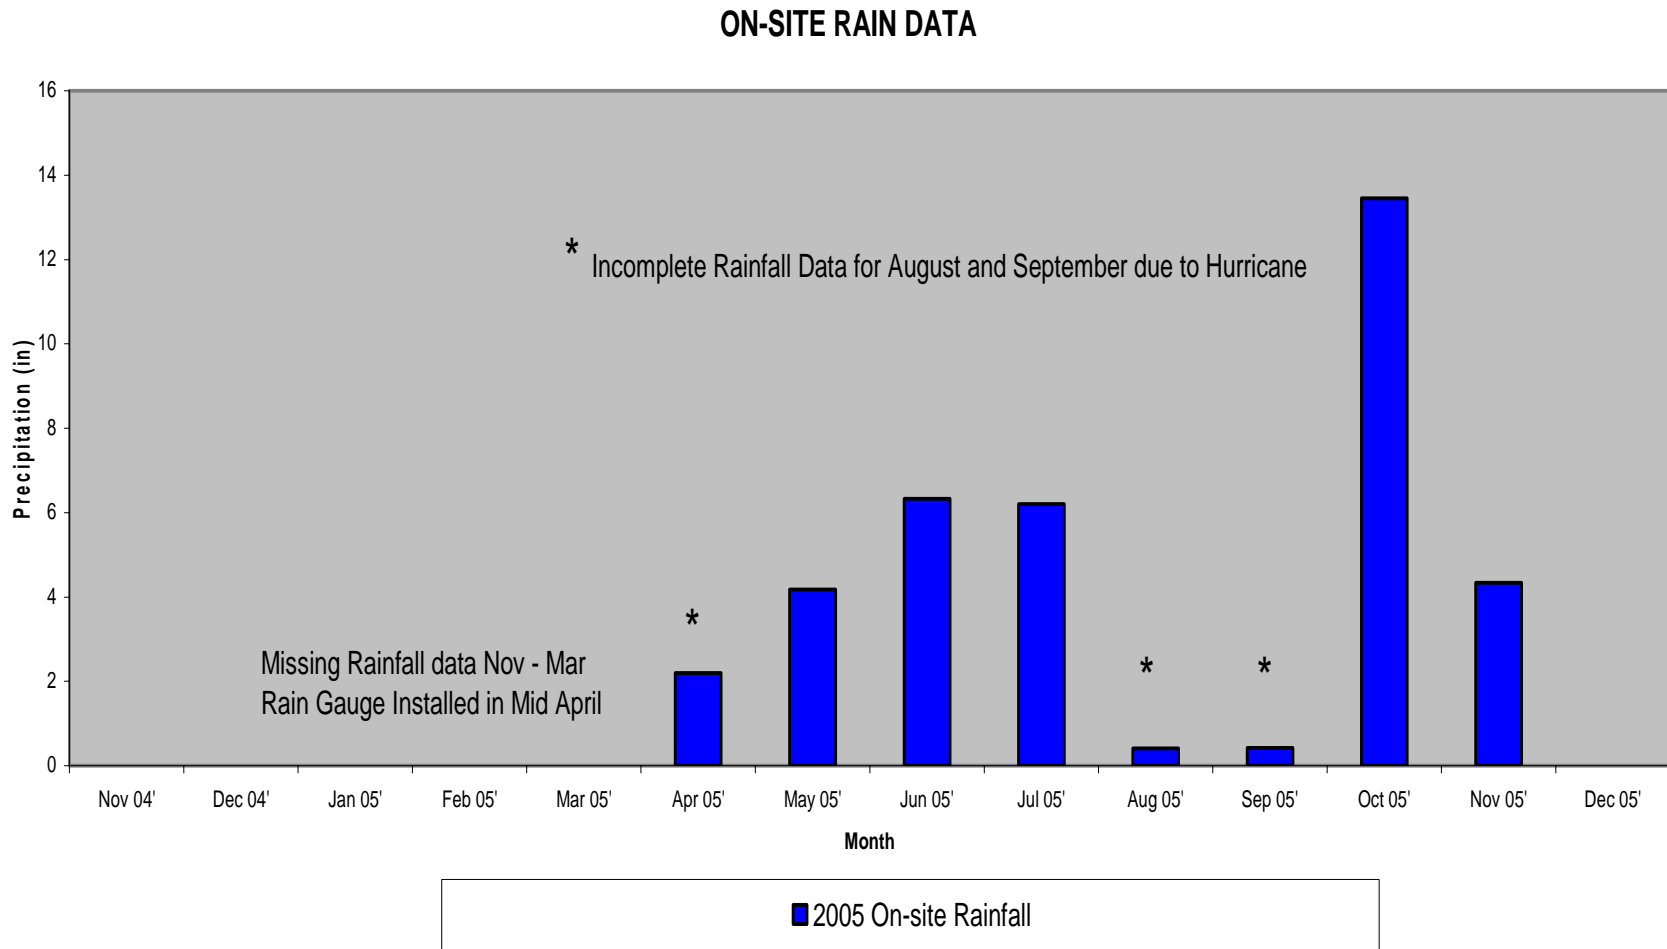
**Figure 3. Deer Creek On-site Rainfall Data**

Figure 3 is a depiction of the monthly on-site rainfall for 2005. In 2005, the Morehead Climate Station did not collect rainfall data, therefore no comparison between historic rainfall data and on-site rainfall data can be made. There is no on-site rainfall data available for November 2004 through March 2005. The on-site rain gauge was installed mid-April 2005. The on-site rain gauge was destroyed during Hurricane Ophelia and data is incomplete for August and September 2005.
