ANNUAL REPORT FOR 2003

Bridge Maintenance Mitigation Site

New Hanover County

Project No. 8.2250109

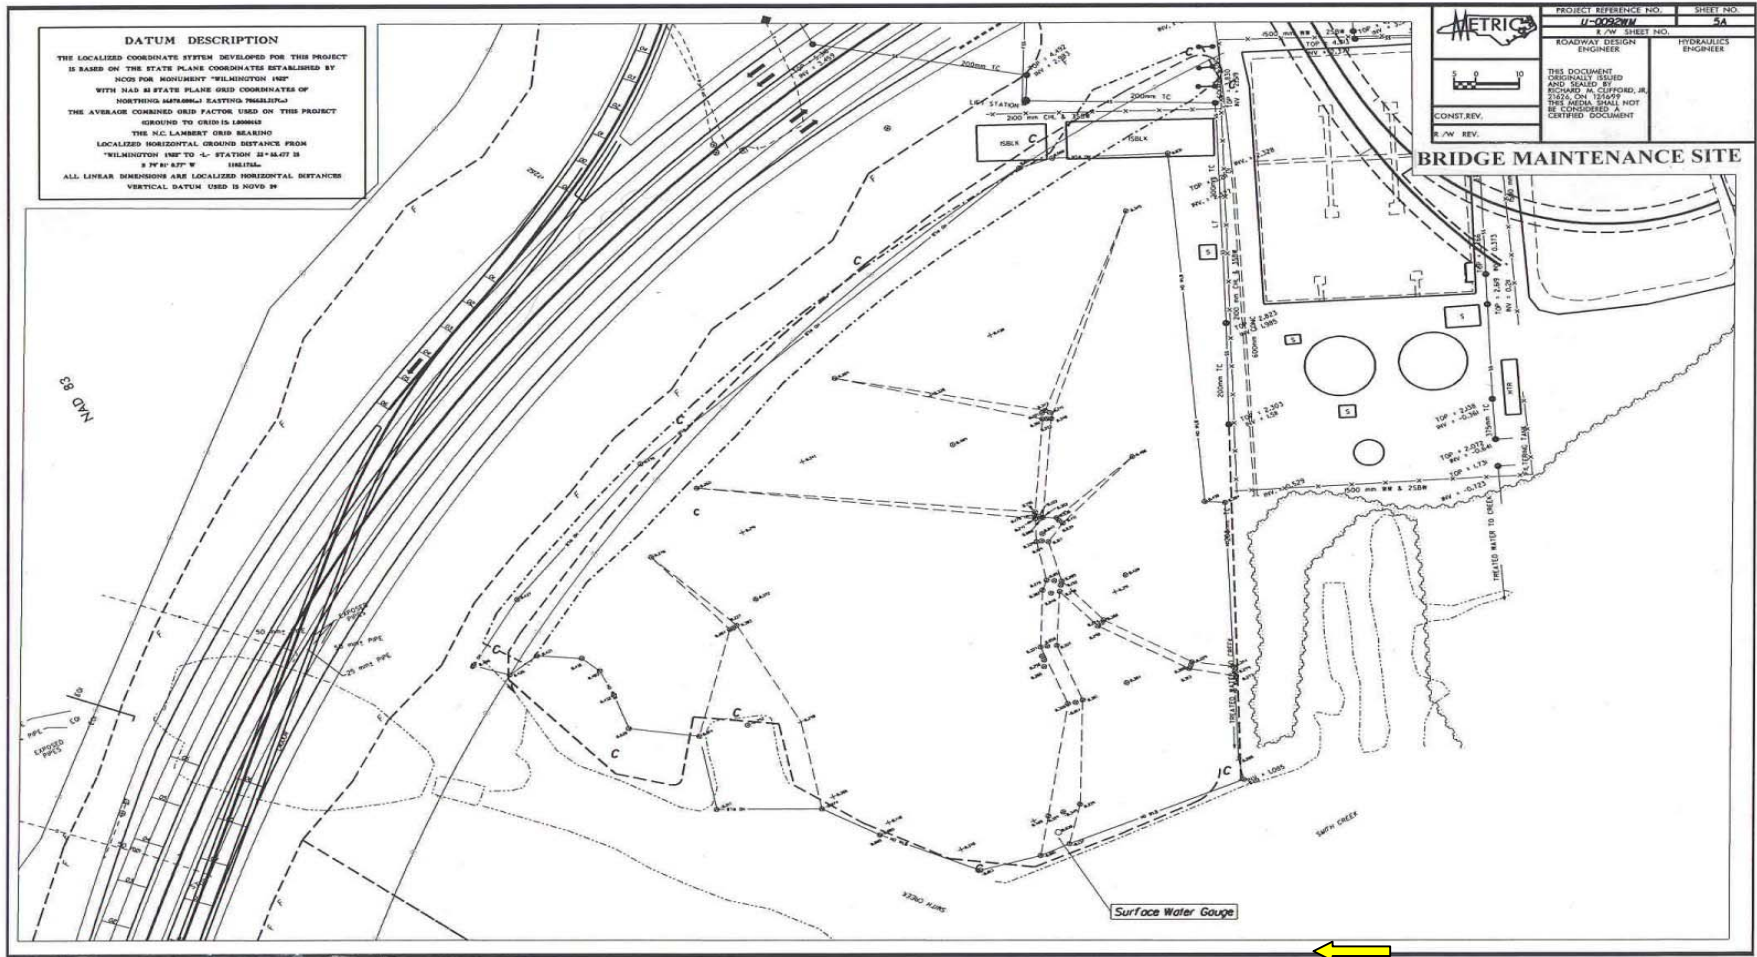
FIGURE 2. Surface Gauge Location Map

One 40-inch surface gauge, set to record hourly readings, was installed in July of 2000 (Figure 2). The elevation of the calibration point of the gauge was located using survey equipment, and was found to be at 33 inches above sea level. On November 6, 2000, the gauge was raised 12 inches on the pole to avoid being submerged during high water, making it 45 inches above sea level.
