# ANNUAL REPORT FOR 2005

**Cedar Point Mitigation Site  
Carteret County  
Project No. 6.16901T  
TIP No. R-2105 AB**

Prepared By:  
Natural Environment Unit & Roadside Environmental Unit  
North Carolina Department of Transportation  
December 2005

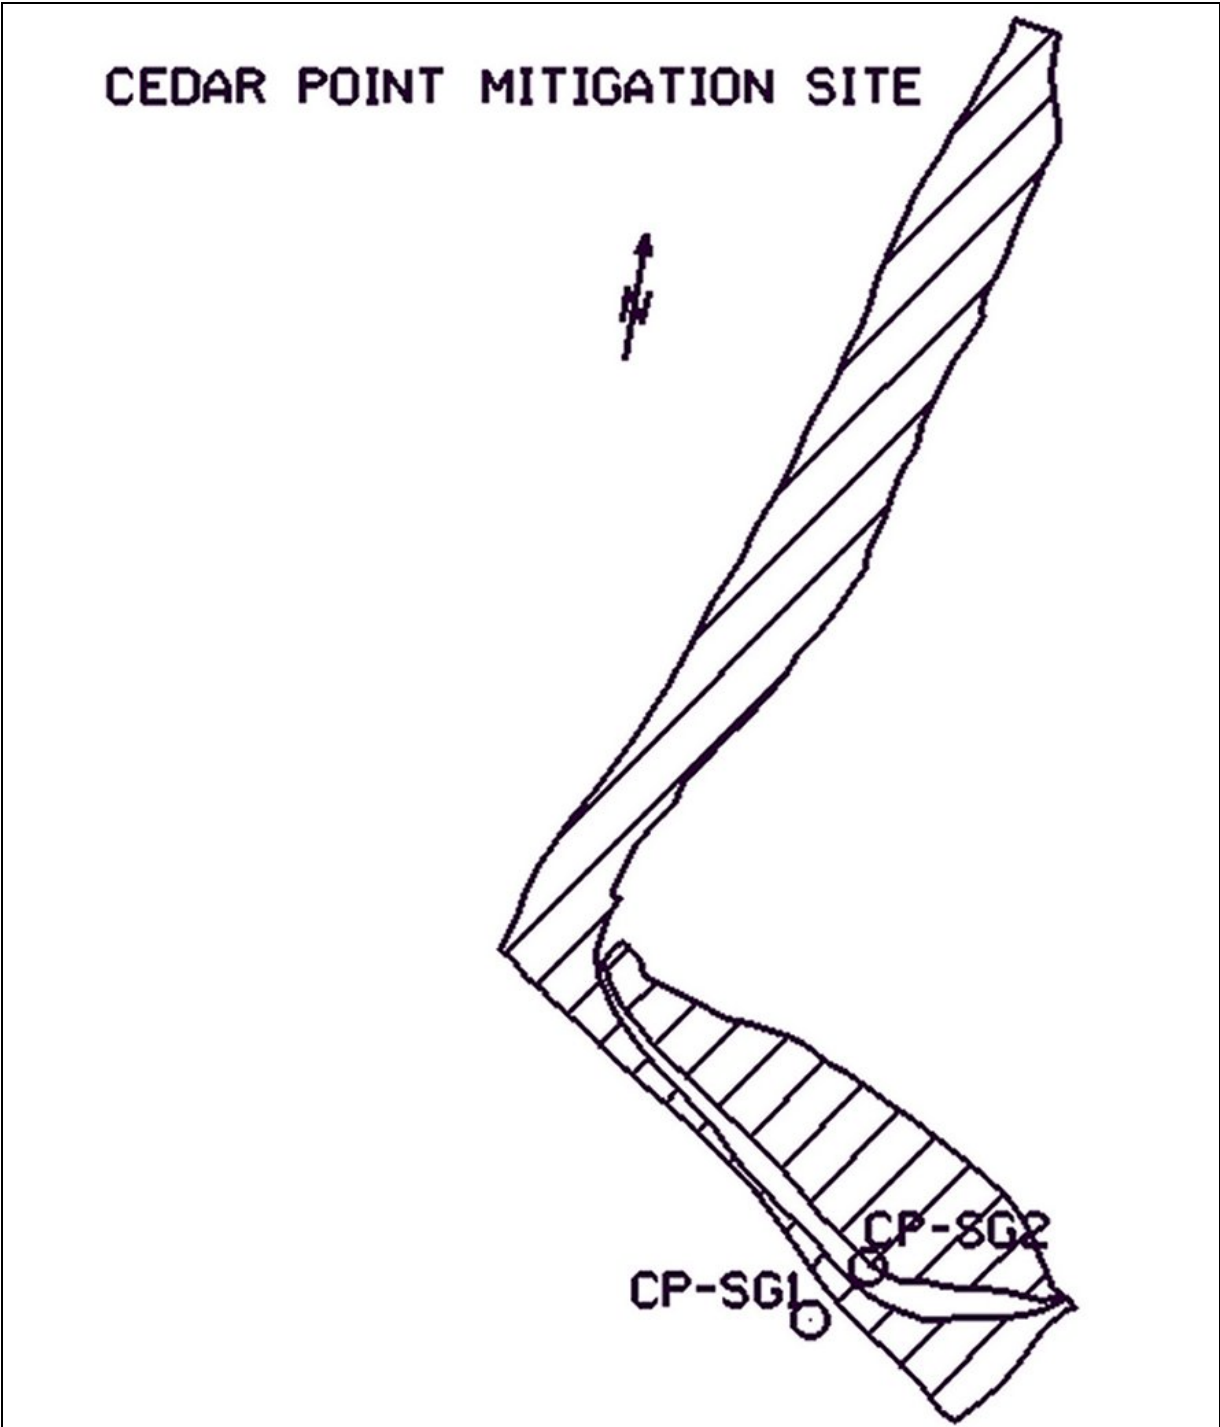
Figure 2. Gauge Location Map

Due to the site's proximity to the White Oak River, as well as the constructed channel designed to increase tidal exchange, the Cedar Point Site is monitored by surface water gauges (Figure 2). These gauges should indicate if the site is flooded twice daily as is required for success. The flooding regime of the site is expected to be the same as that measured for the biological benchmarks for *Spartina alterniflora*, since it can reflect long-term tidal fluctuations. A rain gauge was not installed as surface water is the primary hydrologic input to this site.
